BUILDING CONDITION ASSESSMENT
THE TEA PAVILION
200 JOHN STREET, NIAGARA-ON-THE-LAKE

April 27, 2022

Prepared by
Mark Shoalts, P.Eng., CAHP

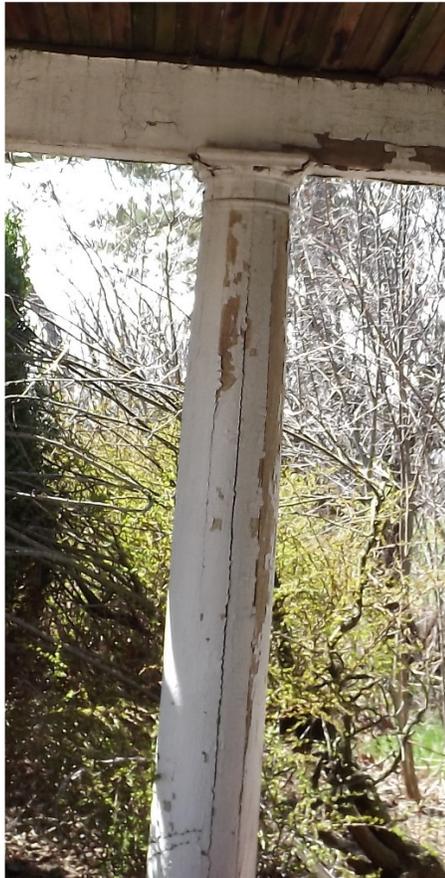
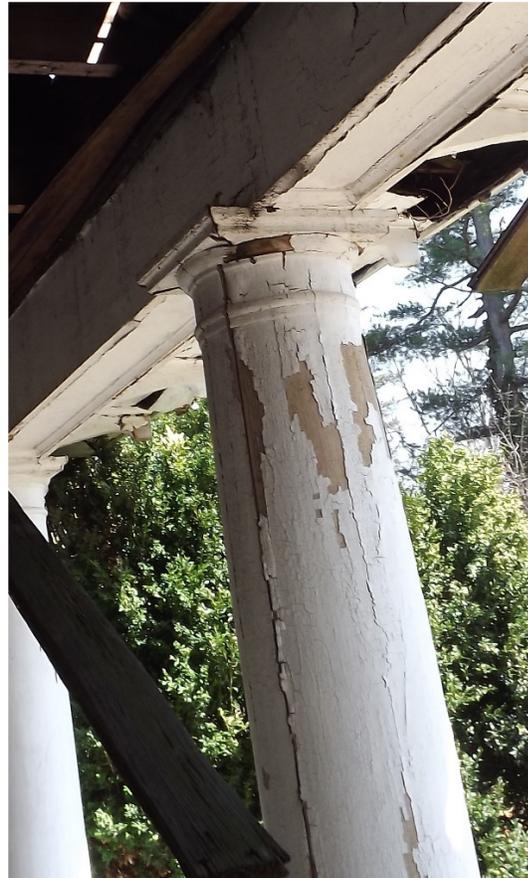
End column

The Tea Pavilion is in poor condition. The metal (presumably copper) roof shown on the Dunington-Grubb plan was not installed and the present asphalt shingles are long past their service life; they have been leaking for years. Much of the tongue and groove wood ceiling has collapsed and substantial sections of the eave have deteriorated. Some of the wood columns exhibit serious decay, especially the bases. Three columns in particular are in poor condition and they appear to possibly be replacements that have failed for a second time. The staves on the centre pair of columns facing the pool and one column in the south end are delaminating and the paint is peeling badly. All of the other columns have retained their paint and no joints between staves are even discernible, much less delaminating. The good columns give every appearance of being solid, but they are hollow as evidenced by electrical switches mounted on two of them. There is no obvious reason why three of the twelve round columns would be in such poor condition. The bases of these three columns as well as the bases of several other columns are also in poor condition and require replacement.

Staved columns failing

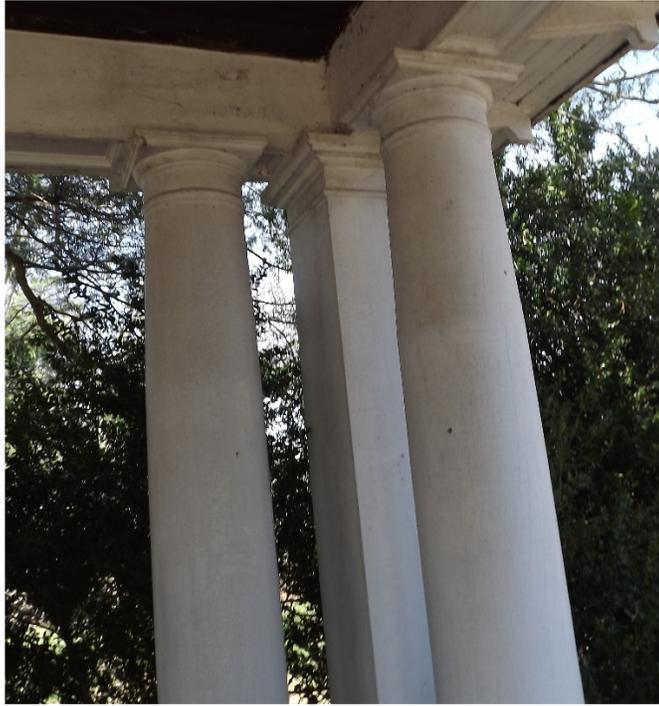
Corner columns in good condition

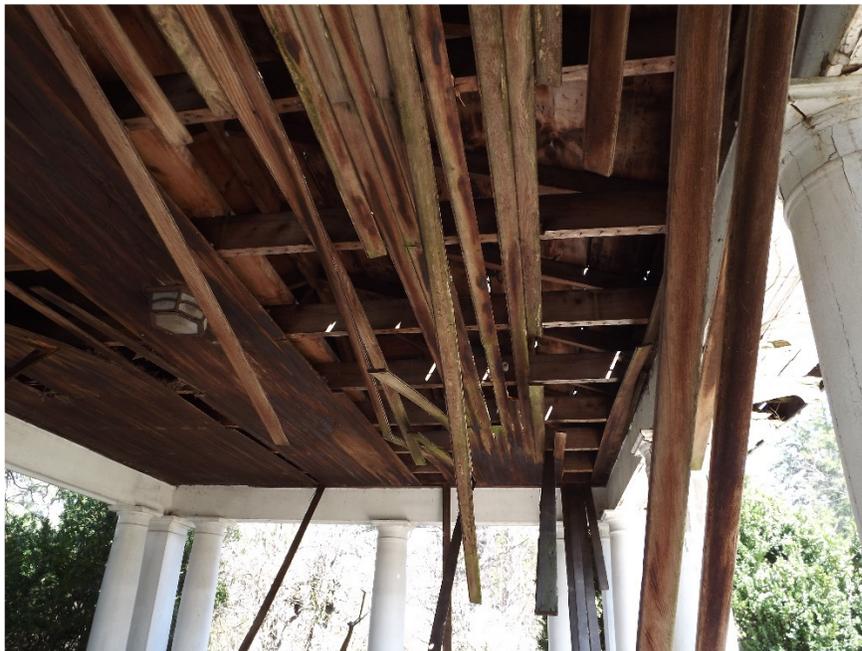
The roof leaks have led to the deterioration of some of the roof sheathing to the point where daylight shows between the planks. Many of the nails holding the ceiling have rusted off and the boards are hanging down or have fallen off completely. Leakage through the eaves has deteriorated a substantial portion of the soffit, although the eave brackets are generally good.

Deteriorated ceiling

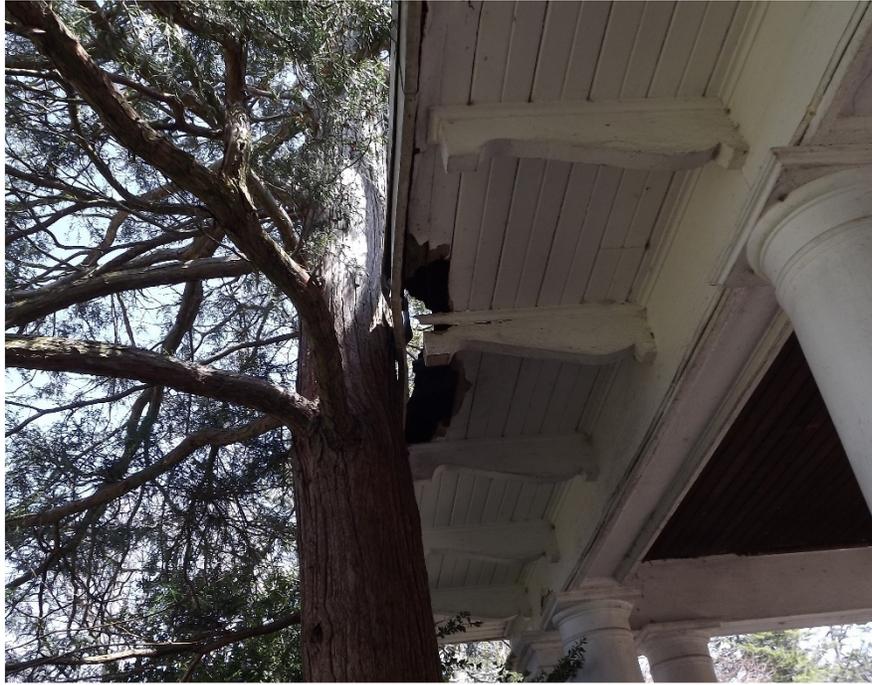
The vegetation around the pavilion is overgrown and requires maintenance, and one cedar tree in particular must be removed. It is not part of the planned landscape plantings but it has grown against the rear overhang, damaging the fascia and roofing, which has led to rotted soffit and ready access for squirrels into the attic.

Cedar tree requiring removal

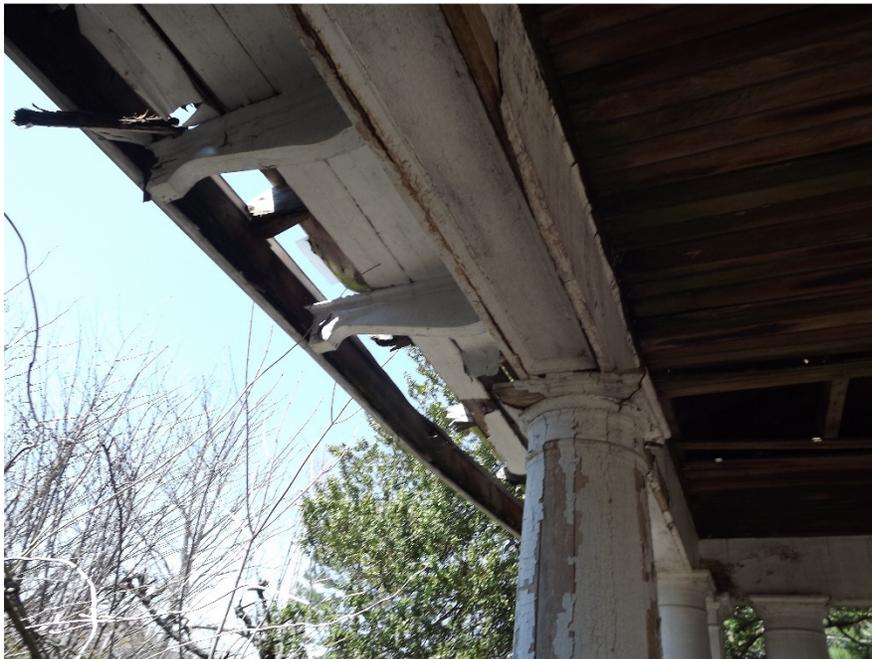
The eave, fascia, and brackets on the front of the pavilion have deteriorated substantially and a section requires replacement, including the cladding of the beam bearing on the columns. The condition of the beam itself was not observed and must be checked during the repairs.

Section of eave requiring replacement

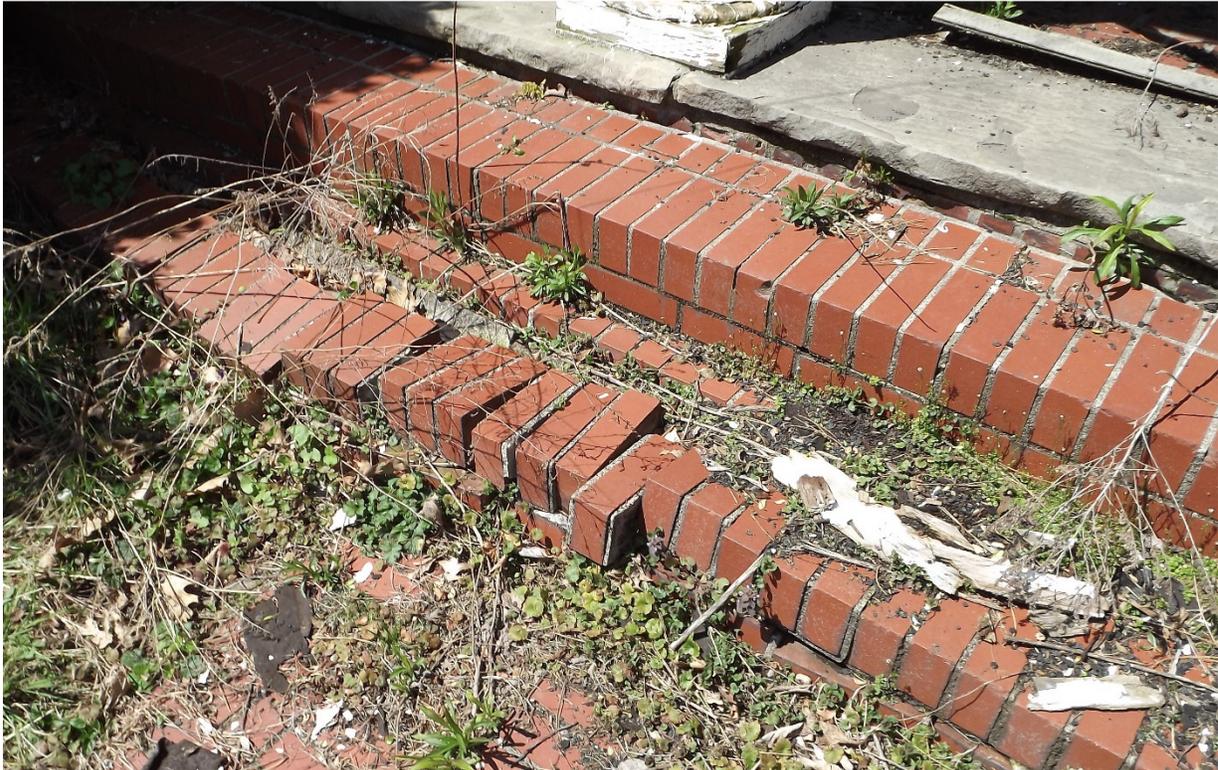
The floor is in good condition within the footprint of the pavilion. The bricks are in excellent condition, the mortar is good, and the sandstone border is good. The mortar joints in the sandstone require some minor cutting out and repointing. The brick steps across the front of the pavilion are in poor condition. The bricks themselves are in good condition but many of

the mortar joints have failed and a substantial portion of the concrete back-up has failed, allowing the steps to collapse.

Collapsed brick steps

The bricks must be removed and salvaged, the failed concrete chipped away, and the steps rebuilt. The concrete back-up must be repoured and the bricks relaid. The mortar joints in brick pavers, treads, and risers are vulnerable to frost damage because they are often wet when they freeze. An appropriate mortar mix with air entrainment must be used, and a sealer to limit water penetration of the joints is advisable.

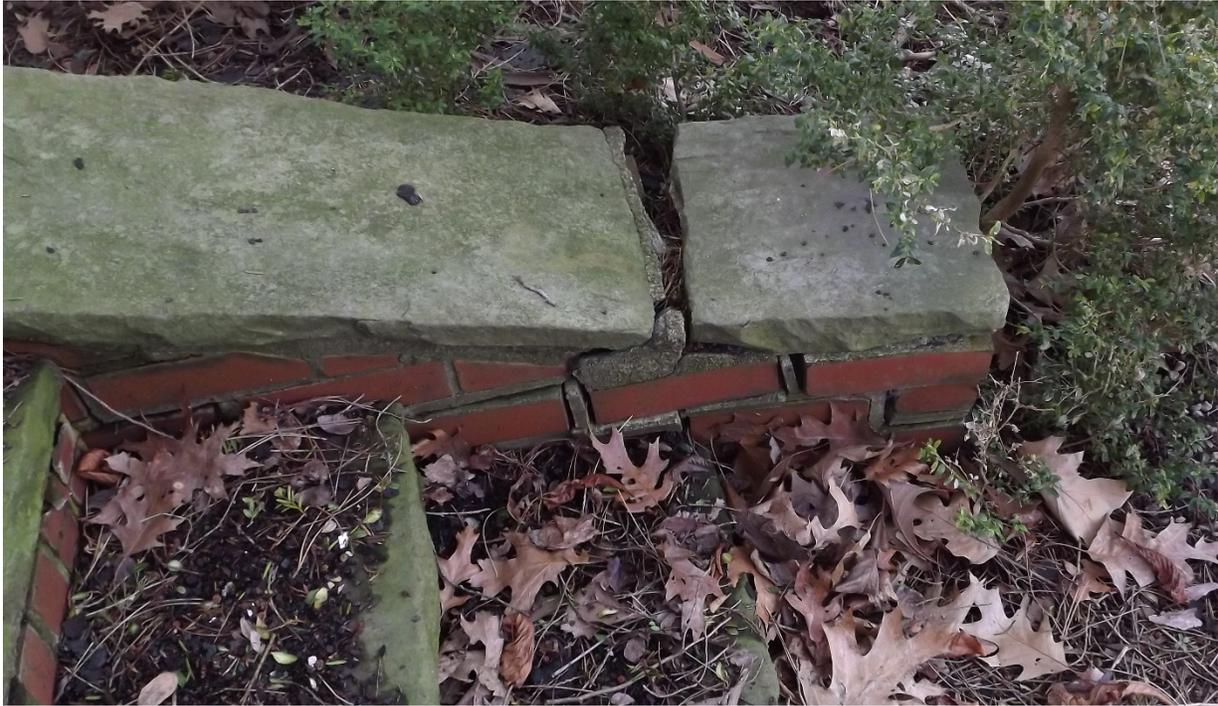
The steps on the rear of the pavilion require rebuilding as well. The brick and stone parapet walls have failed. The skyward-facing mortar joints in the stone capping cracked, allowing water into the wall. Freeze-thaw damage has broken apart the parapet walls and has broken down the concrete back-up. The stone capping and the bricks themselves are in good condition and must be salvaged for reuse. The skyward-facing joints in the capping must be caulked with an appropriate compound such as Permashink rather than pointed with mortar. Skyward-facing mortar joints in parapets and wall caps are prone to early failure and are the source of much damage in exposed masonry walls.

Failed parapet wall on rear stairs

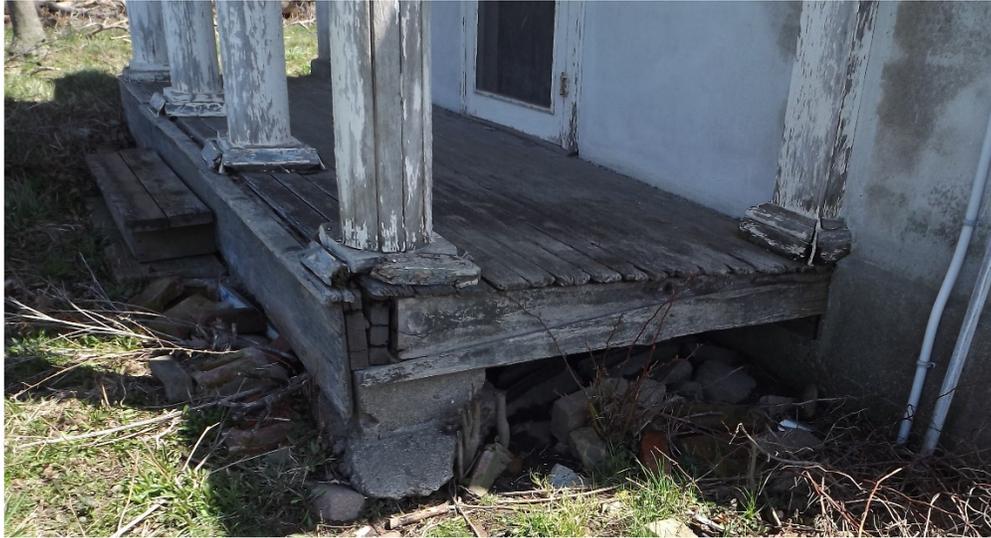
The porch is intact and stable, although it needs some work. The concrete piers carrying the front of the porch are in poor condition and the porch floor itself is less than adequate. The floor framing and decking should be replaced. The corner columns exhibit some decay, especially the bases, and both corner columns have holes from woodpeckers that have become access holes for squirrels to nest in them. The staves on the corner columns are delaminating. The pilasters on the front wall are relatively good with the exception of their bases. There are holes from carpenter bees in the cornice and geison (the horizontal shelf below the triangular tympanum on the front of the porch). Woodpeckers have enlarged some holes and created others while pursuing carpenter bee larvae. The holes must be repaired and proper finishes applied to the woodwork to discourage both the bees and the birds, although they can be very persistent and very destructive.

Porch floor and column bases requiring replacement

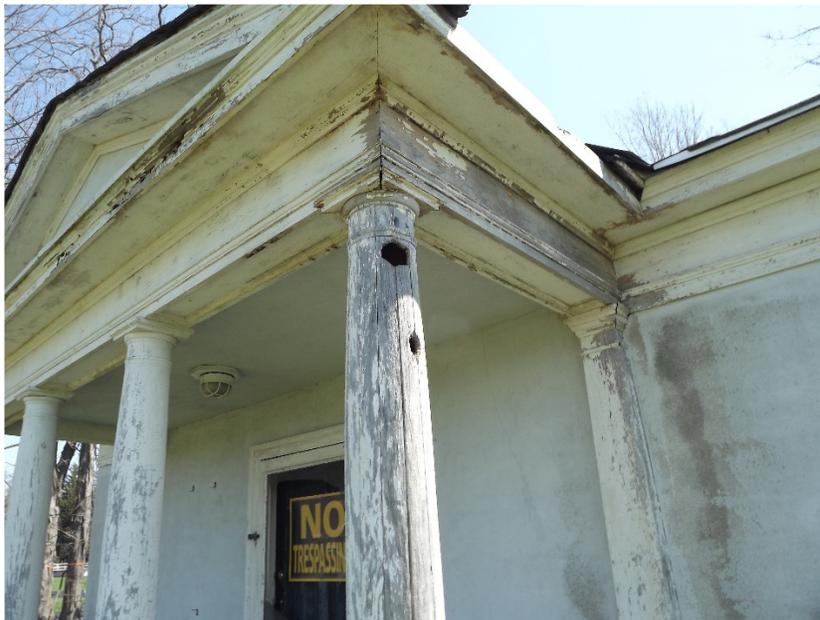
Porch southwest corner showing delaminating column and insect and woodpecker damage. The concrete foundation of the building appears to be in good condition. It projects to form a water table at the floor line and it has been parged to match the stucco wall finish. There does not appear to be any settlement or significant cracking. The stucco on the building and the majority of the wood trims are in good condition. The trims require scraping and painting, but little repair is required other than the previously noted damage and deterioration on the front porch and the small section of the overhang on the south side.

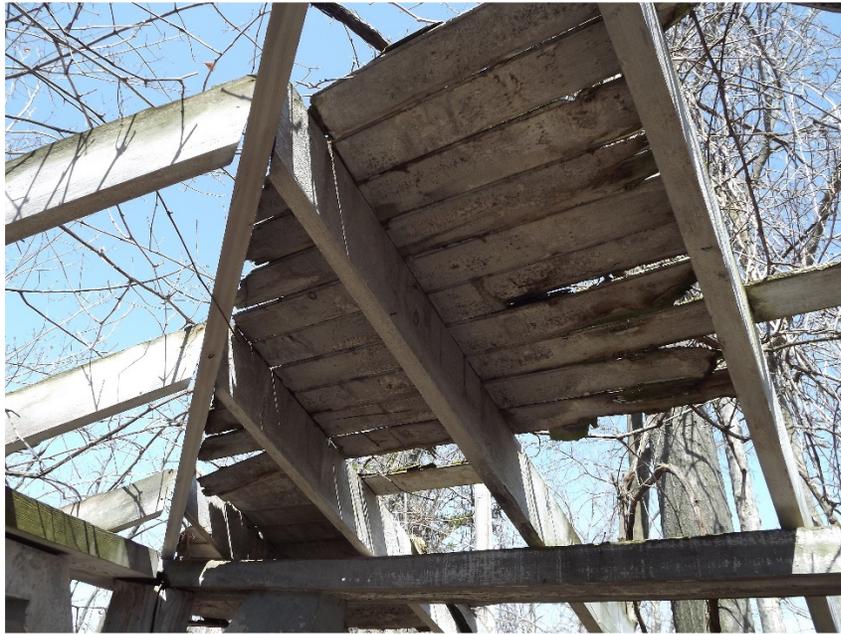
Remnant of roof sheathing, rafters, and plank beam, northwest corner

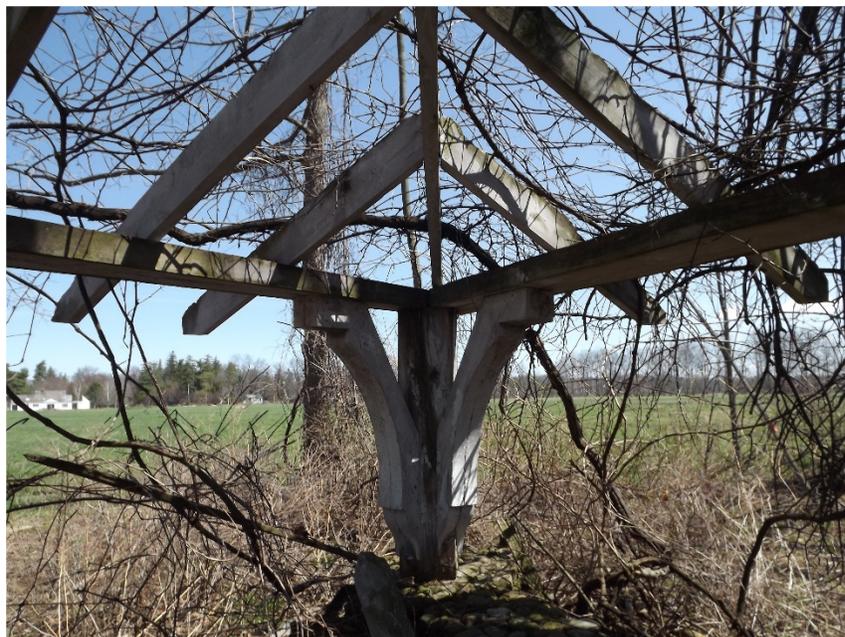
Intact but deteriorated framing, northeast corner

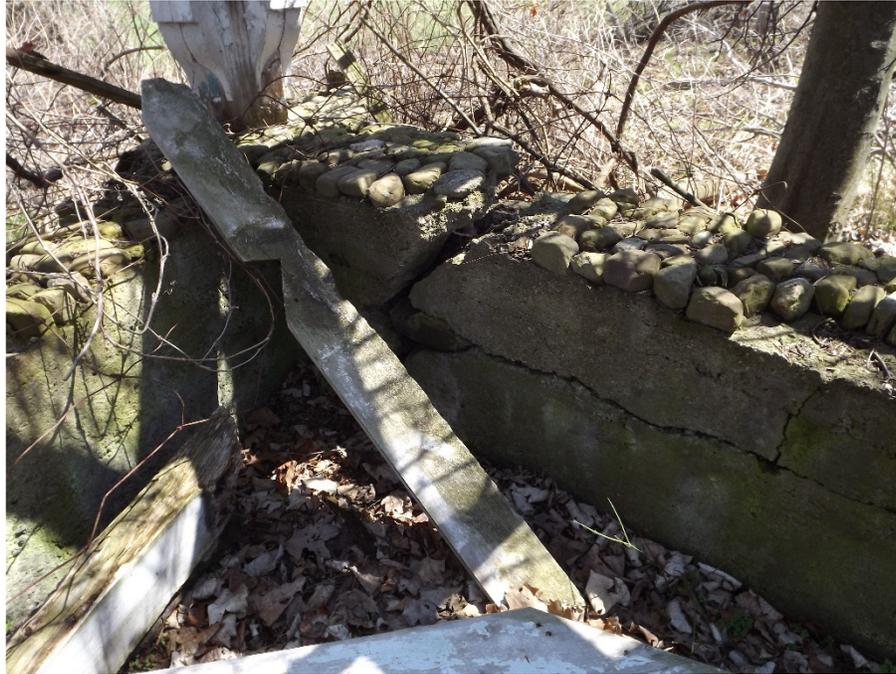
The Whistle Stop is essentially a complete ruins, but there are enough fragments of the wood structure and enough of the concrete and masonry walls and floor to enable one to replicate it. The wood structure has deteriorated to the point that with the exception of three or four brackets, none of it can be used in restoring the building. The various pieces are sufficiently intact to serve as patterns for replication. There is one small section of roof sheathing extant with a few fragments of cedar shingles; there appears to have been a fire some time in the past although the majority of the damage to the roof seems to be a consequence of failed roofing. The small amount of charred material on the ground could be from someone building a fire with collapsed pieces of the structure. It is not clear why the majority of the roof sheathing and all of the roofing is gone; the intact rafters are not charred and although the tops of some of the rafters are in poor condition with extensive rot, many appear relatively sound. There is not much roof sheathing on the ground, so it does not appear as though it simply fell off or blew off. Much of the roof may have been intentionally removed.

Broken and displaced wall and rafters, northeast corner

The concrete and stone walls are broken and displaced, and much of the former coping of cobbles is missing. The walls cannot function as support for the roof structure without extensive repairs. The extent of the former flagstone floor that remains is not clear, much of the interior appears to have a dirt floor but the flagstone might exist under a layer of debris.

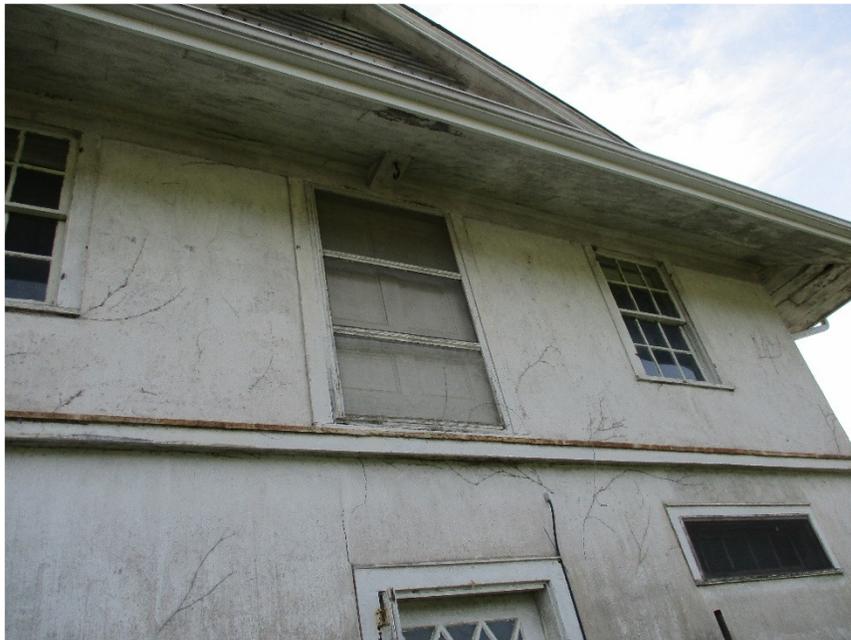
The exterior wood trims at the eaves, including the wide T&G soffits, and the doors and windows all need scraping and painting. There is a belt course moulding around the building at the line of the second floor, the flashing on top of it is rusting and requires paint. The brick chimney is in fair condition above the roof and excellent condition inside the building. The west end has an exterior door to the hay loft with a hoisting hook above it. There has been a fixed insect screen added to the door since the conversion to living quarters.

West end, trims need minor work and paint, hay loft door with hook above

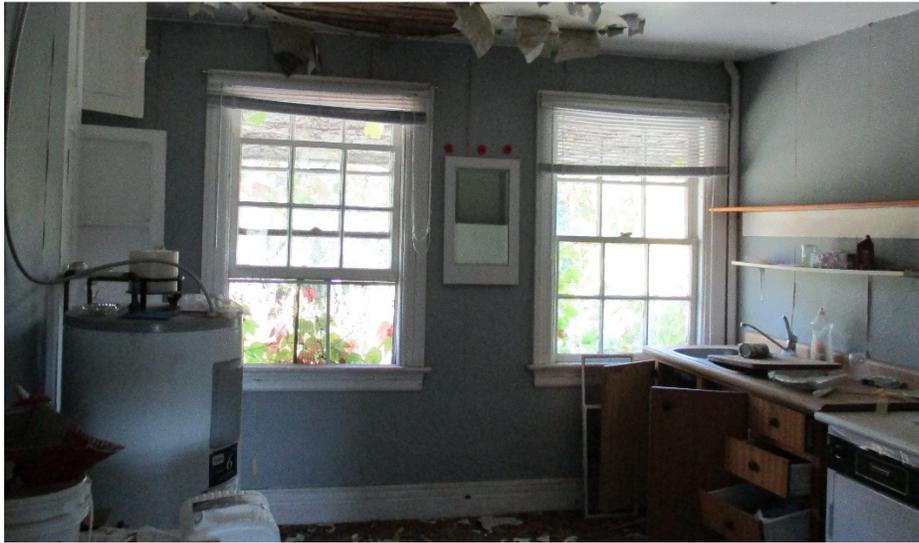
regard to aesthetics. An electric water heater sits in the kitchen with exposed wiring and plumbing. Very inferior cabinets have been added in the kitchen to increase storage space. The bathroom requires a complete overhaul to be usable.

Kitchen with original cabinets on the left, new on the right
