**325 King Street, Niagara-On-The-Lake, Ontario Arborist Report:
Tree Inventory and Preservation
Plan**

March 3, 2023

Stantec Consulting Ltd.

Buchanan Expert Tree Care Inc.

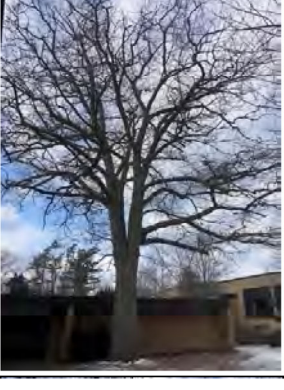
28	Red Oak	<i>Quercus rubra</i>

Based on observations on January 3, 2023, by Bill Buchanan, HBSc Forestry, ISA Board Certified Master Arborist assessment of tree 28, the tree is in a state of decline due to age and environmental factors. The explanation is as follows:

1. Red Oak (*Quercus rubra*) has a biological life expectancy of about 350 years. It is the opinion of the Master Arborist that the red oak tree is over 300 years old. A more accurate age can be determined, if required, by using an increment bore to count annual growth rings. Due to its age, the tree is in a state of decline called 'senescence'. It is similar to a person at the age of 100 and biological functions start failing which lead to natural death.

2. Signs of this decline are evident in the lack of twig elongation throughout the canopy. Also, the top outermost region of the canopy is developing dead limbs. This is typical of senescence because that is the farthest part of the tree that water needs to travel. With biological functions failing, that part of the tree suffers.

3. There are significant dead limbs throughout the canopy which is expected for a tree this age and a major crossing limb (50cm diameter) near the main crotch of the tree causing major decay.

These items are more of an indication of the lack of care and maintenance that has occurred by the previous owner responsible for the health of the tree.

4. Lastly, there are signs of Phytophthora canker on the main trunk of the tree. This is also not uncommon but is another reason that this tree will have difficulty staying alive and healthy for any significant amount of time.

In summary, it is in the opinion of the master arborist that this tree will be short lived with or without Buchanan Expert Tree Care's involvement, but will be slightly longer with some care. Any and all construction, grade changes, and especially slight changes in the natural water table will greatly affect the tree's longevity.

As a result of the assessment denoted in Section 4.1 of this report, extra caution will be taken during preservation, protection, and maintenance measures for tree 28. For example, the tree protection zone will be located at the dripline or as near as possible with respect to required construction.
