BUILDING CONDITION ASSESSMENT  
THE TEA PAVILION  
200 JOHN STREET, NIAGARA-ON-THE-LAKE

April 27, 2022

Prepared by  
Mark Shoalts, P.Eng., CAHP

BUILDING CONDITION ASSESSMENT  
THE BATH HOUSE  
200 JOHN STREET, NIAGARA-ON-THE-LAKE

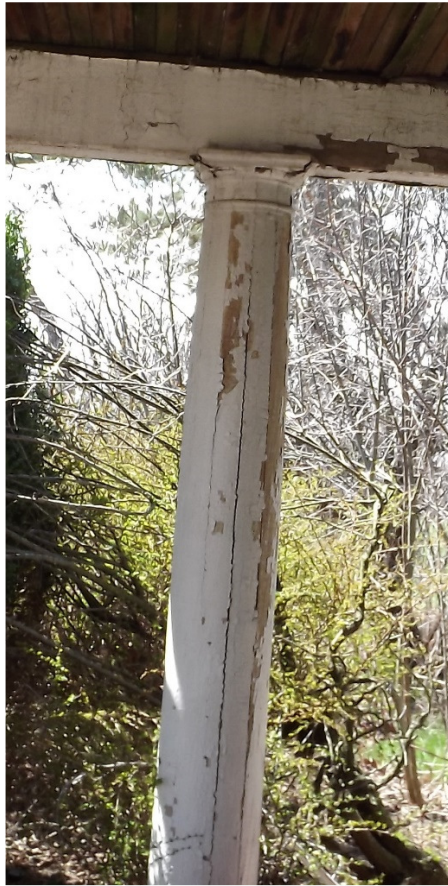
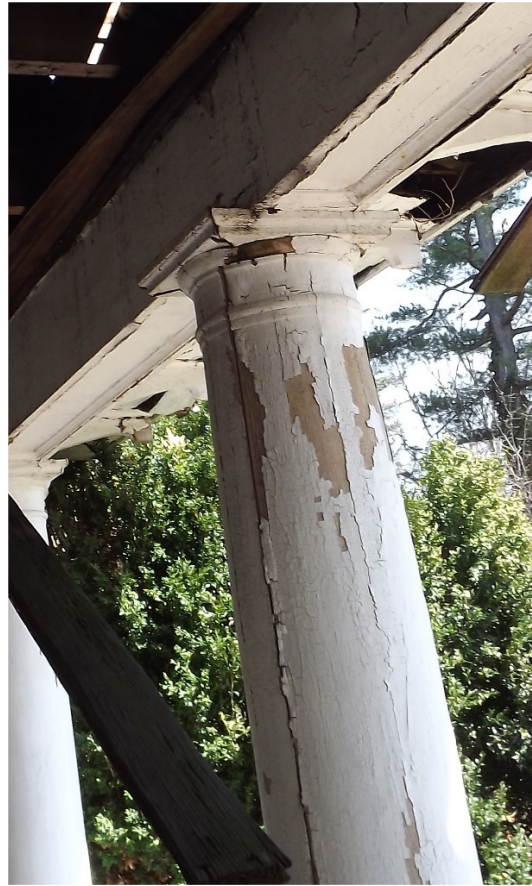
End column

The Tea Pavilion is in poor condition. The metal (presumably copper) roof shown on the Dunington-Grubb plan was not installed and the present asphalt shingles are long past their service life; they have been leaking for years. Much of the tongue and groove wood ceiling has collapsed and substantial sections of the eave have deteriorated. Some of the wood columns exhibit serious decay, especially the bases. Three columns in particular are in poor condition and they appear to possibly be replacements that have failed for a second time. The staves on the centre pair of columns facing the pool and one column in the south end are delaminating and the paint is peeling badly. All of the other columns have retained their paint and no joints between staves are even discernible, much less delaminating. The good columns give every appearance of being solid, but they are hollow as evidenced by electrical switches mounted on two of them. There is no obvious reason why three of the twelve round columns would be in such poor condition. The bases of these three columns as well as the bases of several other columns are also in poor condition and require replacement.

Staved columns failing

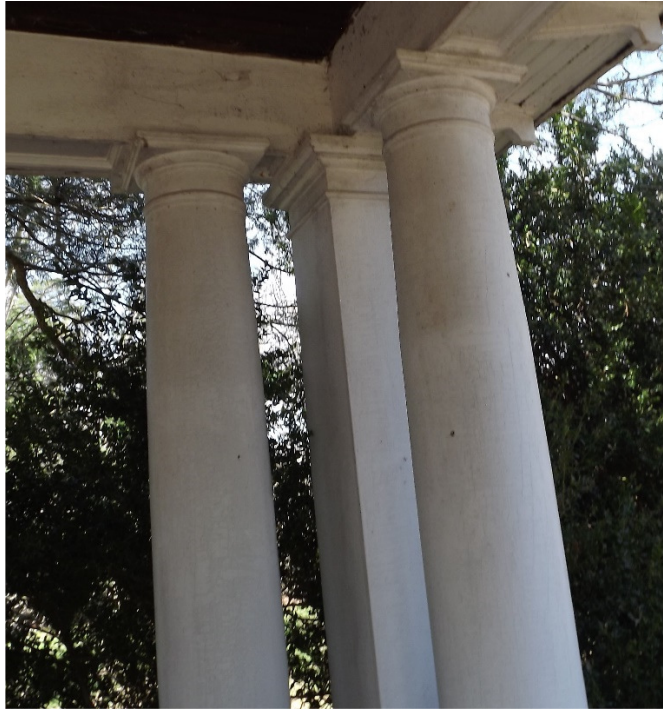
Corner columns in good condition

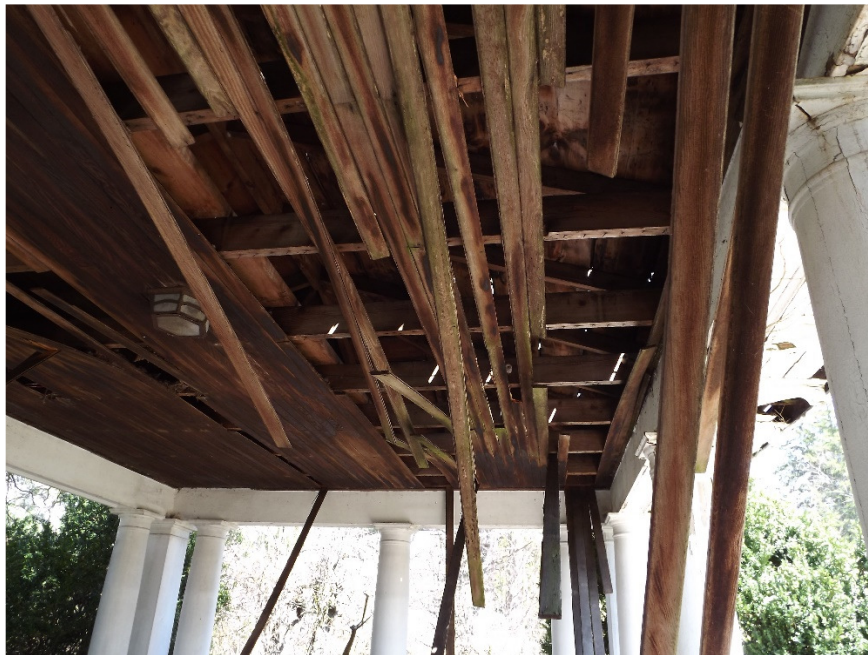
The roof leaks have led to the deterioration of some of the roof sheathing to the point where daylight shows between the planks. Many of the nails holding the ceiling have rusted off and the boards are hanging down or have fallen off completely. Leakage through the eaves has deteriorated a substantial portion of the soffit, although the eave brackets are generally good.

Deteriorated ceiling

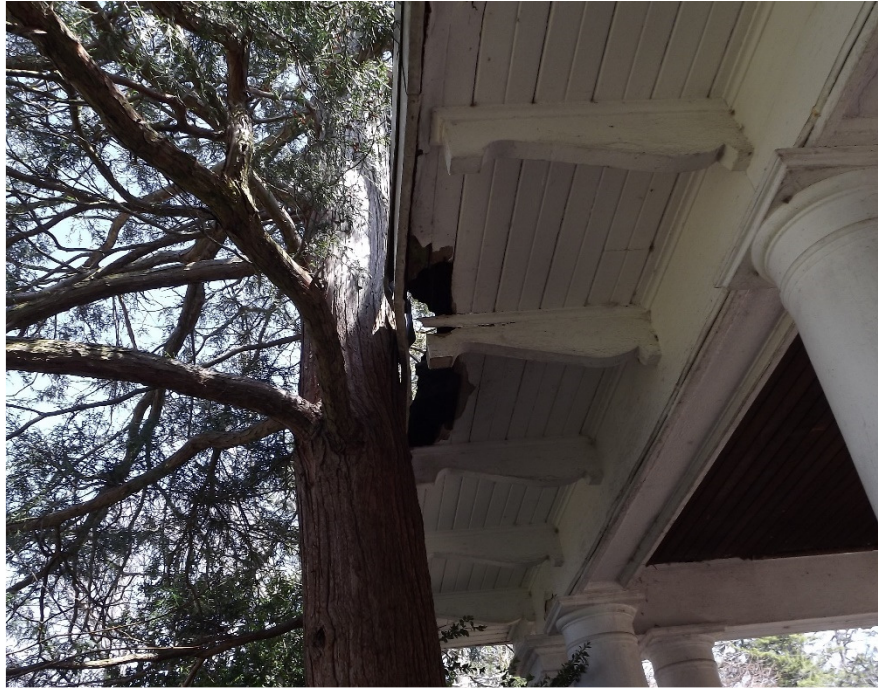
The vegetation around the pavilion is overgrown and requires maintenance, and one cedar tree in particular must be removed. It is not part of the planned landscape plantings but it has grown against the rear overhang, damaging the fascia and roofing, which has led to rotted soffit and ready access for squirrels into the attic.

Cedar tree requiring removal

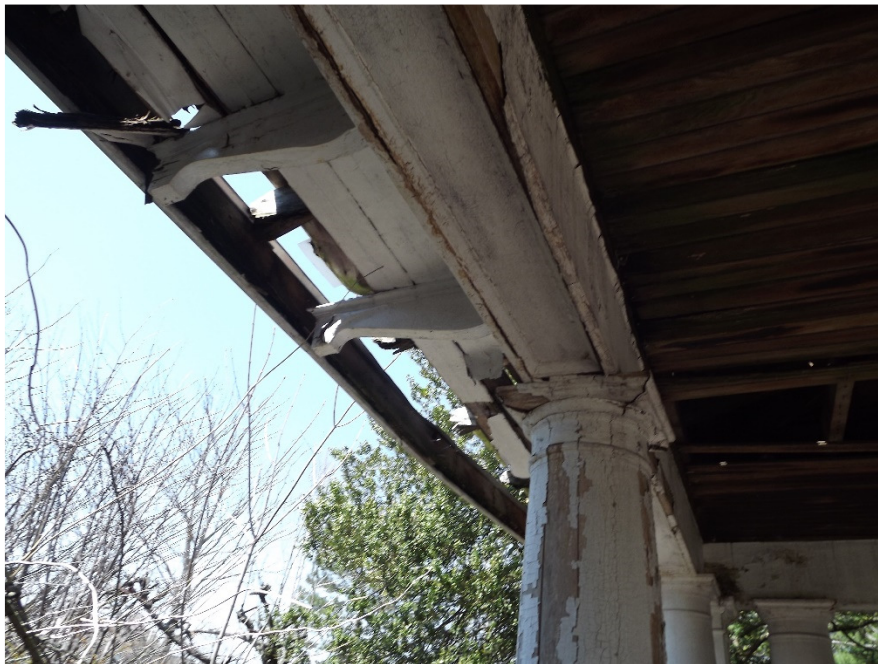
The eave, fascia, and brackets on the front of the pavilion have deteriorated substantially and a section requires replacement, including the cladding of the beam bearing on the columns. The condition of the beam itself was not observed and must be checked during the repairs.

Section of eave requiring replacement

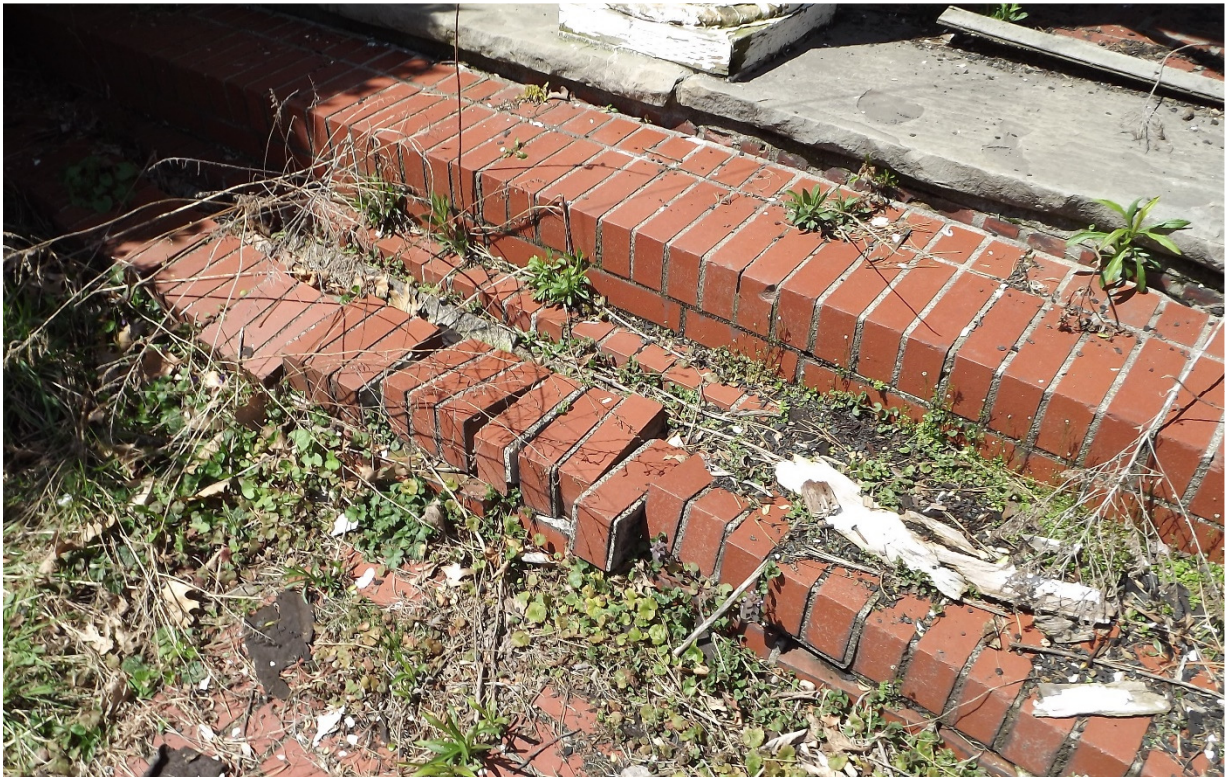
The floor is in good condition within the footprint of the pavilion. The bricks are in excellent condition, the mortar is good, and the sandstone border is good. The mortar joints in the sandstone require some minor cutting out and repointing. The brick steps across the front of the pavilion are in poor condition. The bricks themselves are in good condition but many of

the mortar joints have failed and a substantial portion of the concrete back-up has failed, allowing the steps to collapse.

Collapsed brick steps

The bricks must be removed and salvaged, the failed concrete chipped away, and the steps rebuilt. The concrete back-up must be repoured and the bricks relaid. The mortar joints in brick pavers, treads, and risers are vulnerable to frost damage because they are often wet when they freeze. An appropriate mortar mix with air entrainment must be used, and a sealer to limit water penetration of the joints is advisable.

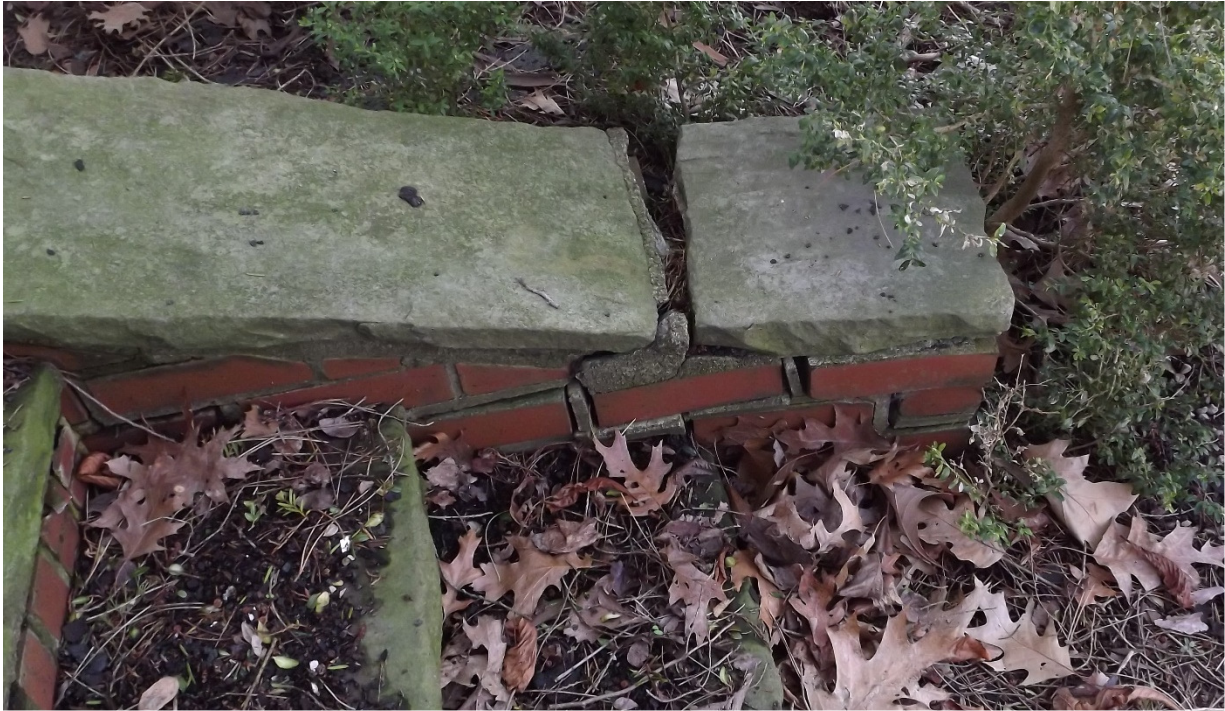
The steps on the rear of the pavilion require rebuilding as well. The brick and stone parapet walls have failed. The skyward-facing mortar joints in the stone capping cracked, allowing water into the wall. Freeze-thaw damage has broken apart the parapet walls and has broken down the concrete back-up. The stone capping and the bricks themselves are in good condition and must be salvaged for reuse. The skyward-facing joints in the capping must be caulked with an appropriate compound such as Permashink rather than pointed with mortar. Skyward-facing mortar joints in parapets and wall caps are prone to early failure and are the source of much damage in exposed masonry walls.

Failed parapet wall on rear stairs

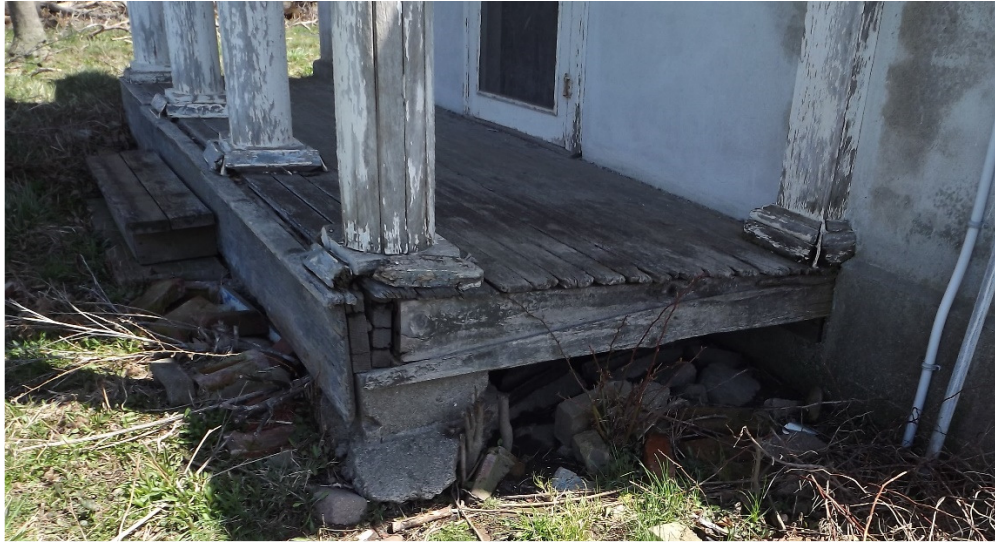
The porch is intact and stable, although it needs some work. The concrete piers carrying the front of the porch are in poor condition and the porch floor itself is less than adequate. The floor framing and decking should be replaced. The corner columns exhibit some decay, especially the bases, and both corner columns have holes from woodpeckers that have become access holes for squirrels to nest in them. The staves on the corner columns are delaminating. The pilasters on the front wall are relatively good with the exception of their bases. There are holes from carpenter bees in the cornice and geison (the horizontal shelf below the triangular tympanum on the front of the porch). Woodpeckers have enlarged some holes and created others while pursuing carpenter bee larvae. The holes must be repaired and proper finishes applied to the woodwork to discourage both the bees and the birds, although they can be very persistent and very destructive.

Porch floor and column bases requiring replacement

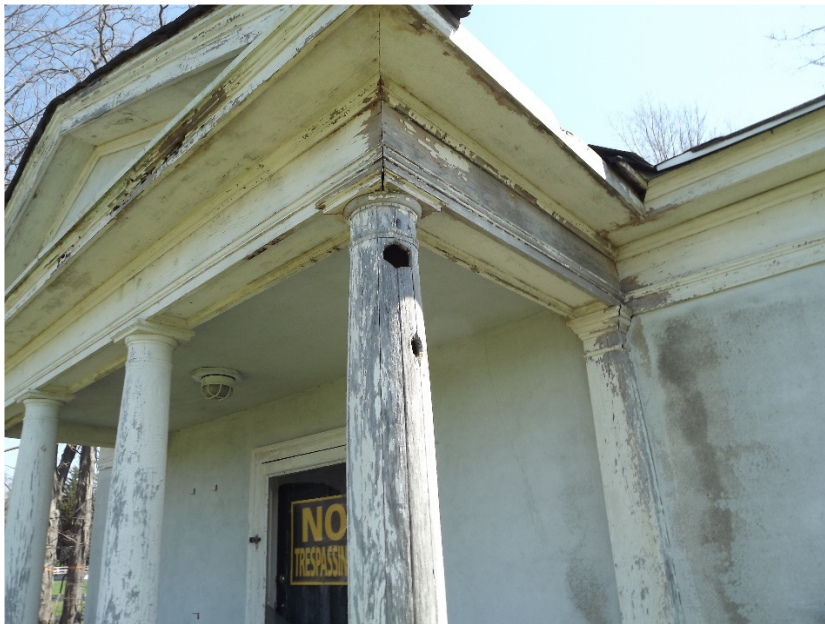
Porch southwest corner showing delaminating column and insect and woodpecker damage. The concrete foundation of the building appears to be in good condition. It projects to form a water table at the floor line and it has been parged to match the stucco wall finish. There does not appear to be any settlement or significant cracking. The stucco on the building and the majority of the wood trims are in good condition. The trims require scraping and painting, but little repair is required other than the previously noted damage and deterioration on the front porch and the small section of the overhang on the south side.

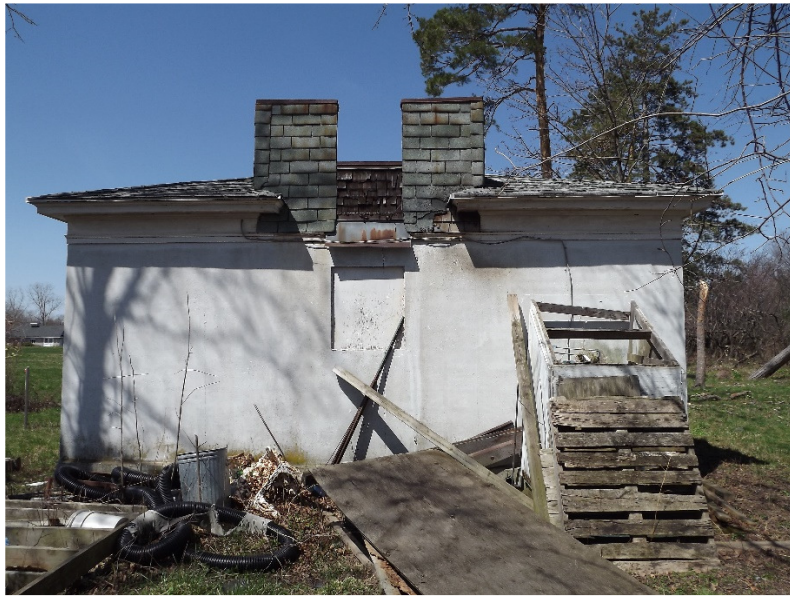
The roofing is in poor condition and requires replacement. Roof leaks through the south eave have deteriorated a portion of the soffit, fascia, and frieze, and the leaks must be repaired as soon as possible to prevent further deterioration. The platform and its surrounding walls on the rear of the roof should be investigated further to try to determine its original purpose. Unless there is significant heritage value in the original purpose, it would simplify the roof, extend its longevity, and make maintenance much easier if it were removed and the roof and overhang were filled in to match the rest of the building. There was an opening in the rear

wall directly below the platform that seems to have been related but it has been covered by the plywood that was installed as an interior wall finish.

Rear wall of Bath House showing roof platform

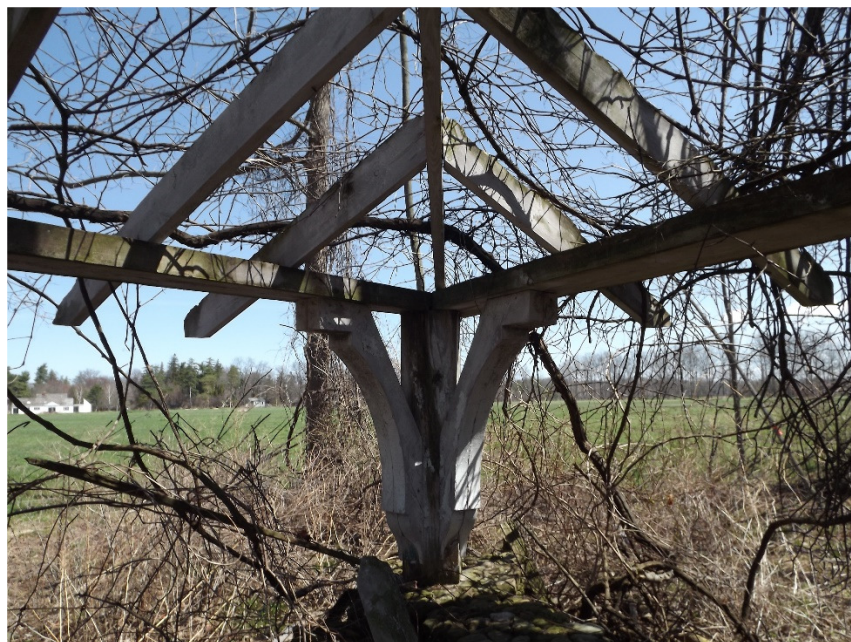
Intact but deteriorated framing, northeast corner

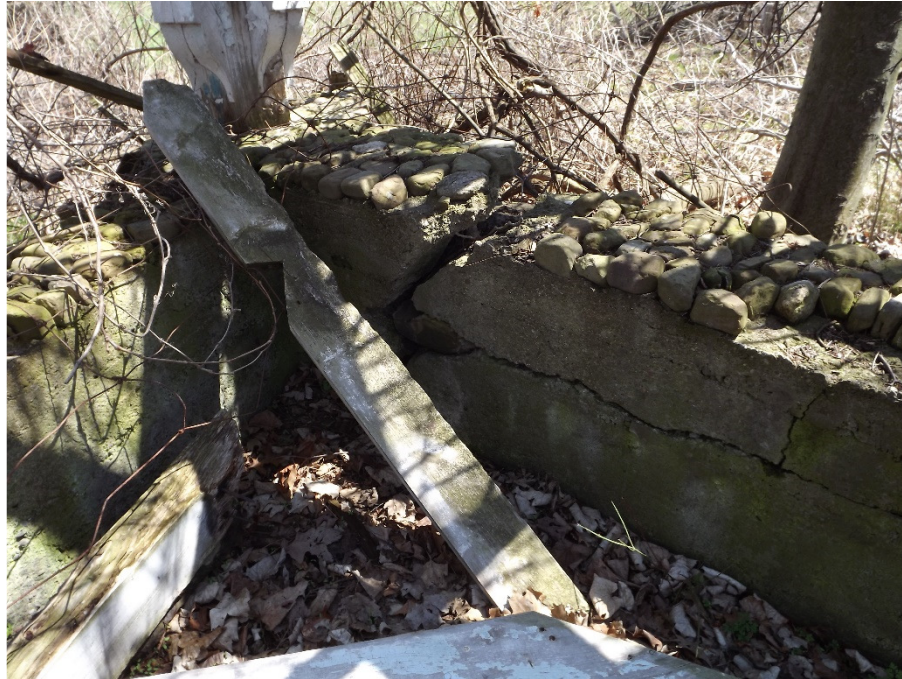
The Whistle Stop is essentially a complete ruins, but there are enough fragments of the wood structure and enough of the concrete and masonry walls and floor to enable one to replicate it. The wood structure has deteriorated to the point that with the exception of three or four brackets, none of it can be used in restoring the building. The various pieces are sufficiently intact to serve as patterns for replication. There is one small section of roof sheathing extant with a few fragments of cedar shingles; there appears to have been a fire some time in the past although the majority of the damage to the roof seems to be a consequence of failed roofing. The small amount of charred material on the ground could be from someone building a fire with collapsed pieces of the structure. It is not clear why the majority of the roof sheathing and all of the roofing is gone; the intact rafters are not charred and although the tops of some of the rafters are in poor condition with extensive rot, many appear relatively sound. There is not much roof sheathing on the ground, so it does not appear as though it simply fell off or blew off. Much of the roof may have been intentionally removed.

Broken and displaced wall and rafters, northeast corner

The concrete and stone walls are broken and displaced, and much of the former coping of cobbles is missing. The walls cannot function as support for the roof structure without extensive repairs. The extent of the former flagstone floor that remains is not clear, much of the interior appears to have a dirt floor but the flagstone might exist under a layer of debris.

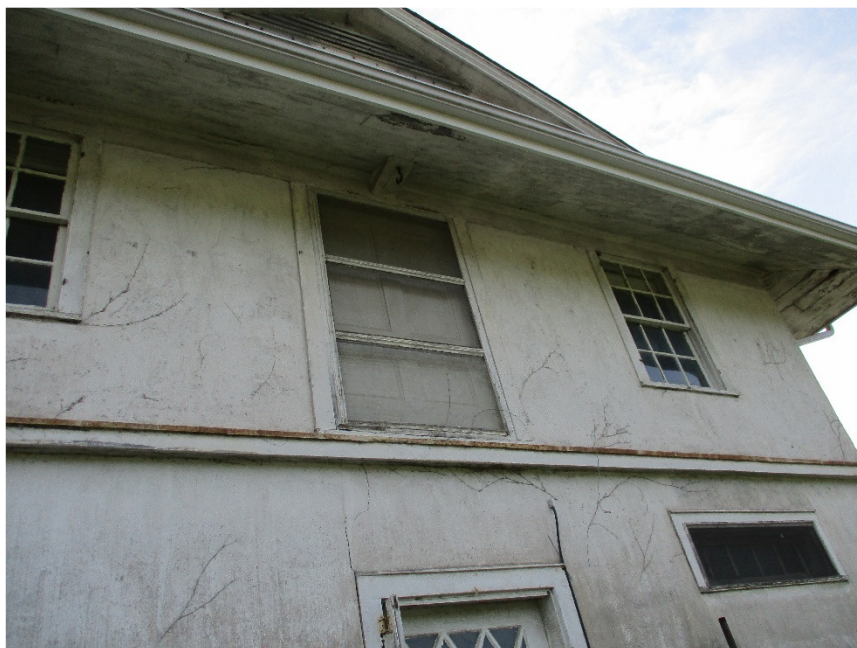
The exterior wood trims at the eaves, including the wide T&G soffits, and the doors and windows all need scraping and painting. There is a belt course moulding around the building at the line of the second floor, the flashing on top of it is rusting and requires paint. The brick chimney is in fair condition above the roof and excellent condition inside the building. The west end has an exterior door to the hay loft with a hoisting hook above it. There has been a fixed insect screen added to the door since the conversion to living quarters.

West end, trims need minor work and paint, hay loft door with hook above

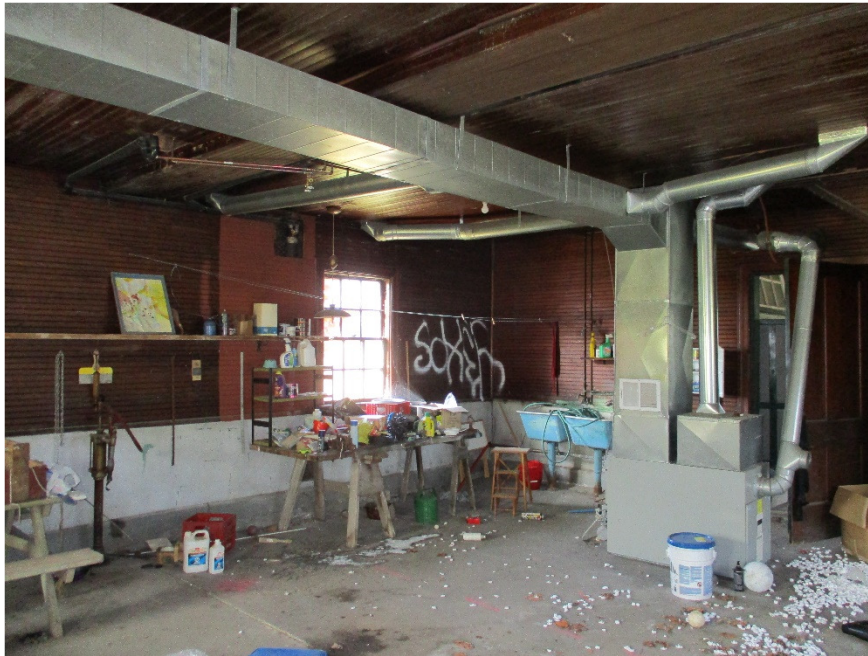
The interior of the Carriage House is in fair to good condition on the ground floor and fair to poor condition on the second floor. The concrete floor is badly cracked. It is very likely that the concrete floor would have to be removed no matter what decision is made on retaining or relocating the Carriage House. The building was used as a garage for the storage and servicing of automobiles. There is a drain in the floor with an unknown outlet. There is also a hand pump near the back wall connected to iron pipe that emerges from the concrete floor. While it could be a water pump, there is plumbing in the building which makes that questionable. It is possibly an oil or fuel pump and it is possible that there is a tank under the floor; this requires further investigation.

Interior of garage, note hand pump at left

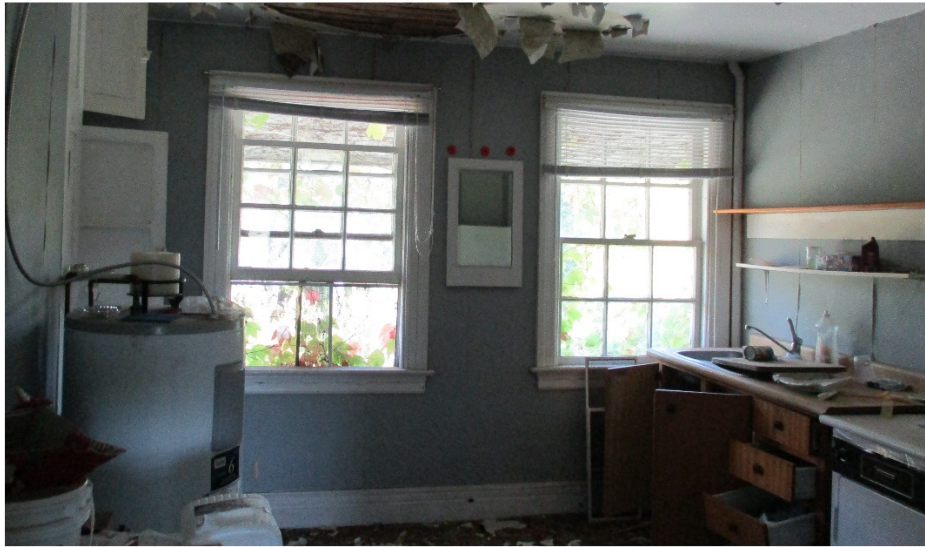
regard to aesthetics. An electric water heater sits in the kitchen with exposed wiring and plumbing. Very inferior cabinets have been added in the kitchen to increase storage space. The bathroom requires a complete overhaul to be usable.

Kitchen with original cabinets on the left, new on the right
