Re: foundation issue in the house at 134 Victoria Street, Niagara-on-the-Lake, ON

We have been retained by the owner to review on site the existing house foundation condition, we conduct a filed review on October 15,2023 with the owner.

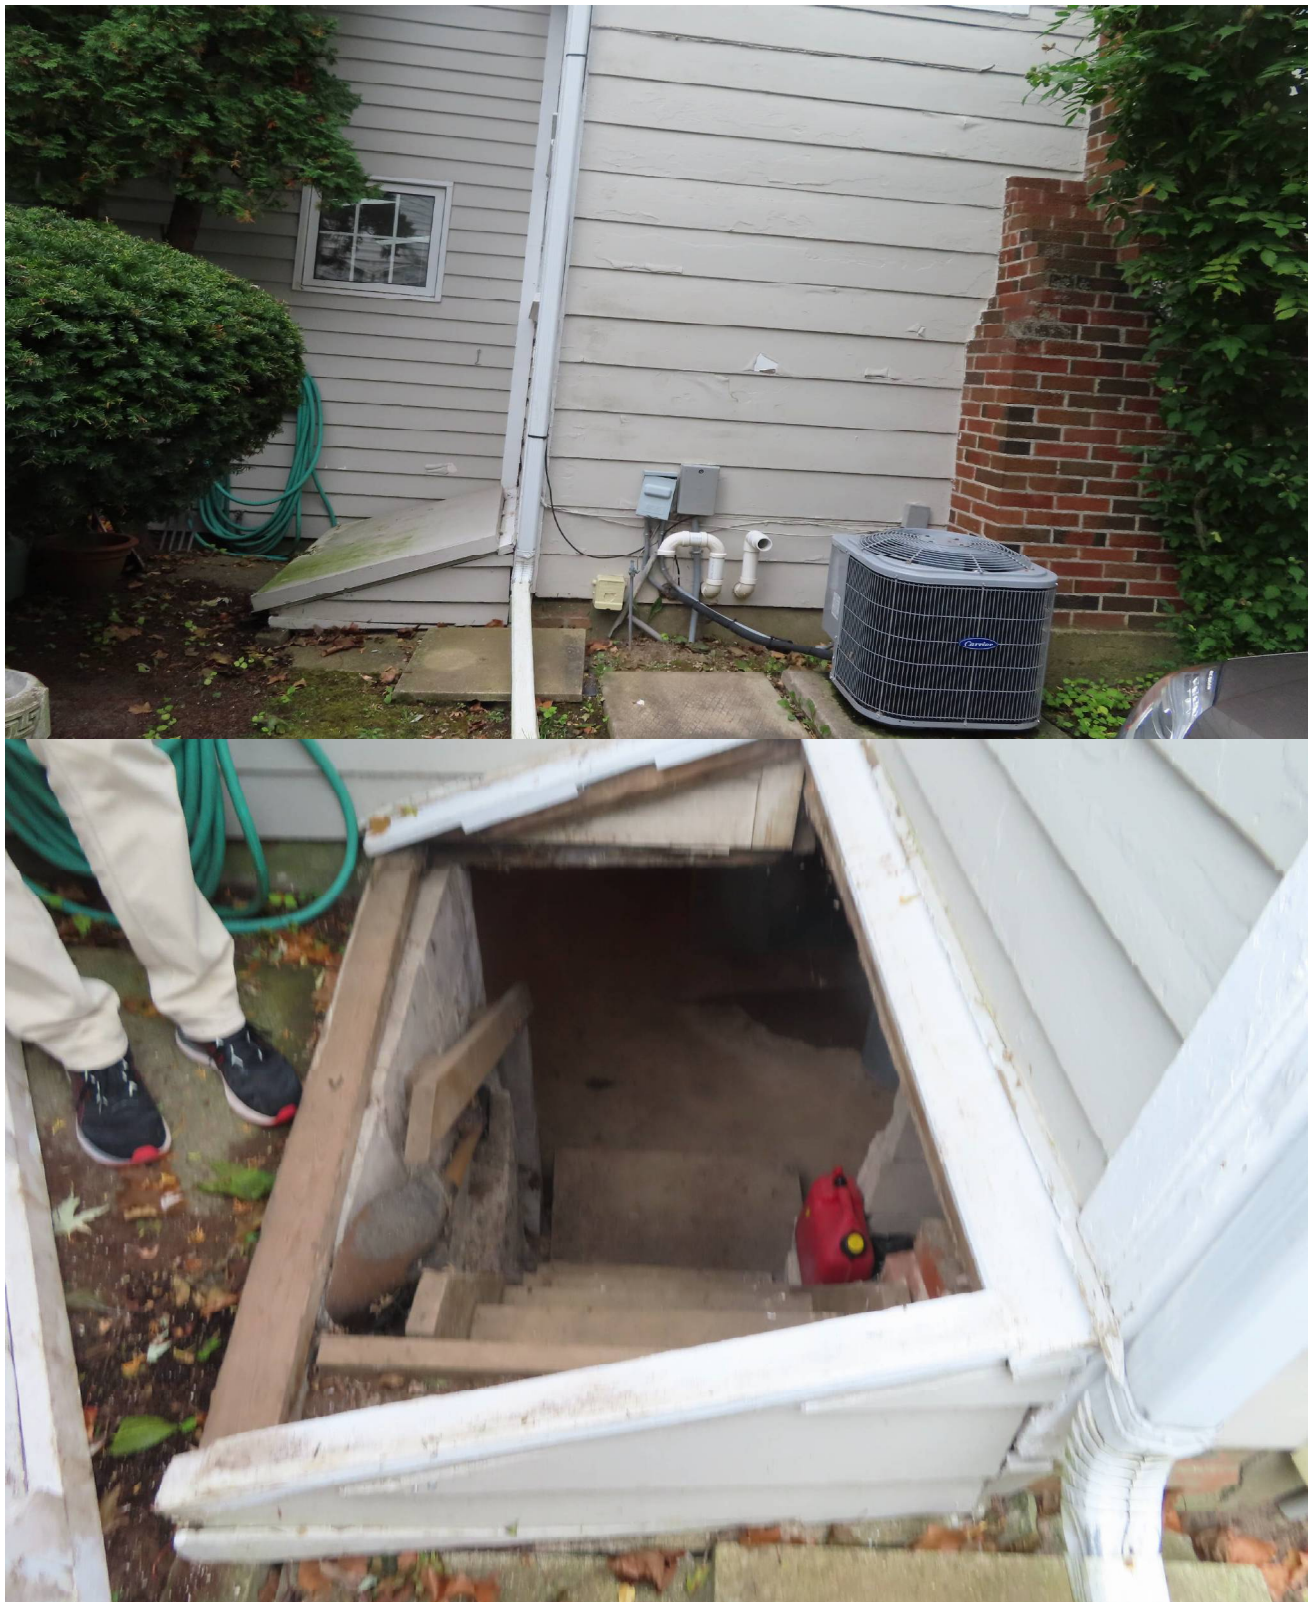
Our visual inspection revealed that the entrance to the basement is a basement wooden bulkhead, also called a basement cellar door, it is almost horizontal opening with the same grade level. bulkhead doors are susceptible to mold, rot and warpage. Over time the bulkhead door can fail to function and develop gaps that allow rain and debris to enter your basement. This can cause water leakage, flooding, and the growth of mold in the basement.

. see the photos below

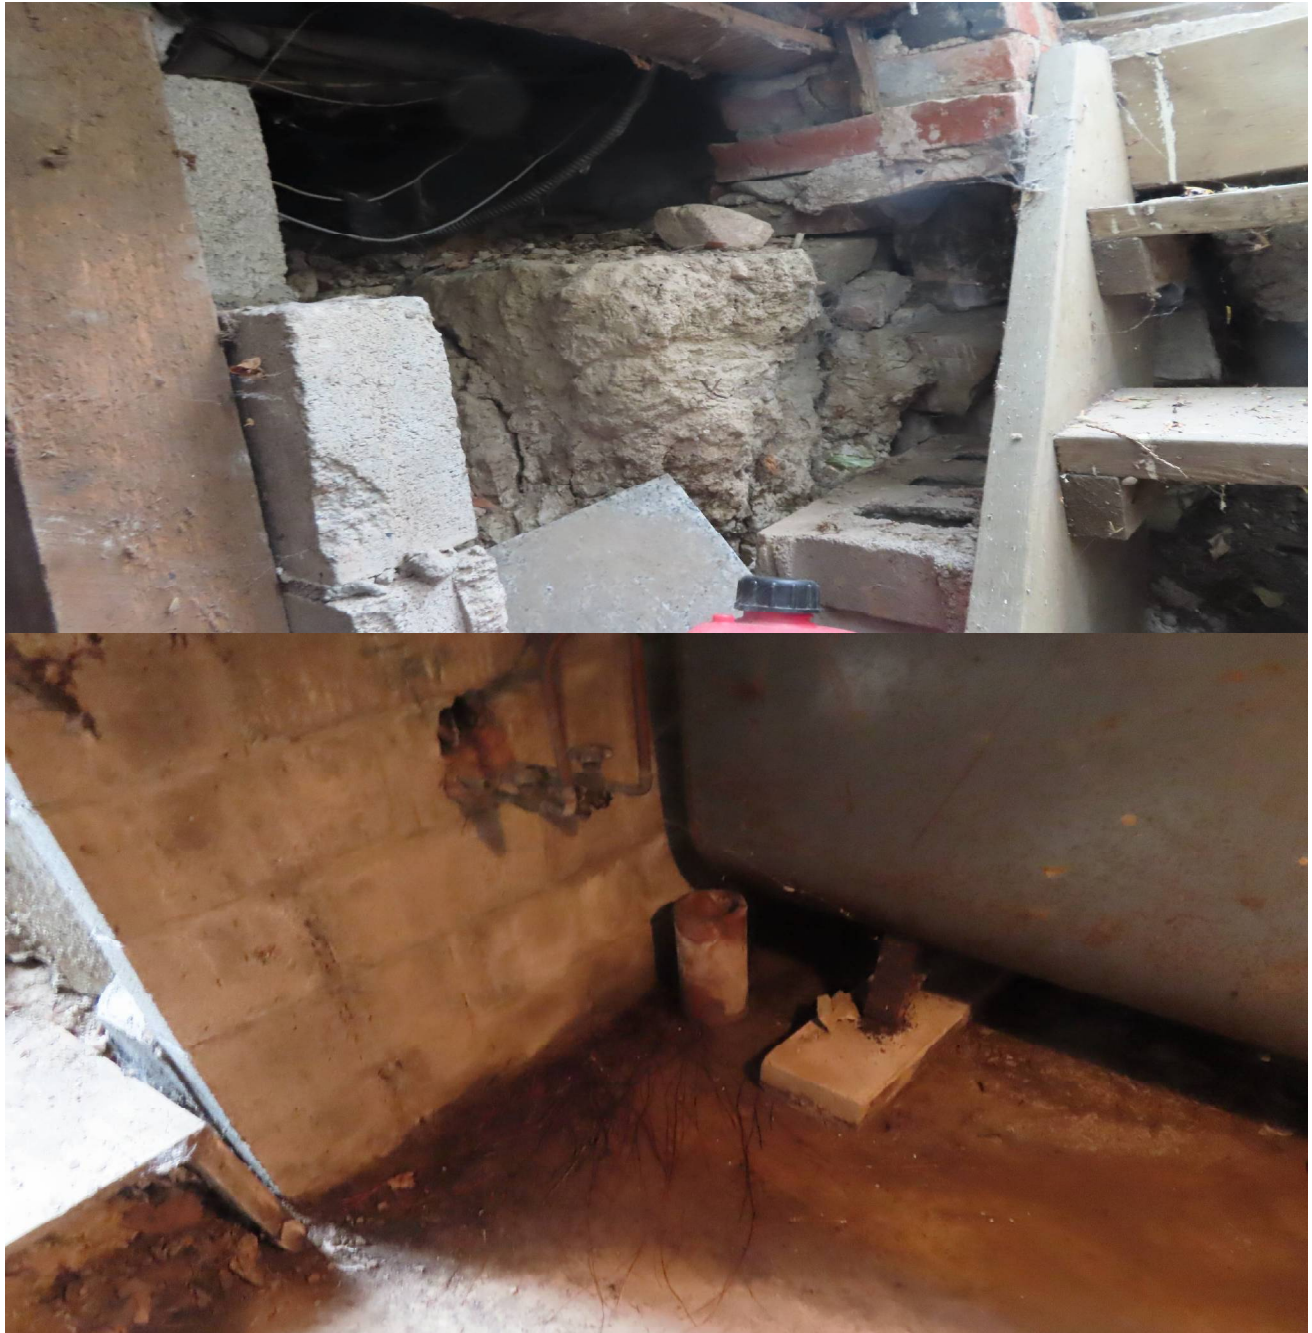
-the basement entrance is in very poor conditions, there is no retaining wall and any neither proper support for the wall above support for, it is structurally it seem there was no maintenance for long time to the basement entrance there are signs of water leaking, see photos below.

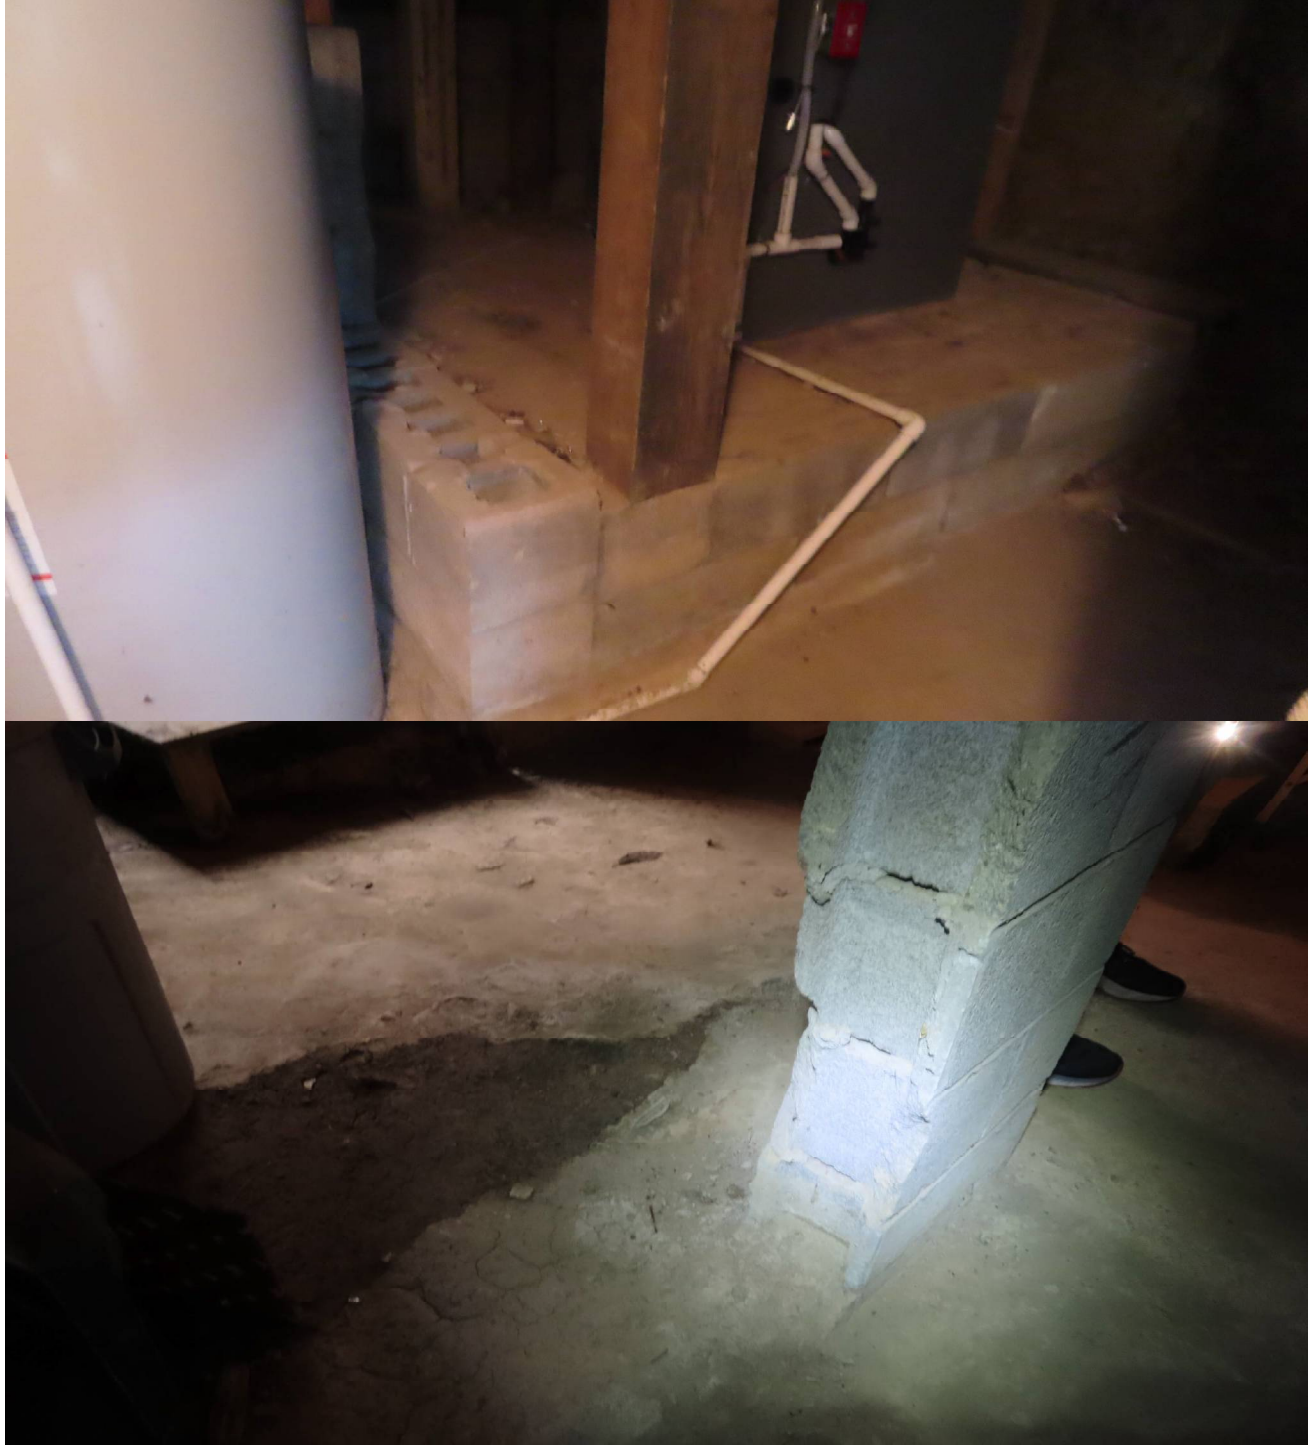
-There are many posts that have been added to support the floor above without having proper footing. See photos below.

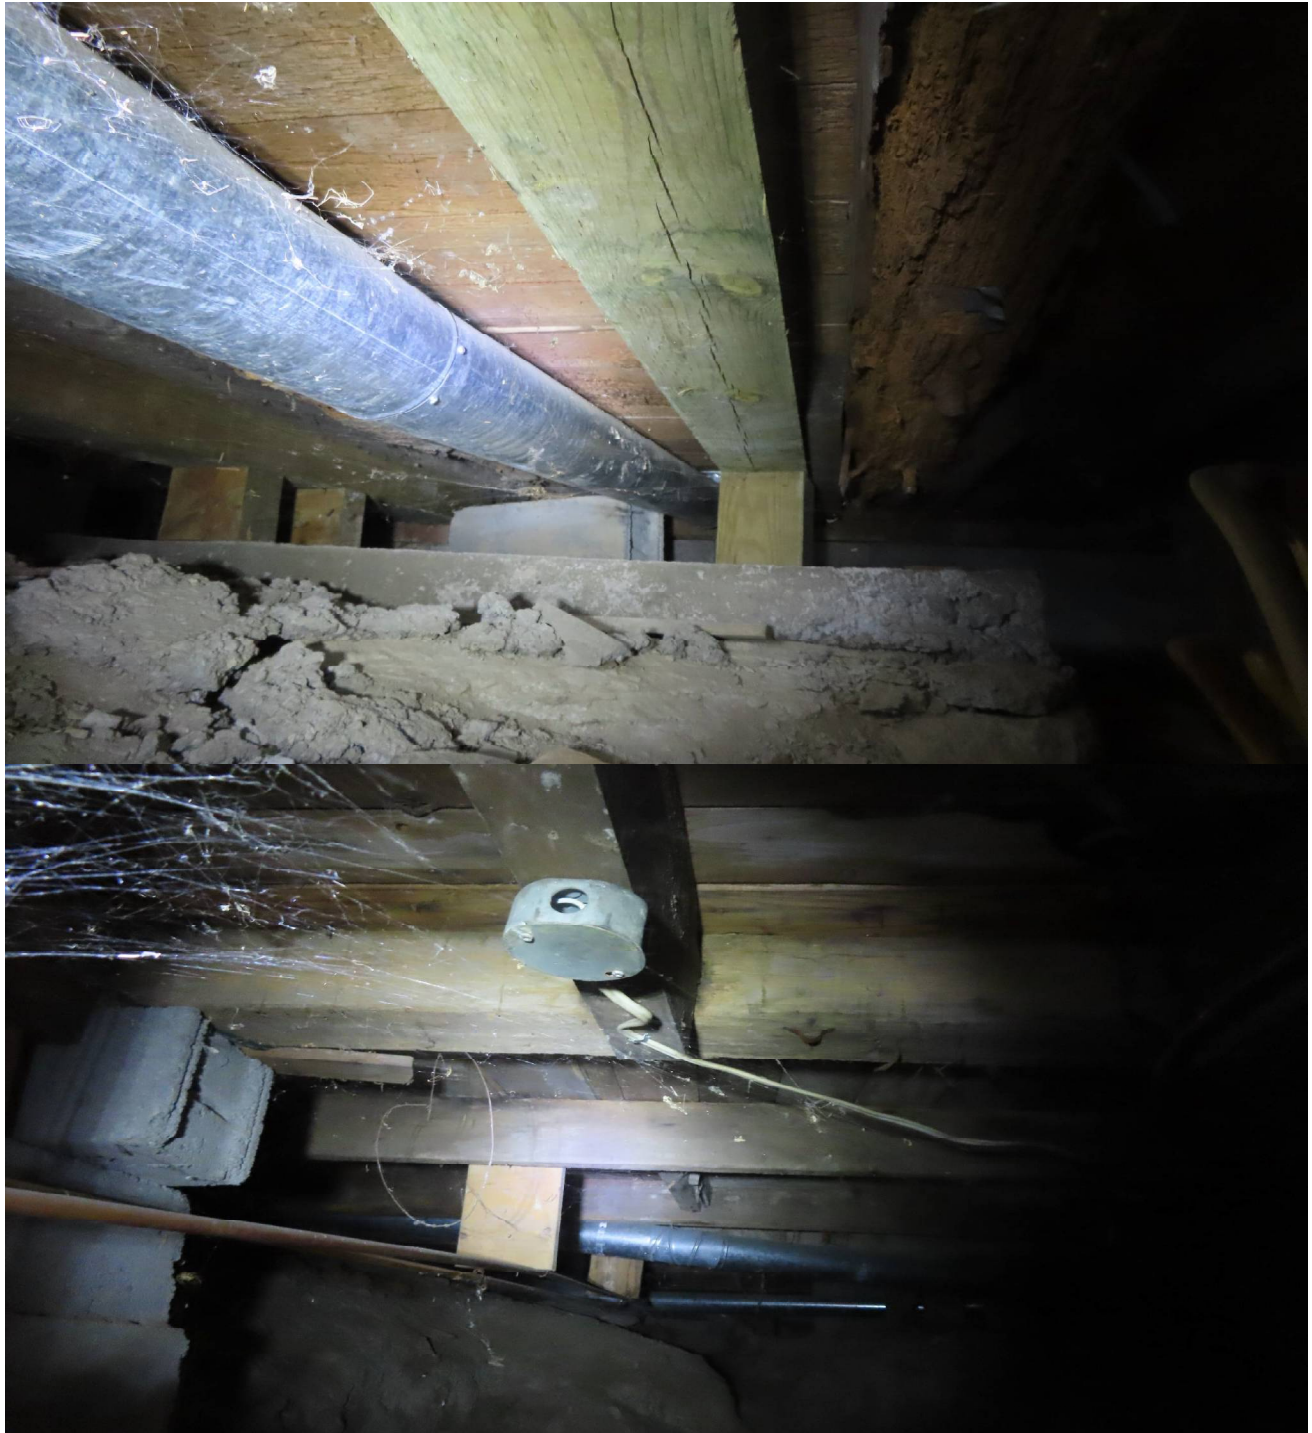
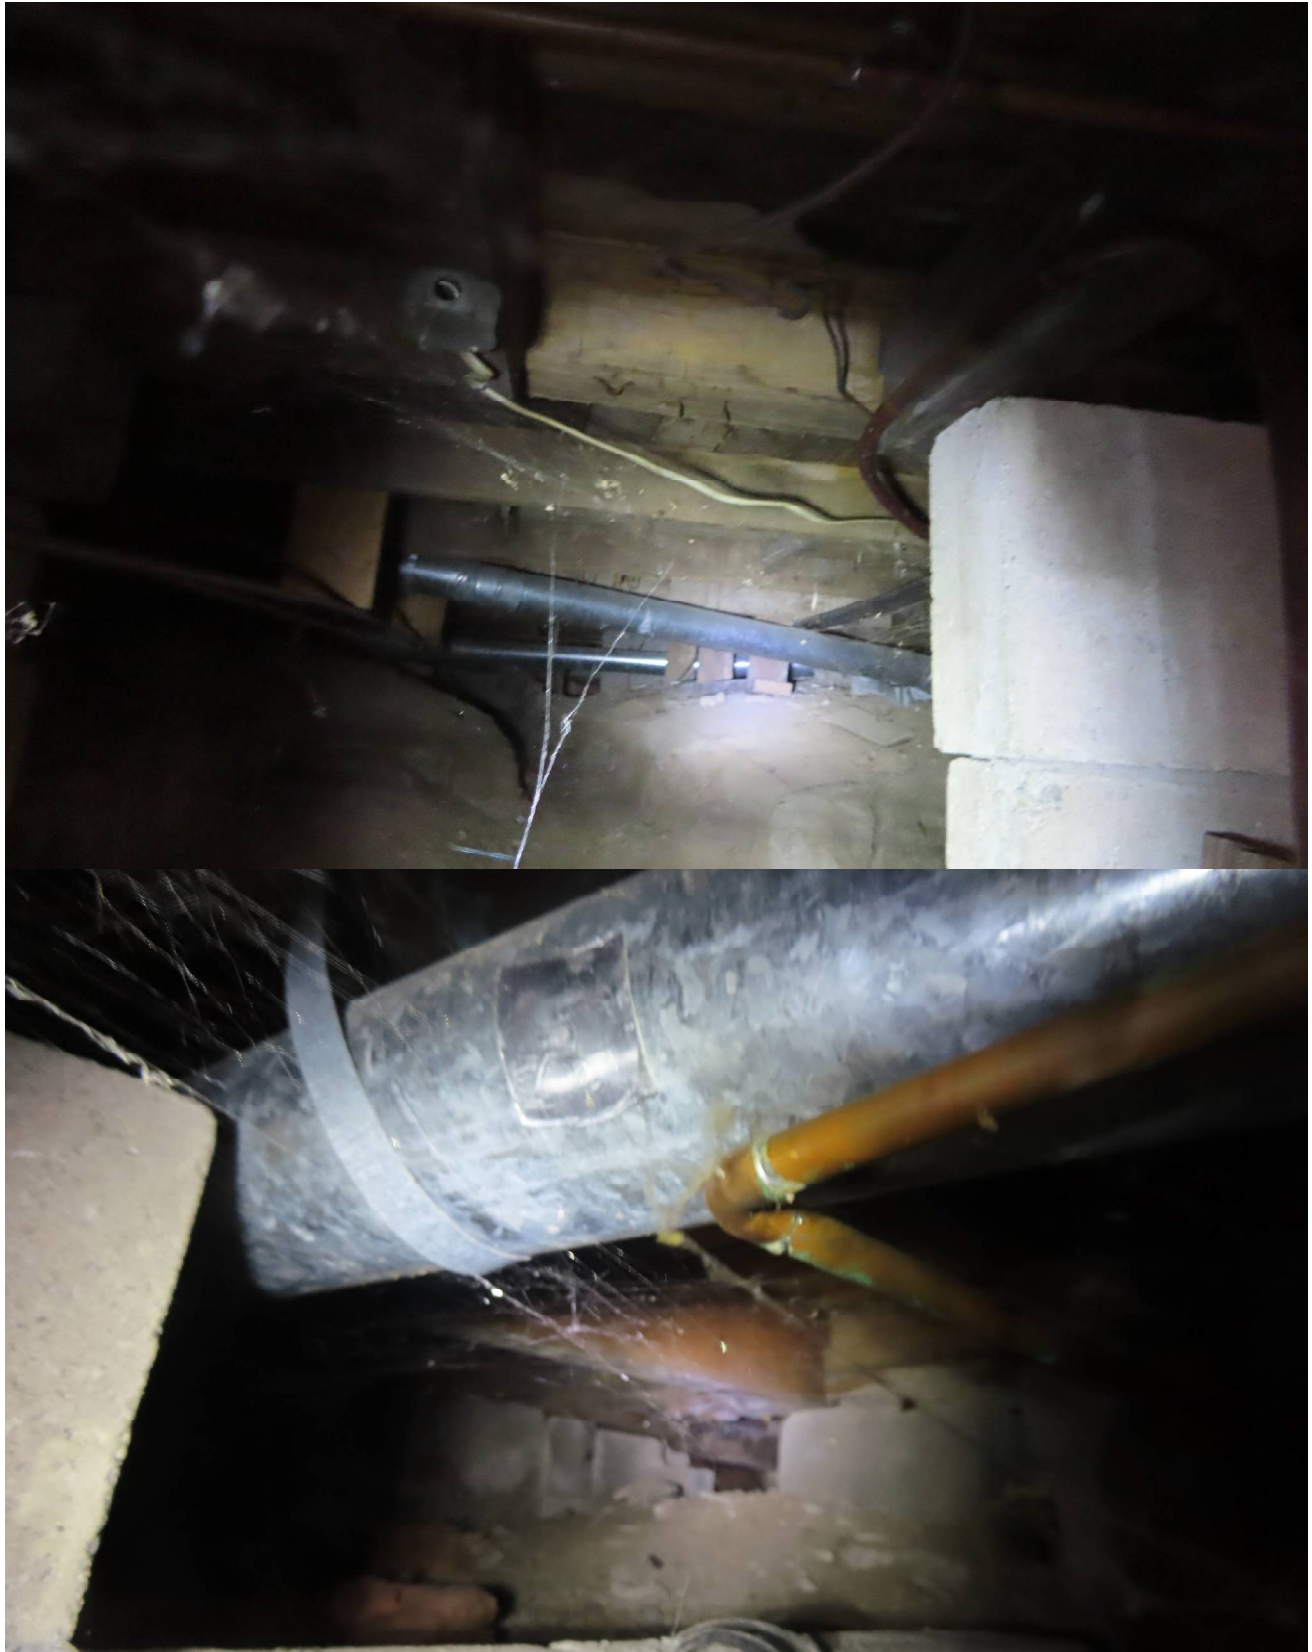
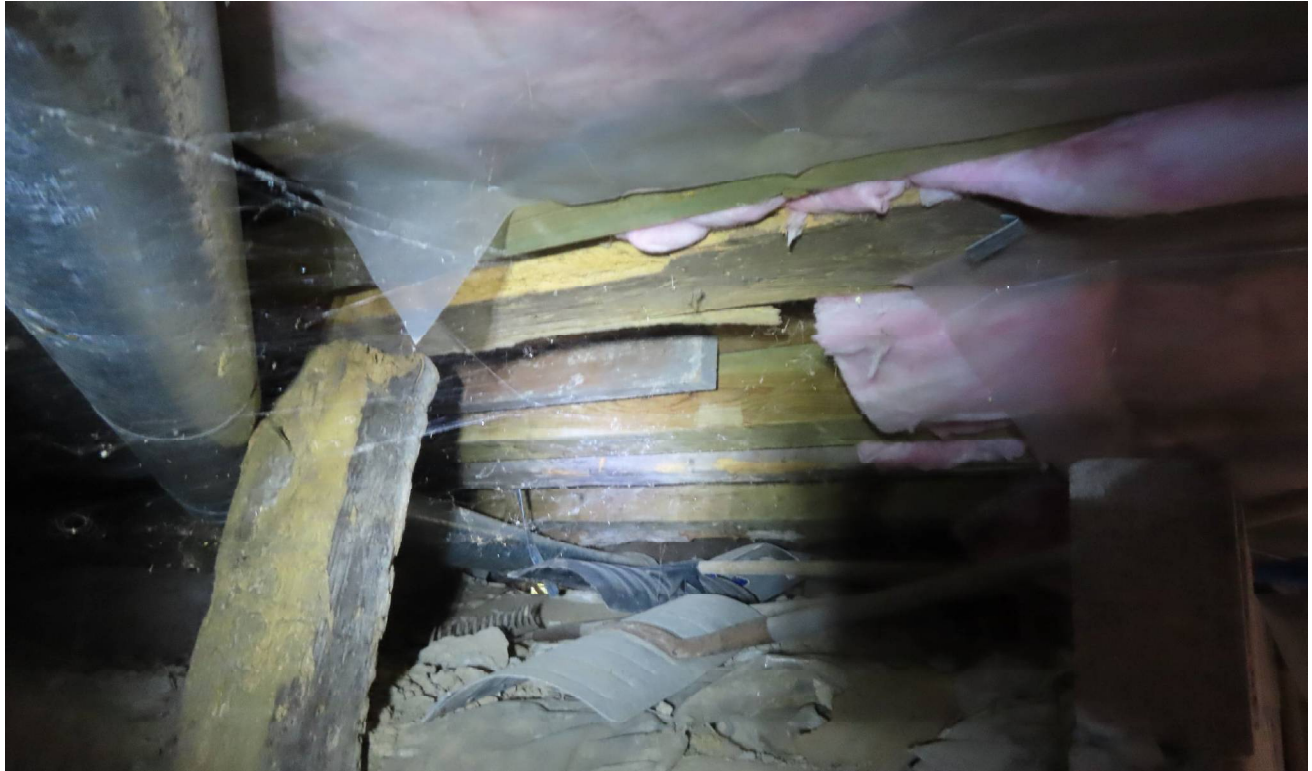
-There are many posts that have been added on top of concrete slab that bearing on a soil which doesn't have a proper soil bearing. See photos below.
