TOWN OF NIAGARA-ON-THE-LAKE

2023 MUNICIPAL BRIDGE APPRAISAL REHABILITATION/REPLACEMENT NEEDS

February 2024

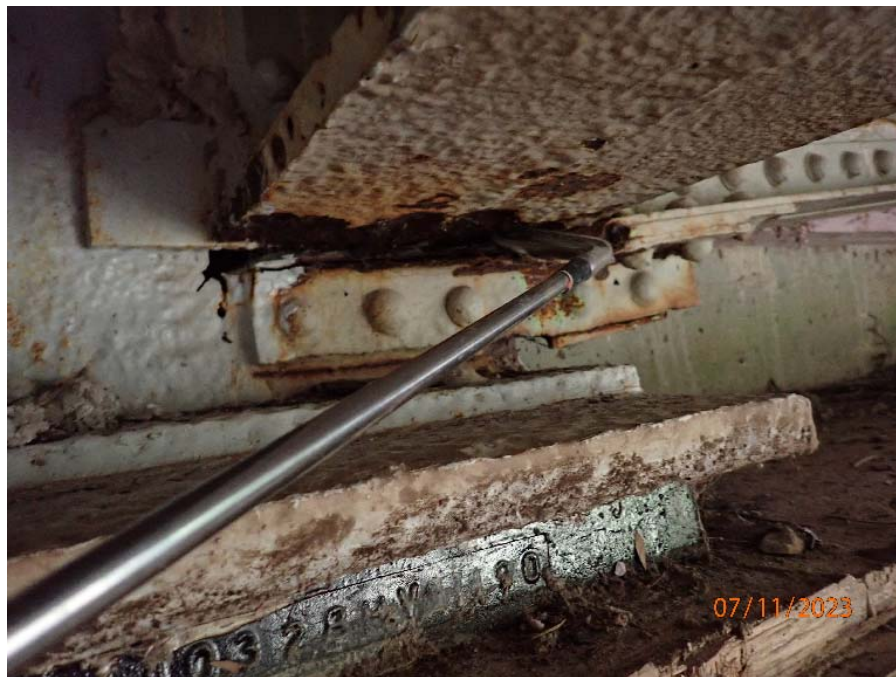
Photograph No. 4: 0885: Severe corrosion on the south exterior girder.

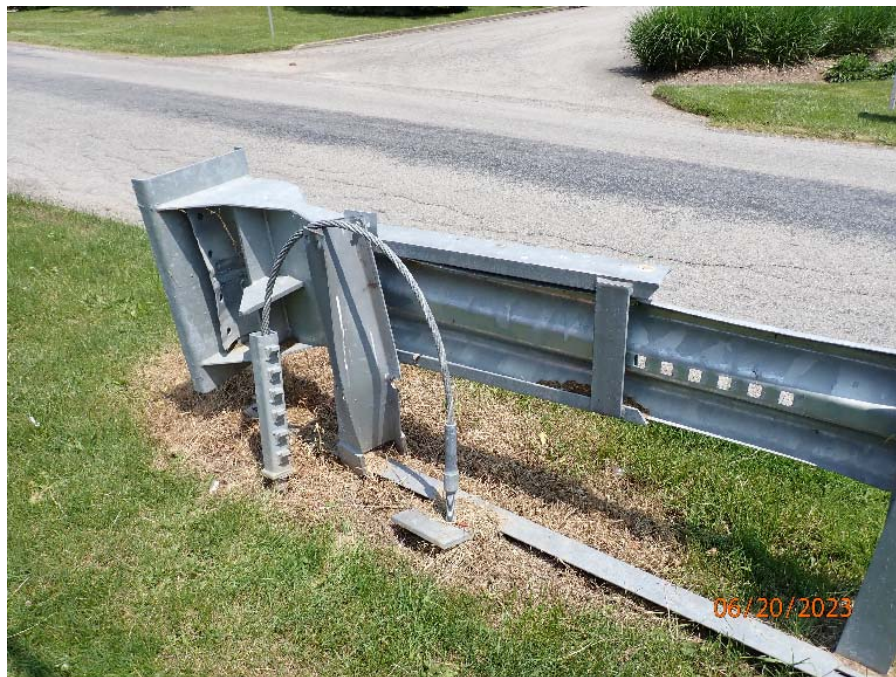
Photograph No. 4: 0746: Damaged end treatment at northwest corner.

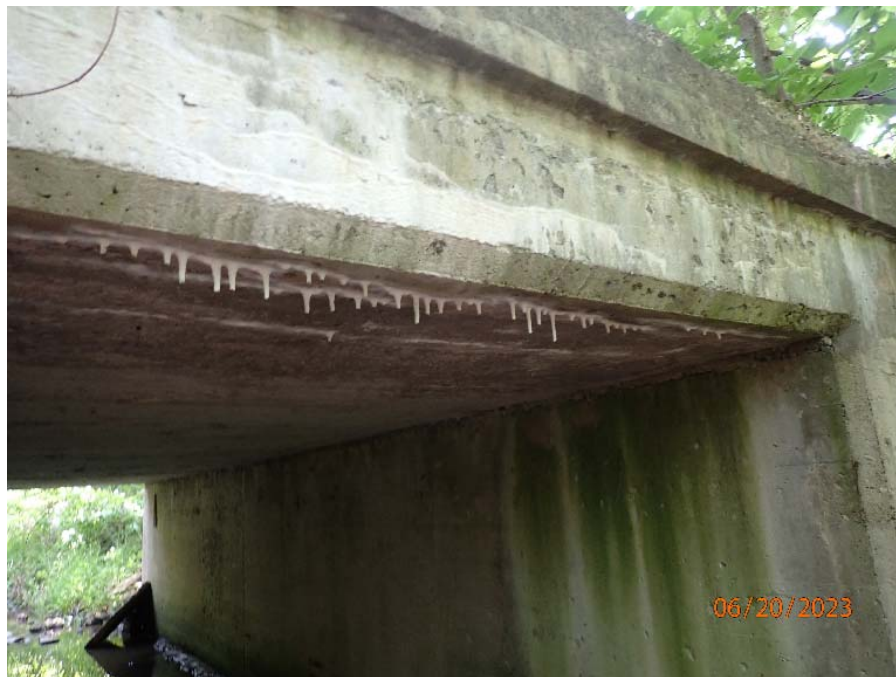
Photograph No. 4: 0898: Efflorescent staining, active leakage and stalactites at north fascia/curb.

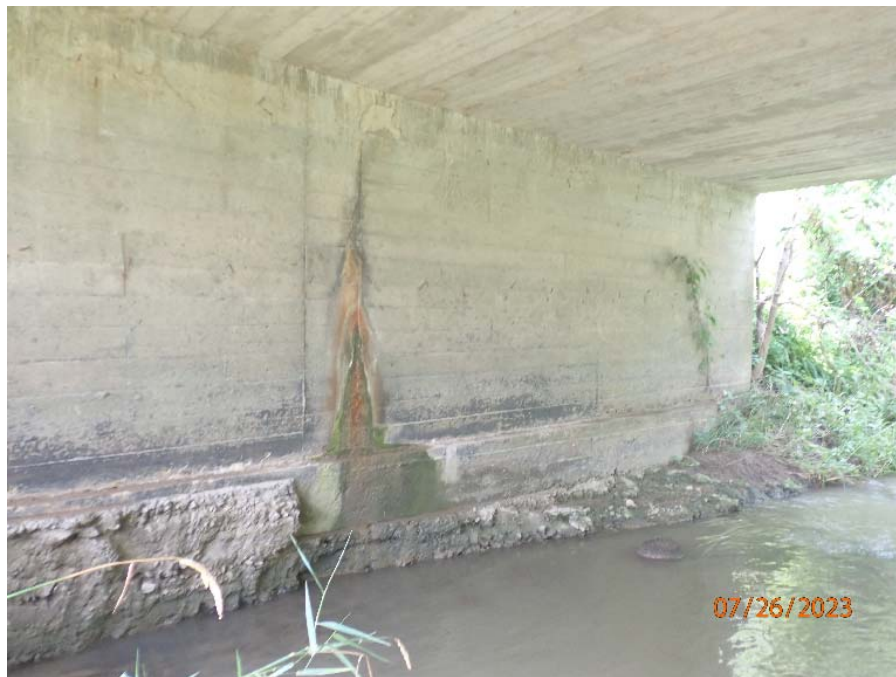
Photograph No. 4: 0550: Severe scour, wide crack with efflorescent staining and active leakage on west abutment.

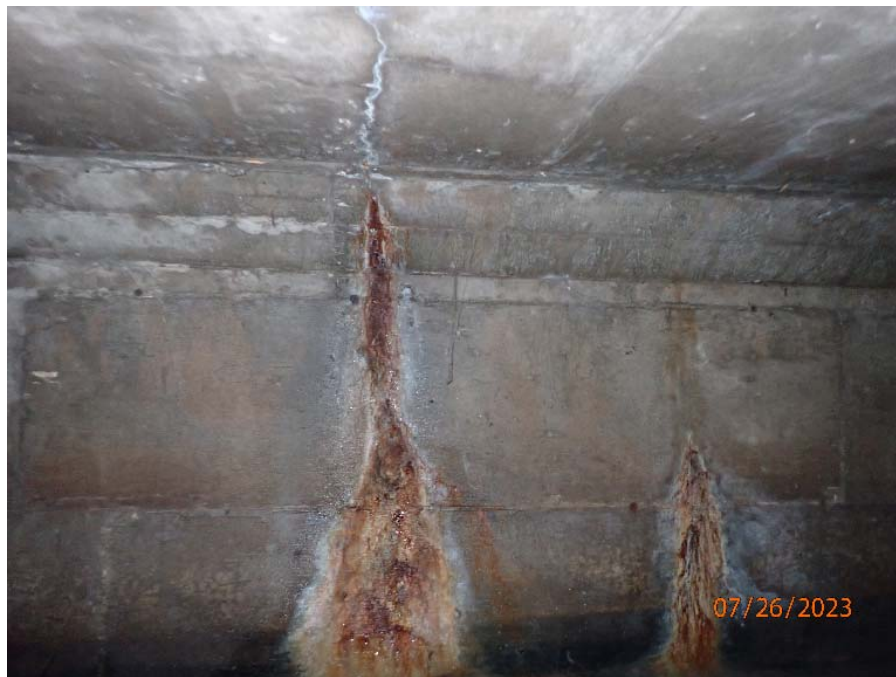
Photograph No. 4: 0090: Isolated narrow to wide cracking with efflorescent staining, rust staining, and evidence of leakage and along west abutment sidewall at centre span.
