**325 King Street, Niagara-On-The-Lake, Ontario Arborist Report:  
Tree Inventory and Preservation  
Plan**

March 3, 2023

Stantec Consulting Ltd.

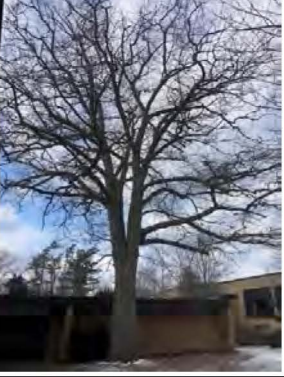
28	Red Oak	<i>Quercus rubra</i>

Based on observations on January 3, 2023, by Bill Buchanan, HBSc Forestry, ISA Board Certified Master Arborist assessment of tree 28, the tree is in a state of decline due to age and environmental factors. The explanation is as follows:

1. Red Oak (*Quercus rubra*) has a biological life expectancy of about 350 years. It is the opinion of the Master Arborist that the red oak tree is over 300 years old. A more accurate age can be determined, if required, by using an increment bore to count annual growth rings. Due to its age, the tree is in a state of decline called 'senescence'. It is similar to a person at the age of 100 and biological functions start failing which lead to natural death.

2. Signs of this decline are evident in the lack of twig elongation throughout the canopy. Also, the top outermost region of the canopy is developing dead limbs. This is typical of senescence because that is the farthest part of the tree that water needs to travel. With biological functions failing, that part of the tree suffers.

3. There are significant dead limbs throughout the canopy which is expected for a tree this age and a major crossing limb (50cm diameter) near the main crotch of the tree causing major decay.

These items are more of an indication of the lack of care and maintenance that has occurred by the previous owner responsible for the health of the tree.

4. Lastly, there are signs of Phytophthora canker on the main trunk of the tree. This is also not uncommon but is another reason that this tree will have difficulty staying alive and healthy for any significant amount of time.

In summary, it is in the opinion of the master arborist that this tree will be short lived with or without Buchanan Expert Tree Care's involvement, but will be slightly longer with some care. Any and all construction, grade changes, and especially slight changes in the natural water table will greatly affect the tree's longevity.

As a result of the assessment denoted in Section 4.1 of this report, extra caution will be taken during preservation, protection, and maintenance measures for tree 28. For example, the tree protection zone will be located at the dripline or as near as possible with respect to required construction.
