Executive Summary

- 1.1.7 The proposal to remove the extant circular Mound Garden on 200 John Street East and construct a new mound garden in a new location be refused;
- 1.1.8 That the existing Mound Garden be retained and the Austrian Pine Trees circling the mound be restored;

- 1.1.13 The proposed removal of the concrete swimming pool structure on 200 John Street East is recommended for approval, subject to the following condition:

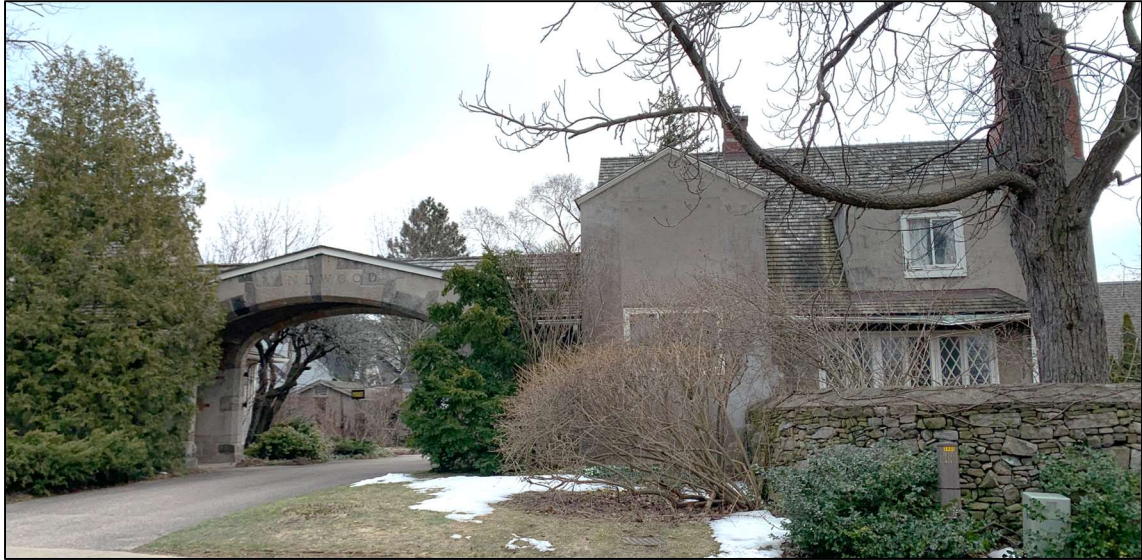
Figure 3 – Gatehouse and Randwood stone entrance arch, 580 Charlotte Street, March 2023.

Buildings constructed to support the estate included the stone entrance arch with the estate title, "Randwood," with attached Gatehouse (now 580 Charlotte Street, Figure 3). The substantial Milkhouse and Stables (now 9 Weatherstone Court, Figure 4). The farm complex (subject property at 588 Charlotte Street, Figure 5), a cottage (later the Calvin Rand Summer House), the Carriage House and Bath Pavilion (subject property at 200 John Street East) followed. The comprehensive plan for the support buildings across the estate is evidenced in the similar design features and materials between these buildings, including the exterior stucco finish, diamond-paned windows and large overhanging eaves.

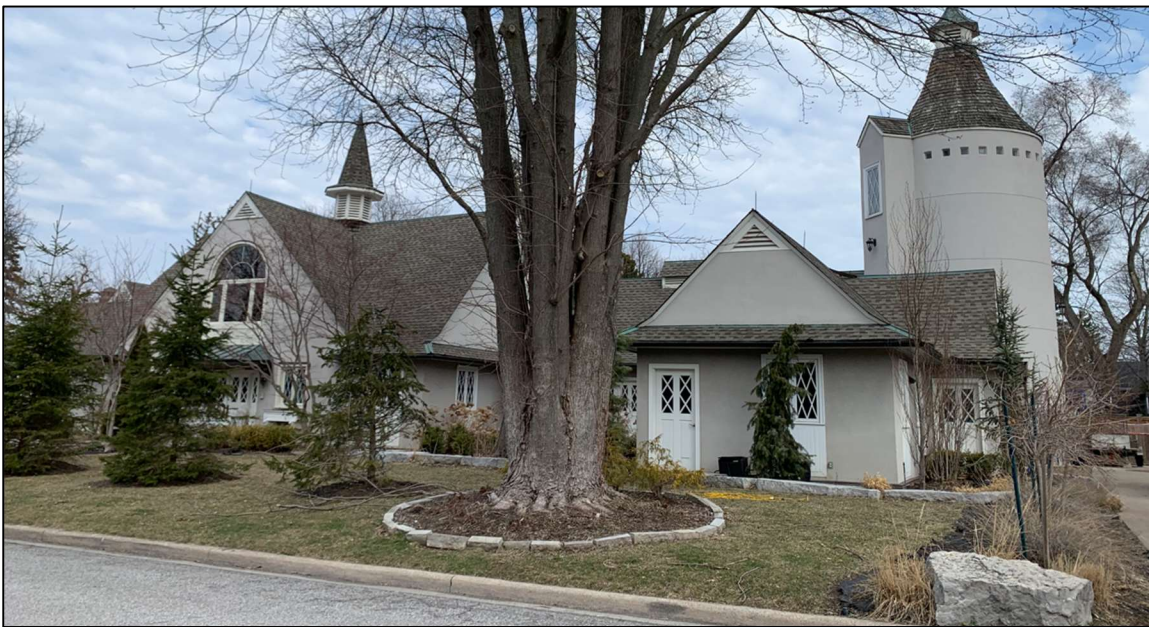
Figure 4 - Milkhouse and Stables, 9 Weatherstone Court, March 2023.

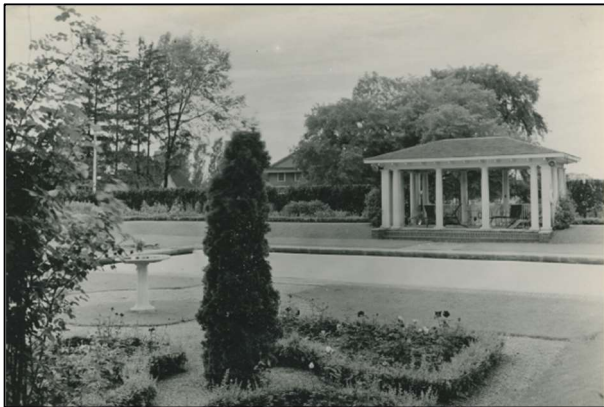
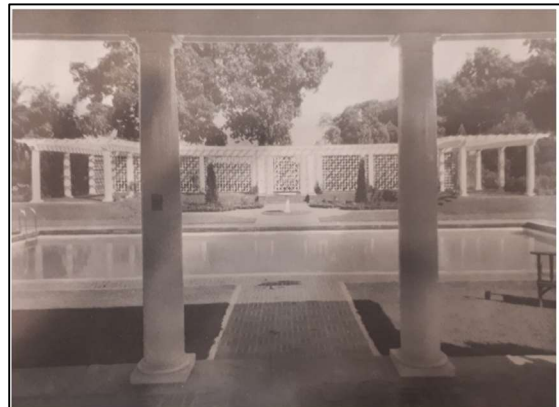
Figure 7. Swimming Pool Garden, date unknown. Source: Sheridan Nurseries Archives, in ERA CHER 2021, 71.

Figure 8. Swimming Pool Garden in 1930 with original pergola in background. Source: Canadian Homes and Garden, February 1930, 39.

A second, but related, design trend had roots in the United States, and merged "the symmetry and formality of the Italian Renaissance garden with the English picturesque approach."⁵⁶ The symmetry, formality and picturesque approaches to landscape design are particularly clear within the formal gardens designed by the Dunington-Grubbs, for which landscape plans and drawings exist, and can be referenced. The Dunington-Grubbs prepared plans for a Beaux-Arts style Sunken Garden in front of the Rand Mansion at 176 John Street East. The Sunken Garden is constructed on an axial line with a water feature (the lily pond) at the centre, surrounded by symmetrical garden layout (see 1917 Dunington-Grubb sketch for the Sunken Garden in Figure 6). The Dunington-Grubbs also prepared plans for the Swimming Pool Garden at 200 John Street East. The Swimming Pool Garden was also a sunken garden design with the pool at the centre, grassed berms and built structures set into the landscape (Figures 7 & 8).

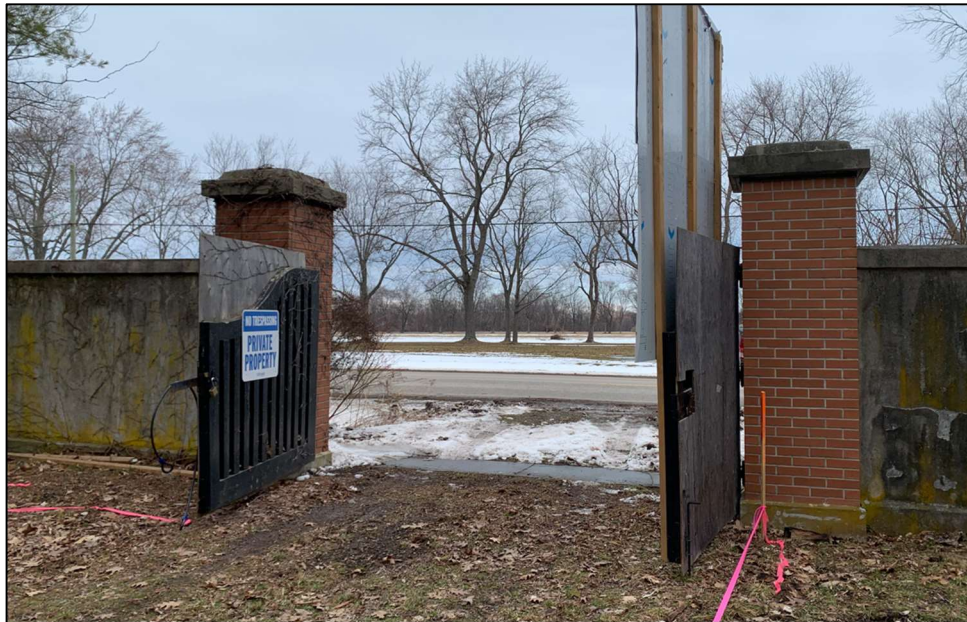
Figure 14 - Brick entrance pillars and boundary wall at entrance, 200 John Street East, March 2023.

In the 1970s the property at 200 John Street East was severed from 176 John Street East, which required a new opening within the boundary wall for street access and the construction of new brick pillars.⁷⁵ The existing brick pillars at 200 John Street East are therefore not original, however, they are compatible in design with the original boundary wall pillars.

The proposal to enlarge the wall opening at 200 John Street East would result in direct impacts to the wall and brick pillars, involving the removal and rebuilding of the brick pillars and portions of the wall. Insufficient information has been provided with the applications to determine the full extent of boundary wall removal or to outline how the integrity of the wall would be maintained with the alteration. In addition, widening the entrance may not be necessary if the proposed road construction through the panhandle is refused because of the negative impacts to the mature trees and other landscape elements.

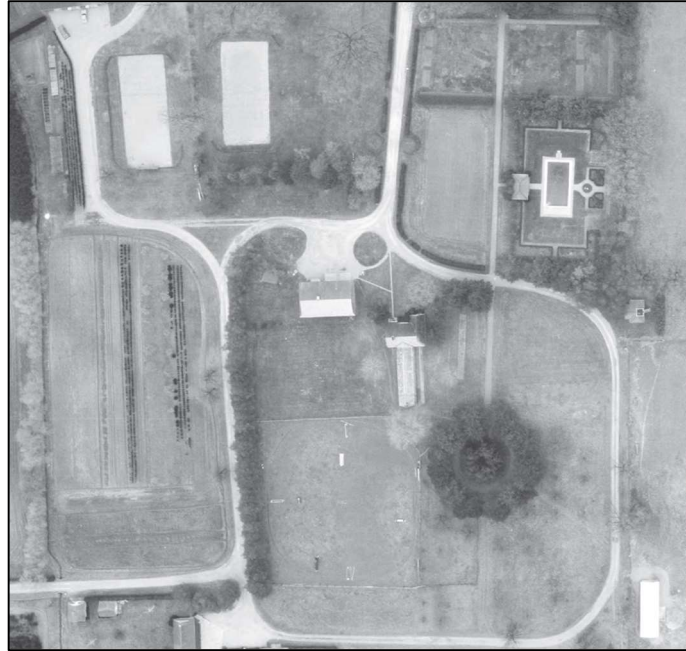
Figure 16 - 1971 Aerial Image showing the Swimming Pool Garden at top right, Axial Walkway (Main Walk) just left of the Swimming Pool Garden and moving south through the Mound Garden. Source: Niagara Air Photo Library, in ERA CHER 2021, 8.

The Axial Walkway passes through a raised, circular Mound Garden that was encircled by mature trees. Aerial images (Figure 16) show that the Mound Garden had a ring of Austrian Pines trees around the outside and a ring of coniferous trees around the inside. The Mound Garden is visible in aerial images from the 1930s into 2018. The mound feature is still extant above grade on site, however, the mature Austrian Pines encircling the mound were removed in November 2018, without Council approval. The trees around the Mound Garden were in place at the time of the service of the Notices of Intent to Designate the property at 200 John Street East, and are a heritage attribute of the property. This report considers the trees to continue to contribute to the Mound Garden as a character-defining element as Council approval was not obtained for their removal.

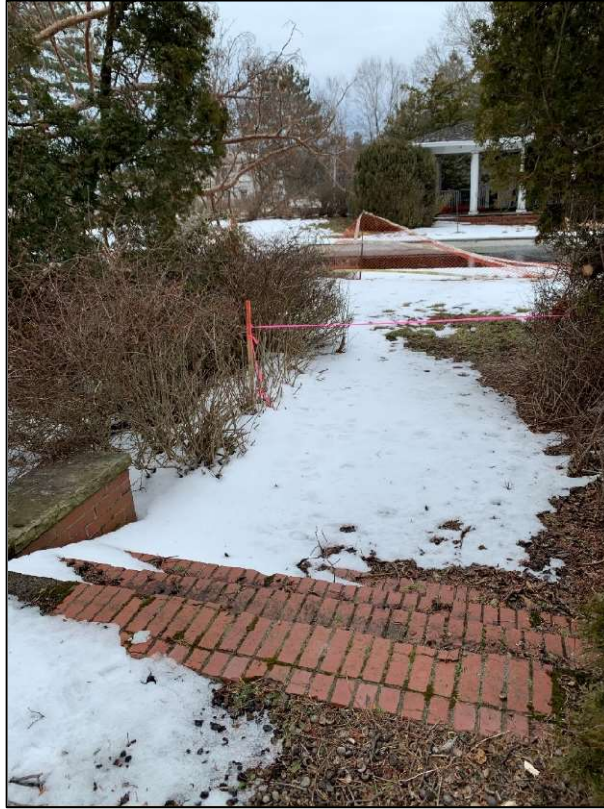
Figure 17 - Brick steps in foreground (proposed for removal) leading to the Swimming Pool Garden, with mature plantings, swimming pool and Tea House visible in background. March 2023.

Only a portion of the Swimming Pool Garden is proposed for Restoration within the applications. The west side of the garden is proposed to be restored based on the 1928 Dunington-Grubb drawings. However, the east side of the garden would be removed to accommodate new lots and the construction of the road through the panhandle to the Subdivision lands. The construction of the proposed lots and road would result in the loss of mature Pine and Cedar trees, including Austrian Pine and Scot's Pine, and surrounding barberry hedges and purple plum hedges.⁹⁵ In addition, the brick steps that led to the pergola structure within the garden (Figure 17) and the former pergola's footings would be removed.

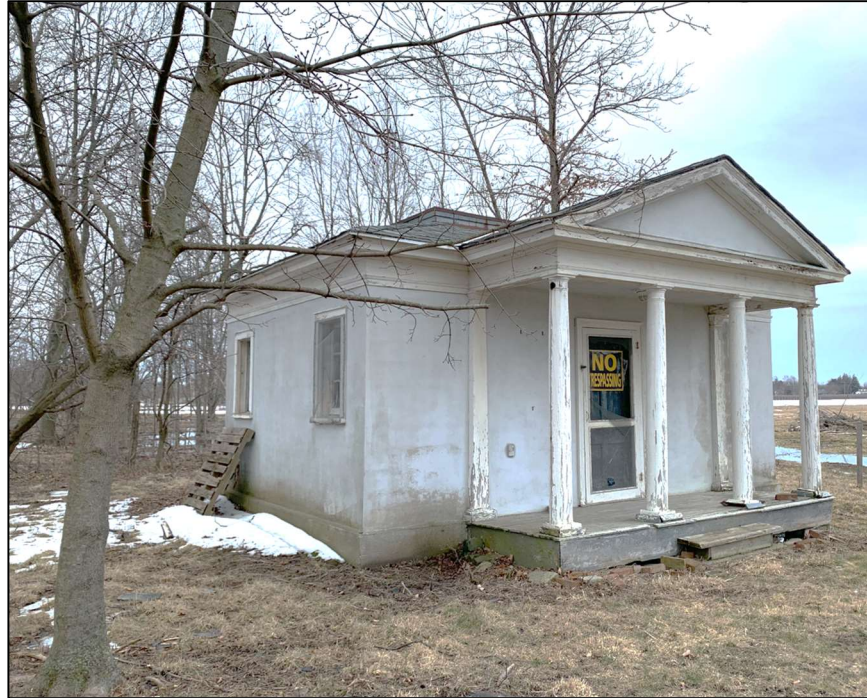
Figure 18 - Bath Pavilion, 200 John Street East, March 2023.

The Bath Pavilion has visual ties to the Swimming Pool Garden through its design relationship with the Swimming Pool Garden. The Dunington-Grubb's used Beaux-Arts landscape design on the Rand Estate. Beaux-Arts designs often included structures with Neo-classical details.¹¹² The Neo-classical design details of the building include the gable pediment roof, open porch supported by columns and central door. The Wallace HIA Addendum states that,

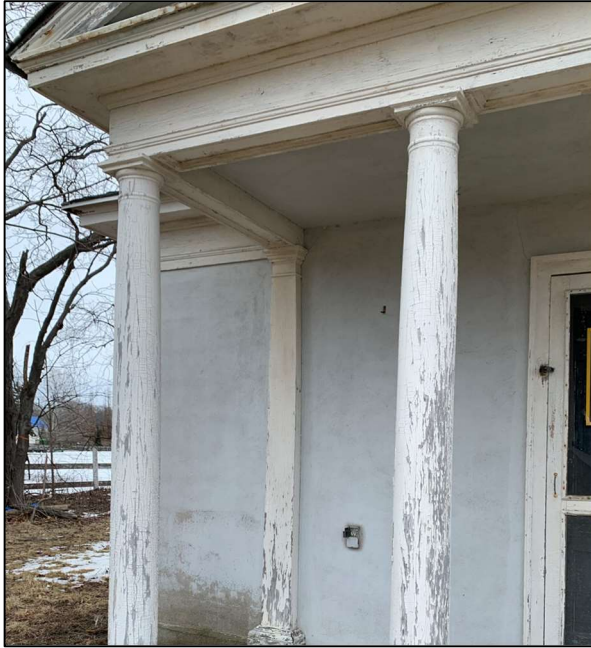
Figure 19 - Bath Pavilion with Tuscan-style Columns, March 2023.

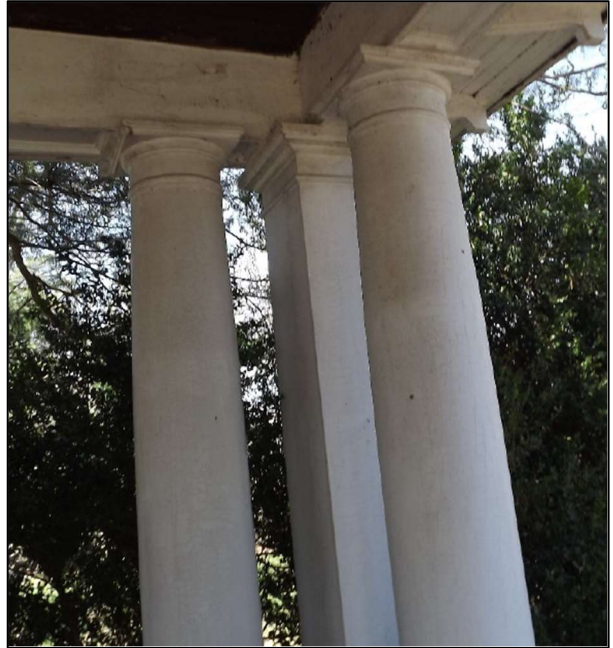
Figure 20 - Tea House with Tuscan-Style Columns, April 2022. Shoalts, Building Condition Assessment - The Tea Pavilion, 7.

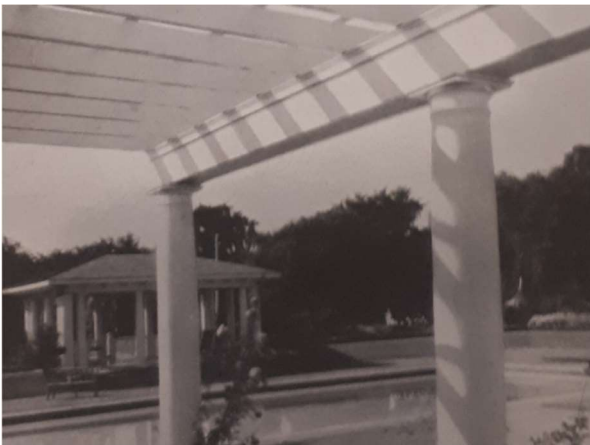
Figure 21- Former Swimming Pool Garden pergola with Tuscan-style Columns in 1930. Source: Canadian Homes and Gardens, 39.

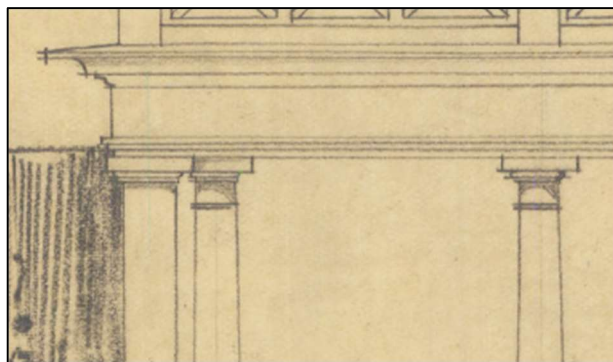
Figure 22 - Dunington-Grubb 1928 Elevation Drawings for a Proposed Tea Pavilion design. Source: University of Guelph Archives.

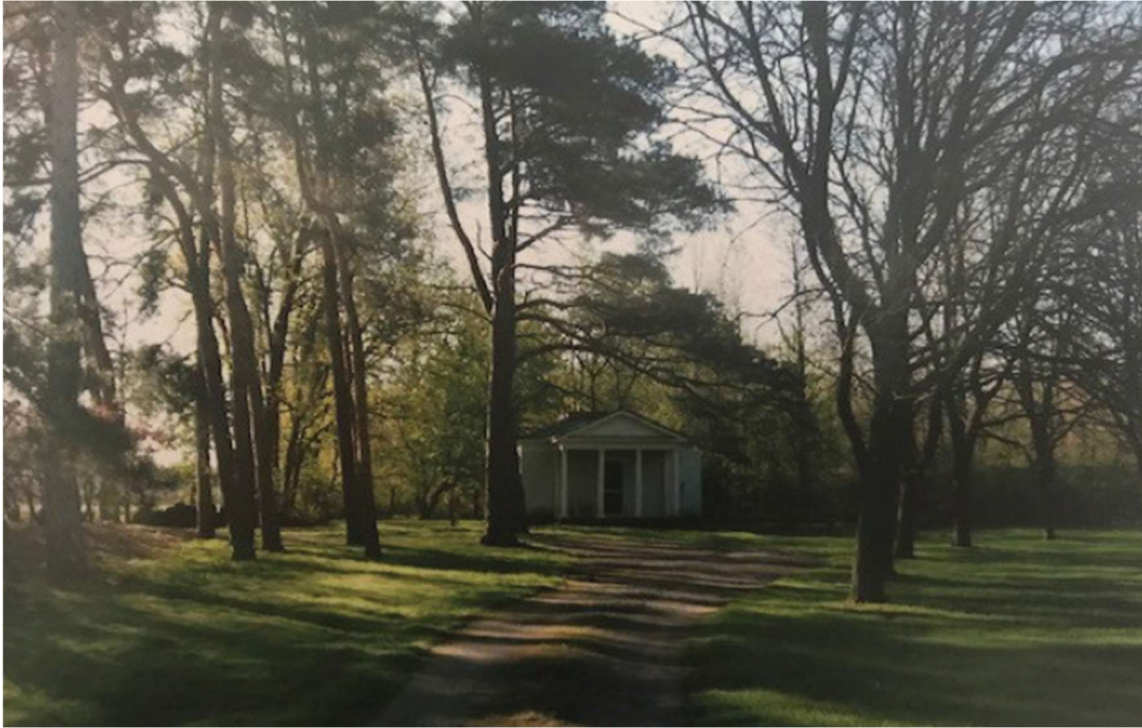
Figure 23 – View towards Bath Pavilion circa 1980s. Source: Rand Family, in ERA CHER 2021, 76.

The final consideration of siting and setting is important. The Bath Pavilion was set within a landscaped area of mature trees (Figure 23) identified as an arboretum within the Stantec Commemoration Plan.¹¹⁸ The formal classical design of the Bath Pavilion may seem unusual within the informal landscape setting. However, the formal architectural character of the building, in contrast to the natural setting, can be reconciled if one considers the Bath Pavilion was designed as a Folly within the landscape. Follies were generally designed to enhance the landscape, built on a smaller scale than the buildings they mimicked,¹¹⁹ and could be situated in seclusion, partially obscured from view, so as to create a feeling of discovery as one traveled through a landscape. Follies were common within the Picturesque movement and the Bath Pavilion appears to have been designed according to the qualities of the Picturesque where,

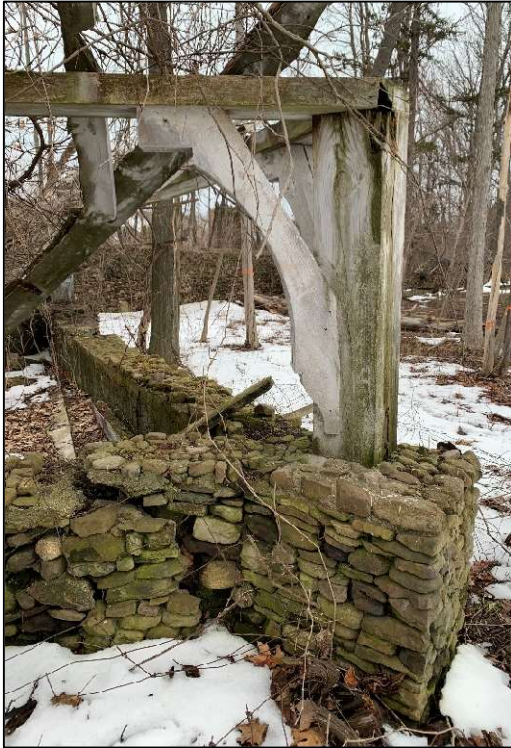
Figure 24 - Whistle Stop with wood bracket detail, March 2023.

In addition, as noted in the Shoalts Building Condition Assessment, there are similarities in construction between the low walls of the Whistle Stop and the Rand Estate boundary wall, with the use of concrete and stone facing and coping.¹³¹

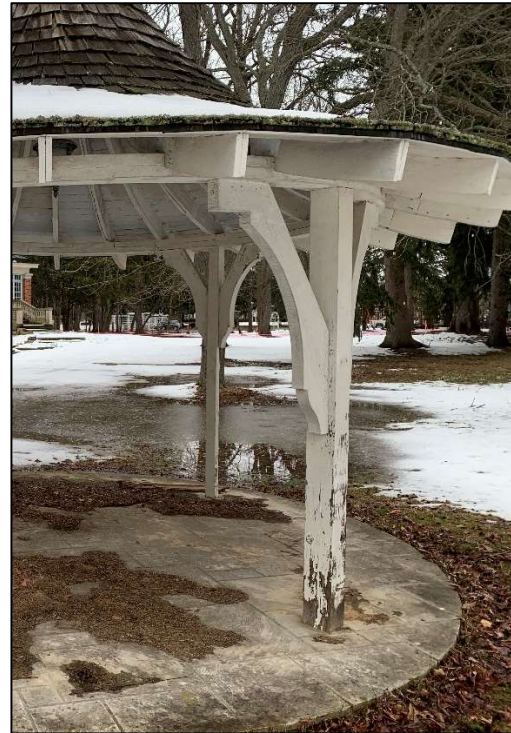
Figure 25 - Victorian Wooden Gazebo with wood bracket detail at 176 John Street East, March 2023.

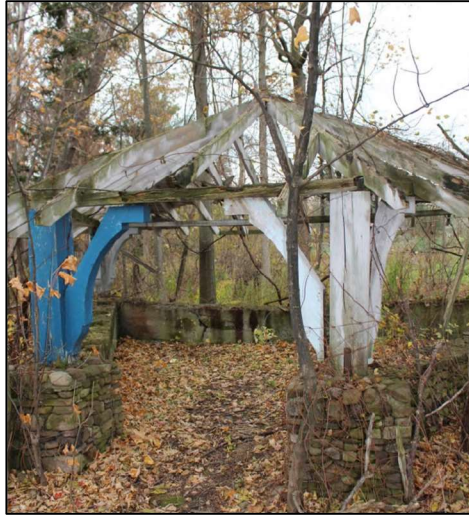
Figure 26 - Whistle Stop in 2018 with roof structure mostly intact. Source: LHC CHER 2021, 200 John Street East, p. 93.

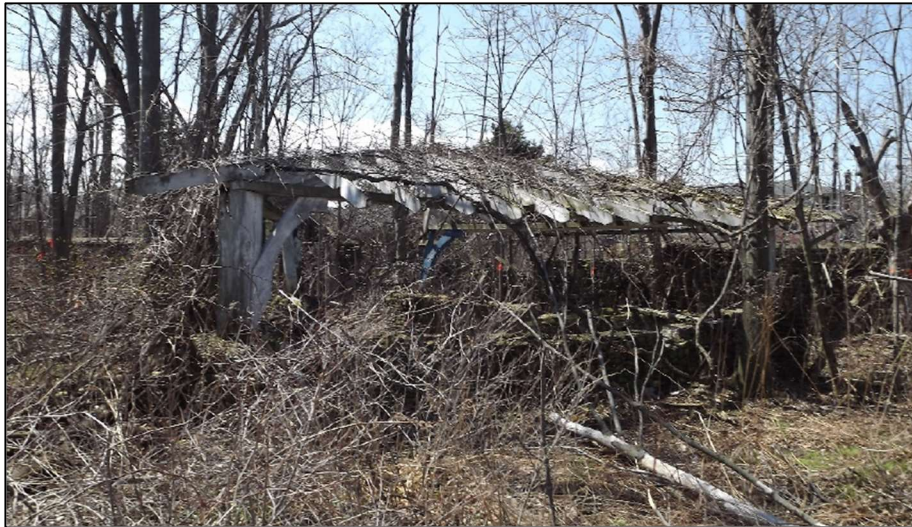
Figure 27 - Whistle Stop gazebo with roof partially intact, April 2022, in Shoalts Building Condition Assessment – Whistle Stop, p. 3.

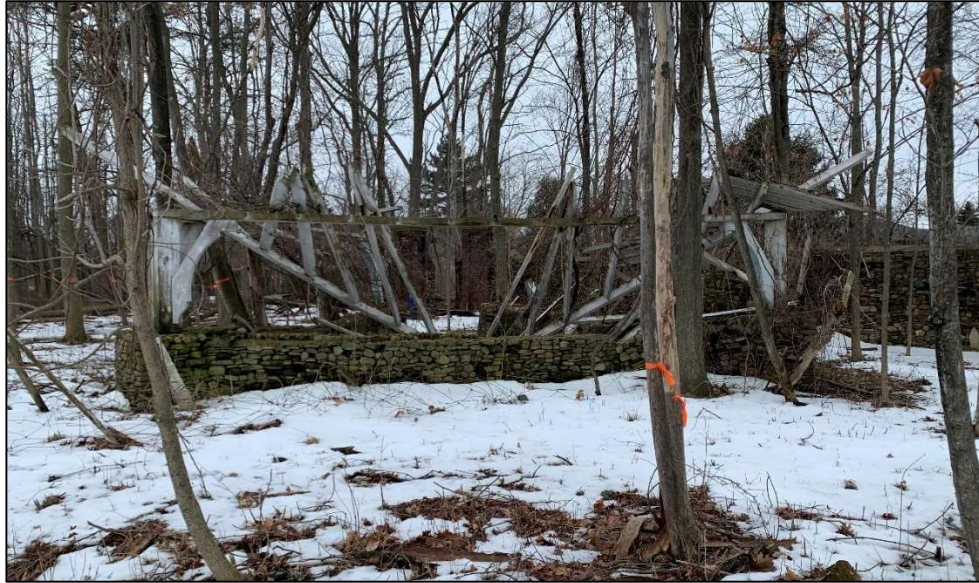
Figure 1 - Whistle Stop Gazebo with collapsed roof, March 2023.

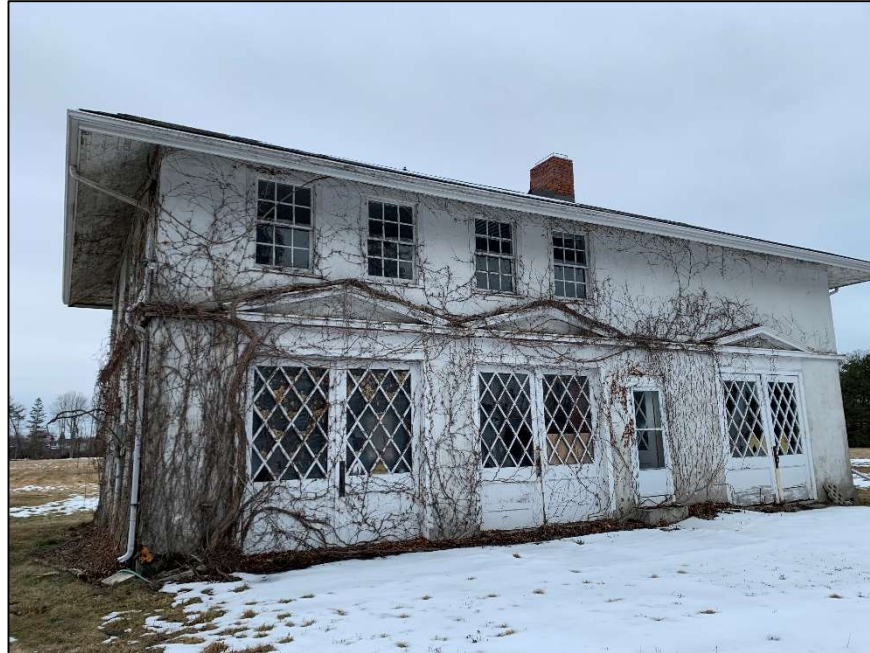
Figure 30 - The Carriage House, 200 John Street East, March 2023.

The Carriage House is a substantial two-storey structure with stucco finish, deep overhanging eaves and Dutch-gabled roof (Figure 30). The building has a rectangular footprint and contains three sets of large double French style doors which have diamond-paned windows. The Carriage House shares these design features with other buildings on the estate. These shared design features between buildings on the hobby-farm are evidence that there was an overall plan for the buildings supporting the estate uses.

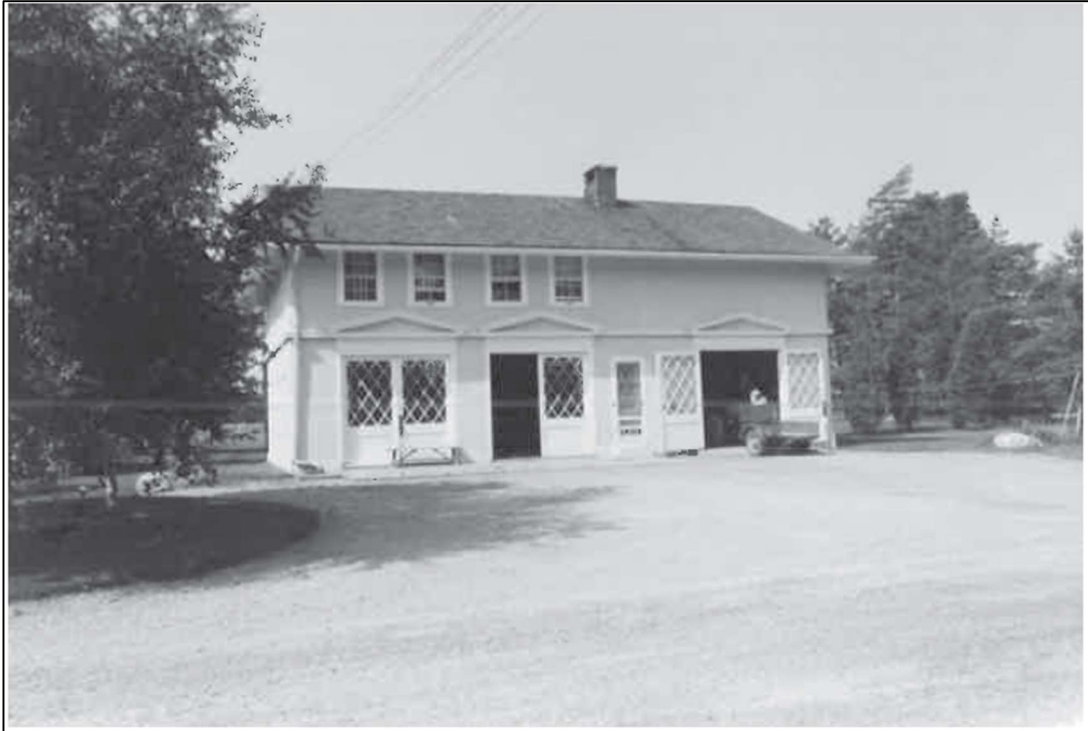
Figure 31 - The Carriage House circa 1974, 200 John Street East. Source: Glenbow Archives, in ERA CHER 2021, 20.

The Carriage House was functionally tied to a **node** devoted to estate support and maintenance.¹⁵² The building remains in its original location along a former service road for the hobby-farm portion of the Rand Estate (Figure 31).

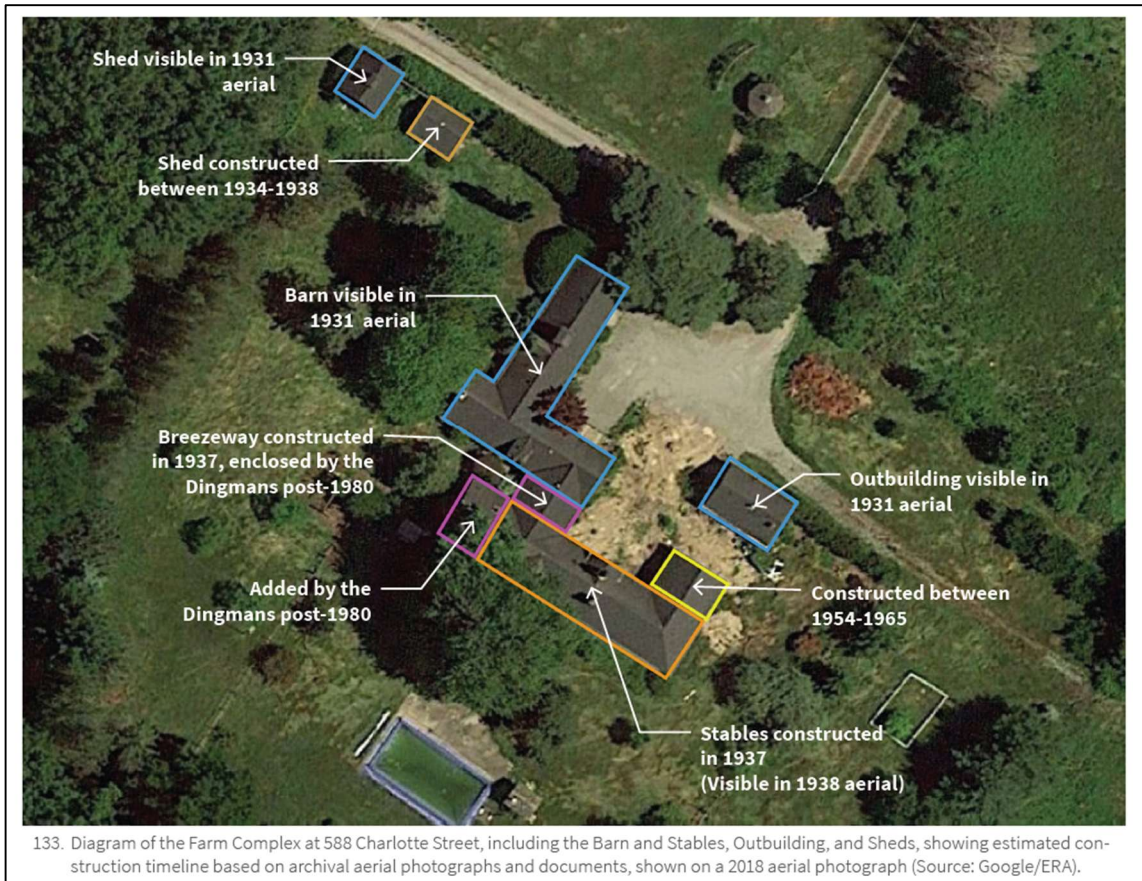
Figure 32 - Diagram of Farm Complex with approximate dates of construction, 588 Charlotte Street. Source: Google, in ERA CHER 2021, 101.

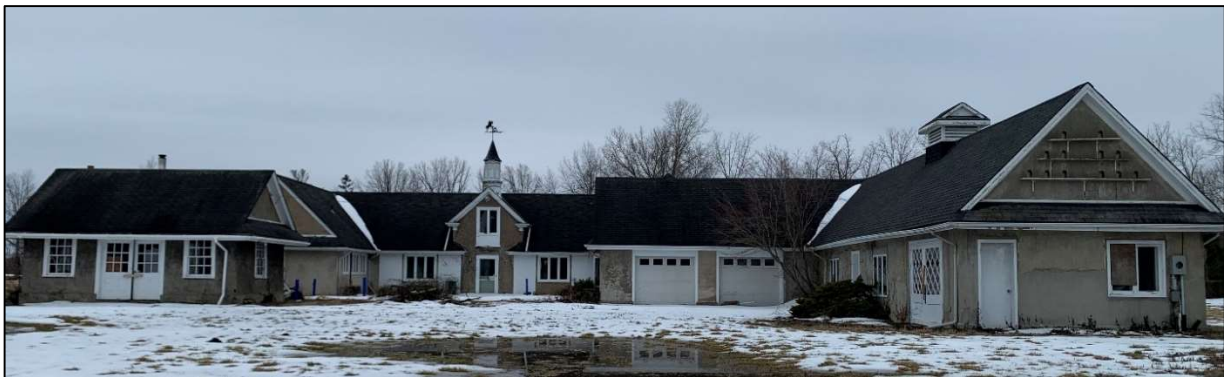
Figure 33 – North elevation of farm complex, early stables shown at centre, early barn at far right, and one-storey rectangular outbuilding at left. March 2023.

The original barn section is visible at the far right in Figure 33, with the defined gable and dovecote (for the housing of doves or pigeons). The barn was constructed prior to 1931 and still contains a few diamond-paned windows, and early barn doors. It also has the original opening for the hayloft on the west elevation. The one-storey rectangular outbuilding was also constructed prior to 1931 (visible in Figure 34 at far left). The barn and one-storey outbuilding are stylistically similar with the stucco finish, dutch-gabled roof design, uniquely defined gables and large overhanging eaves.

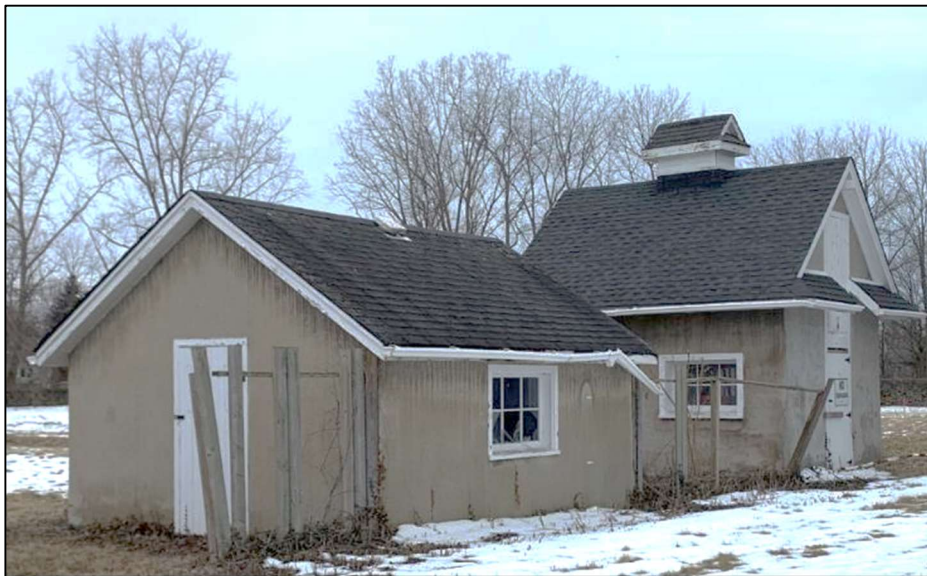
Figure 2 – Two Shed buildings, northeast elevation. March 2023.

The two small sheds are set together along an early service road, northwest of the converted residence and one-storey outbuilding. Again, the sheds are stylistically similar within the farm complex. The two-storey shed, which was a granary, was constructed prior to 1931. Stylistically, it shares much of the same design features as the pre-1931 barn and one-storey outbuilding, including the stucco finish, dutch-gabled roof design, uniquely defined gables and large overhanging eaves. The small shed, which has been identified as a former chicken coop, is simpler in design. Stylistically, it also has a stucco finish, 6-pane windows, and large overhanging eaves.

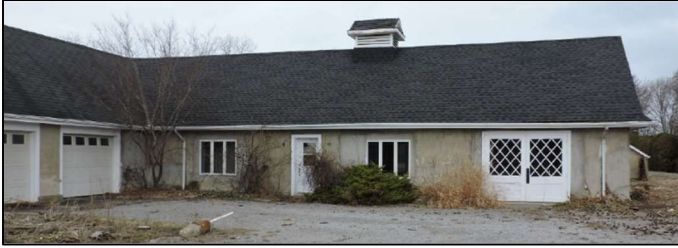
Description	Building
<p>Early Barn (east elevation)</p> <ul style="list-style-type: none"> -constructed prior to 1931 -exterior stucco finish -dutch-gabled roof design -uniquely defined gables -large overhanging eaves -diamond paned windows -original double doors -dovecote -hayloft opening

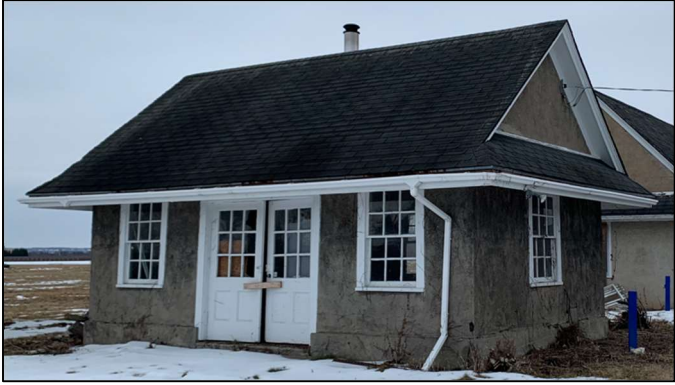
<p>March 2023</p>
<p>One-storey rectangular Outbuilding (north elevation)</p> <ul style="list-style-type: none"> -constructed prior to 1931 -exterior stucco finish -dutch-gabled roof design -uniquely defined gables -large overhanging eaves -6-pane wood windows

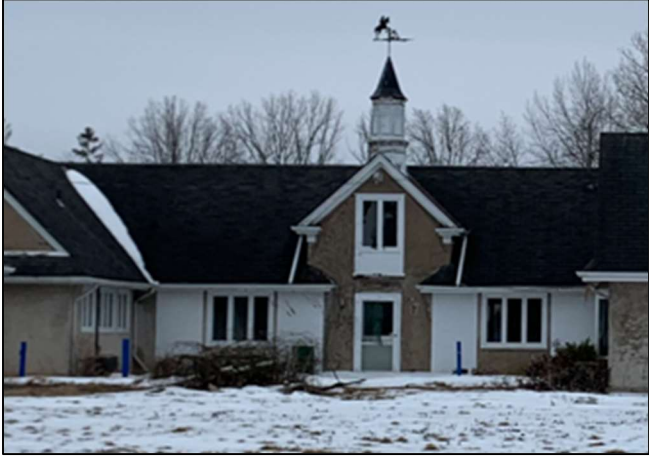
<p>March 2023</p>
<p>Early Stables (north elevation)</p> <ul style="list-style-type: none"> -Constructed circa 1937 -exterior stucco finish -dutch-gabled roof design -uniquely defined gables -large overhanging eaves -cupola and weathervane

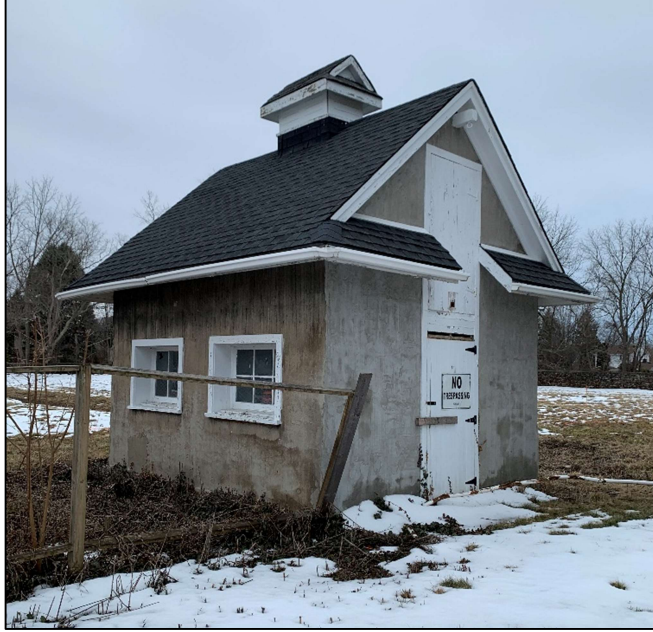
- Constructed prior to 1931
- exterior stucco finish
- Dutch-gabled roof design
- uniquely defined gables
- large overhanging eaves
- 6-pane wood windows

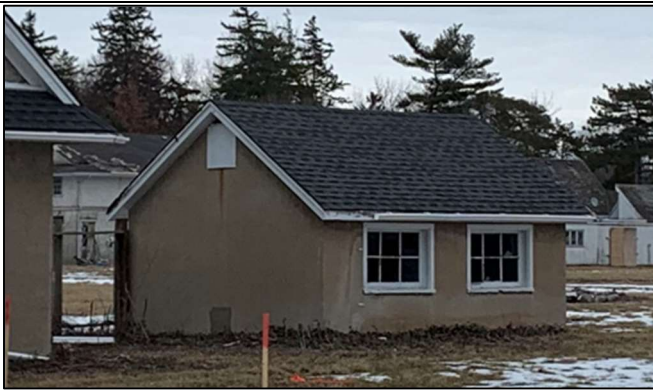
- Constructed circa 1934-1938
- exterior stucco finish
- large overhanging eaves
- 6-pane wood windows
