BUILDING CONDITION ASSESSMENT
THE TEA PAVILION
200 JOHN STREET, NIAGARA-ON-THE-LAKE

April 27, 2022

Prepared by
Mark Shoalts, P.Eng., CAHP

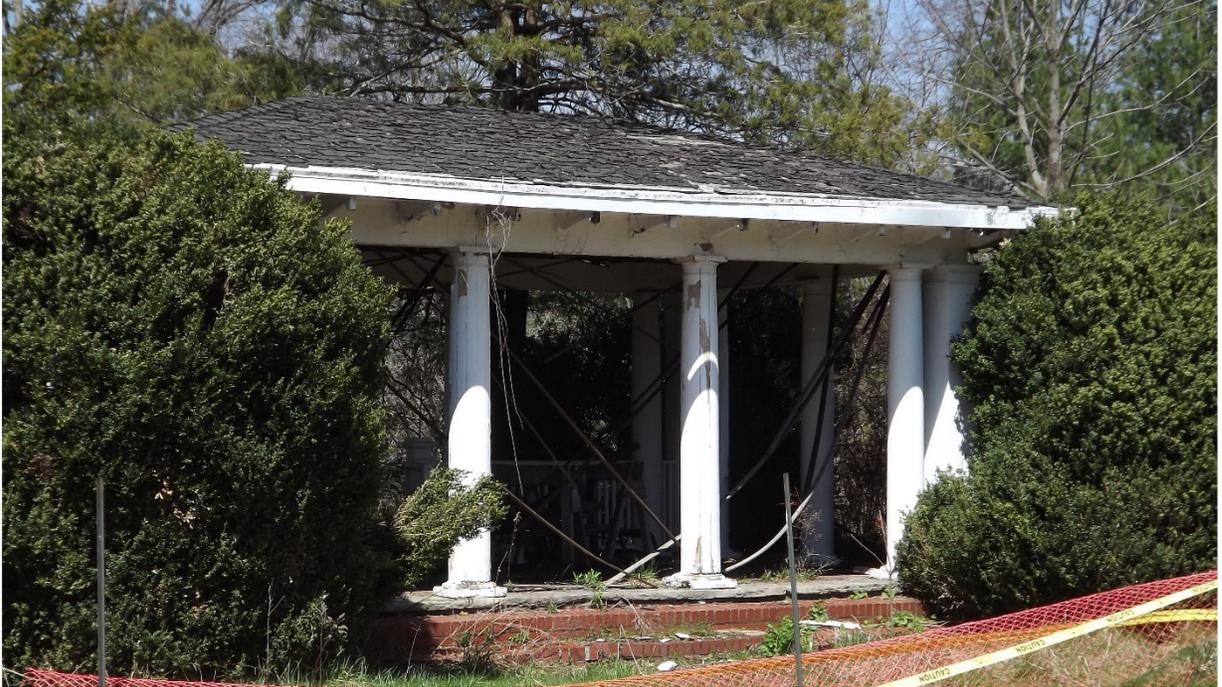
The Tea Pavilion East Elevation, April 2022

The Tea Pavilion is in poor condition. The metal (presumably copper) roof shown on the Dunington-Grubb plan was not installed and the present asphalt shingles are long past their service life; they have been leaking for years. Much of the tongue and groove wood ceiling has collapsed and substantial sections of the eave have deteriorated. Some of the wood columns exhibit serious decay, especially the bases. Three columns in particular are in poor condition and they appear to possibly be replacements that have failed for a second time. The staves on the centre pair of columns facing the pool and one column in the south end are delaminating and the paint is peeling badly. All of the other columns have retained their paint and no joints between staves are even discernible, much less delaminating. The good columns give every appearance of being solid, but they are hollow as evidenced by electrical switches mounted on two of them. There is no obvious reason why three of the twelve round columns would be in such poor condition. The bases of these three columns as well as the bases of several other columns are also in poor condition and require replacement.

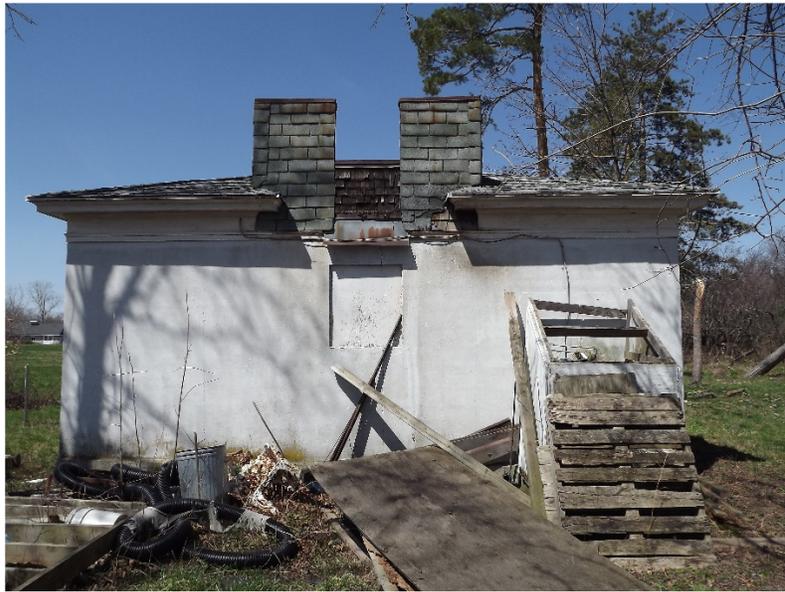
The roofing is in poor condition and requires replacement. Roof leaks through the south eave have deteriorated a portion of the soffit, fascia, and frieze, and the leaks must be repaired as soon as possible to prevent further deterioration. The platform and its surrounding walls on the rear of the roof should be investigated further to try to determine its original purpose. Unless there is significant heritage value in the original purpose, it would simplify the roof, extend its longevity, and make maintenance much easier if it were removed and the roof and overhang were filled in to match the rest of the building. There was an opening in the rear

wall directly below the platform that seems to have been related but it has been covered by the plywood that was installed as an interior wall finish.

Rear wall of Bath House showing roof platform

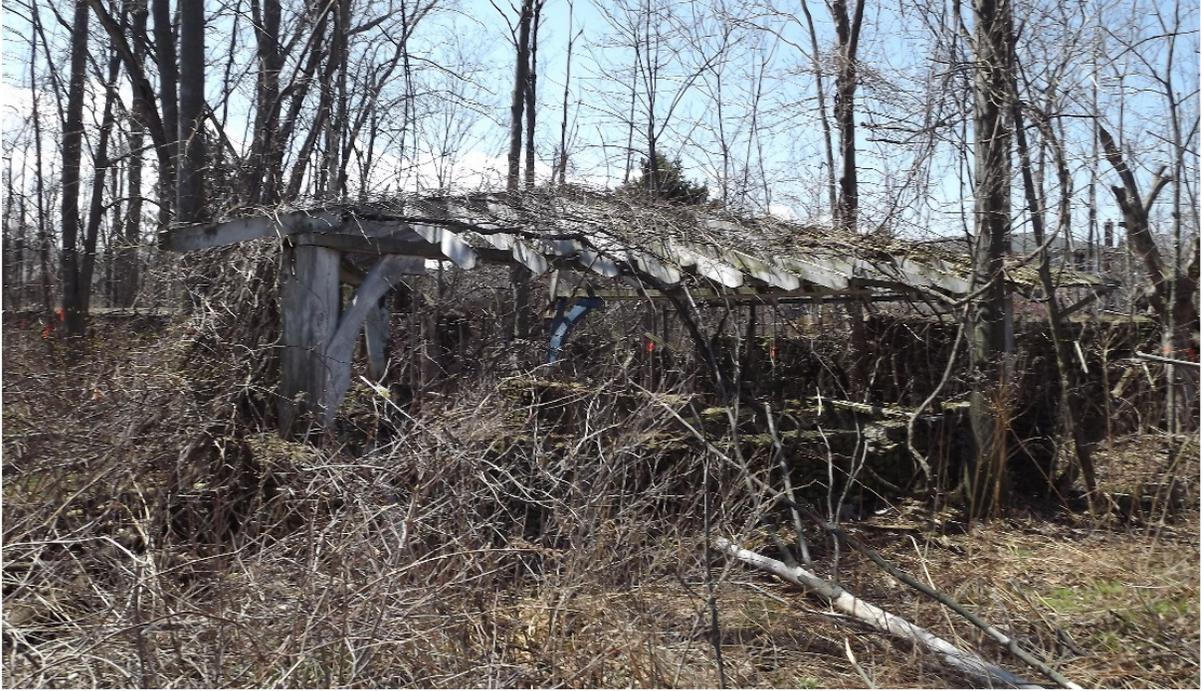
The Whistle Stop Northwest Aspect, April 2022

The Whistle Stop is essentially a complete ruins, but there are enough fragments of the wood structure and enough of the concrete and masonry walls and floor to enable one to replicate it. The wood structure has deteriorated to the point that with the exception of three or four brackets, none of it can be used in restoring the building. The various pieces are sufficiently intact to serve as patterns for replication. There is one small section of roof sheathing extant with a few fragments of cedar shingles; there appears to have been a fire some time in the past although the majority of the damage to the roof seems to be a consequence of failed roofing. The small amount of charred material on the ground could be from someone building a fire with collapsed pieces of the structure. It is not clear why the majority of the roof sheathing and all of the roofing is gone; the intact rafters are not charred and although the tops of some of the rafters are in poor condition with extensive rot, many appear relatively sound. There is not much roof sheathing on the ground, so it does not appear as though it simply fell off or blew off. Much of the roof may have been intentionally removed.

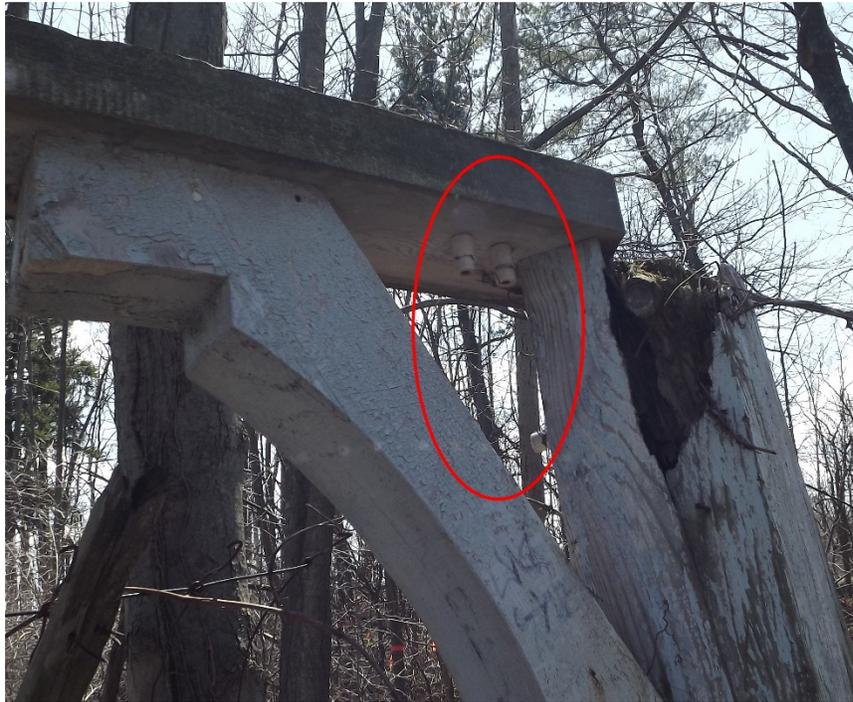
There was electrical power to the building as indicated by porcelain insulators near the entrance and a small fragment of wire, but there is no trace of the purpose for the electrical service. It may have been for interior lights only, or possibly for a light to indicate that someone was waiting for a train.

Porcelain electrical insulators beside south entrance

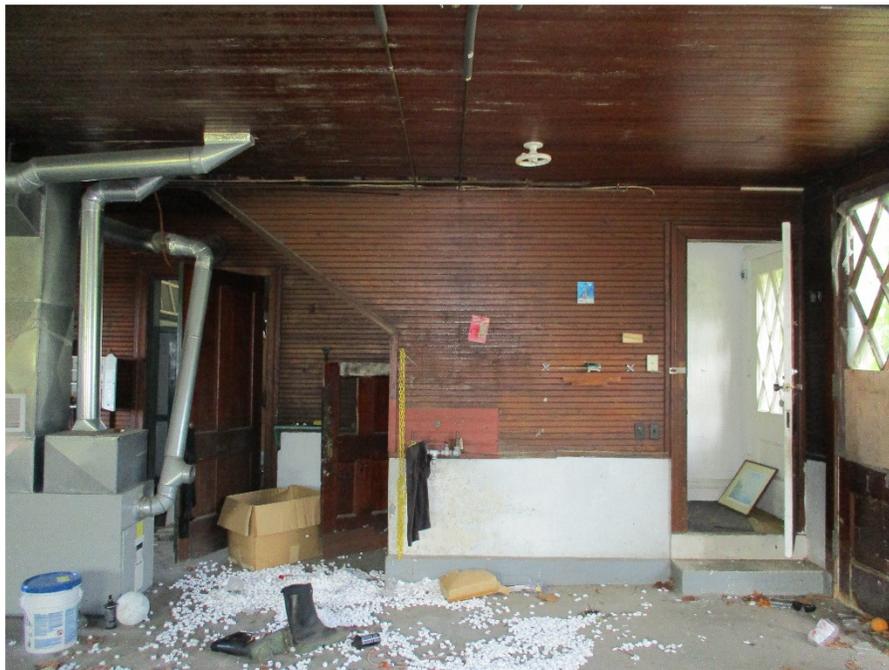
Interior of garage; note new furnace, door to apartment

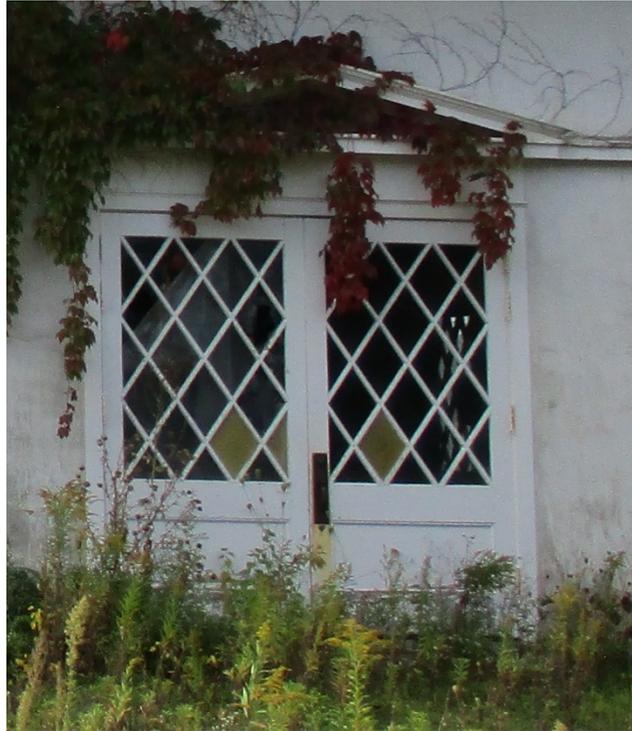
The Carriage House exterior is in fair condition with some elements poor and a few elements in quite good condition. The present asphalt shingles are past their service life and need to be replaced; some have recently blown off of the south side. The stucco is in generally good condition with some small areas of concern. The windows and doors are fairly good with the exception of some glass that has recently been smashed by vandals; the broken windows have been boarded up. The wide carriage doors have sagged a bit, which is to be expected; the hardware is original and in good condition. The doors can be restored.

Drive doors to the workshop

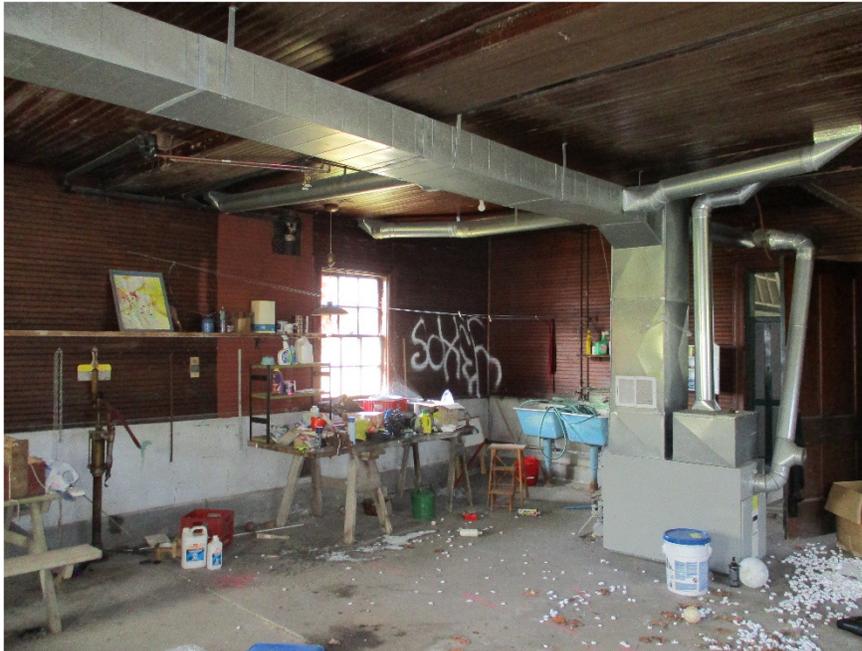
The interior of the Carriage House is in fair to good condition on the ground floor and fair to poor condition on the second floor. The concrete floor is badly cracked. It is very likely that the concrete floor would have to be removed no matter what decision is made on retaining or relocating the Carriage House. The building was used as a garage for the storage and servicing of automobiles. There is a drain in the floor with an unknown outlet. There is also a hand pump near the back wall connected to iron pipe that emerges from the concrete floor. While it could be a water pump, there is plumbing in the building which makes that questionable. It is possibly an oil or fuel pump and it is possible that there is a tank under the floor; this requires further investigation.

Interior of garage, note hand pump at left

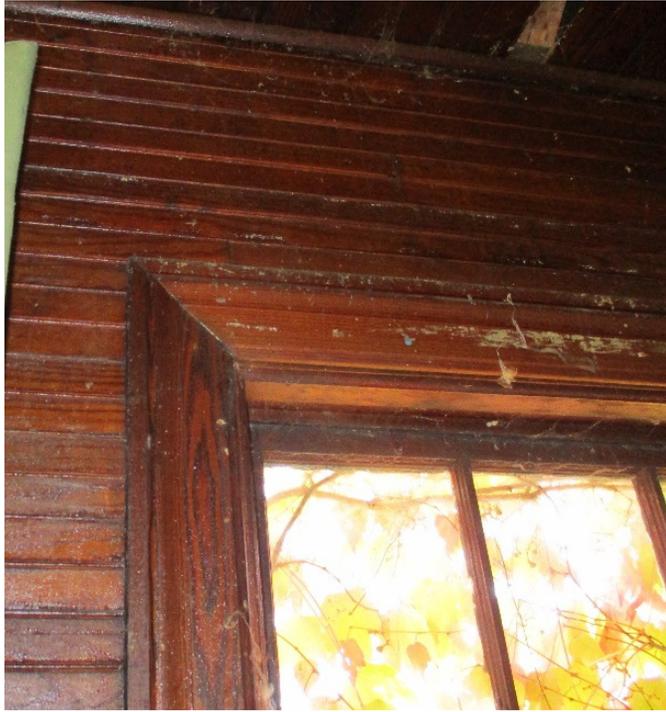
The wood finishes throughout the ground floor are in very good condition. There are a few areas where less than sympathetic installations of newer equipment has done some damage but restoration would be fairly simple. A new furnace was installed with exposed ductwork and heating outlets were cut through the ceiling for the upper apartment. Plumbing lines have been run on the surface, and some strips of T&G panelling have been removed to allow access to concealed plumbing and electrical lines. Most of the damage is relatively minor.

Detail showing fir panelling, window casing, and sash in garage

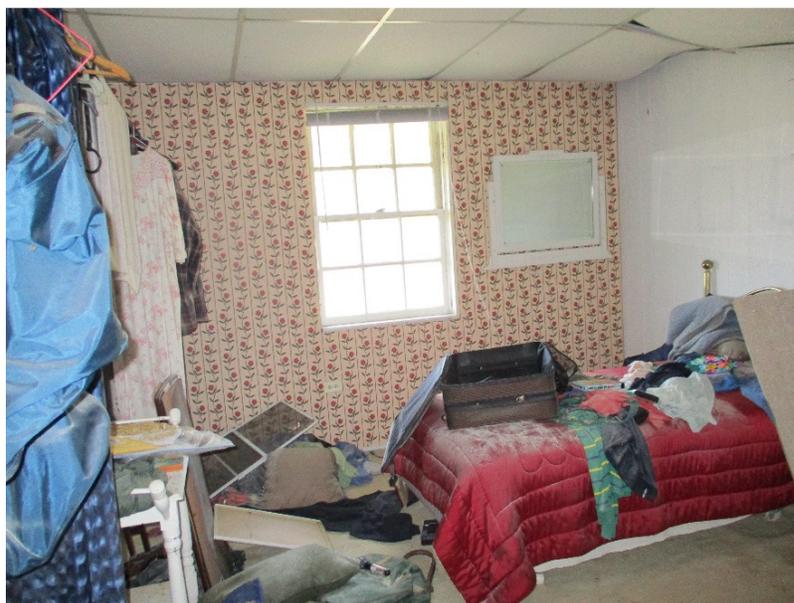
The conversion of the hayloft into living space was done very cheaply with inferior materials, indifferent workmanship, and little regard for functionality. The lack of maintenance has now made the space uninhabitable, but it was barely fit for occupancy when it was first finished. Incomplete insulation, hardboard panelling, and suspended tile ceilings in very poor condition are there at present.

Bedroom in former hay loft

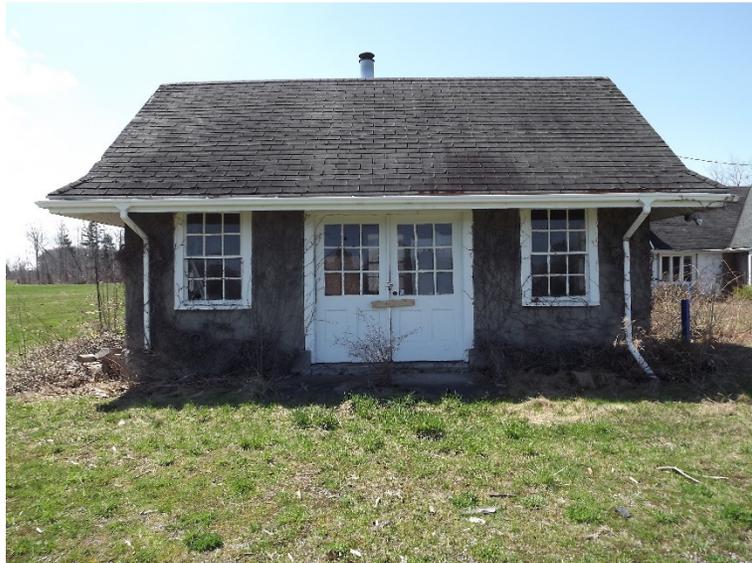
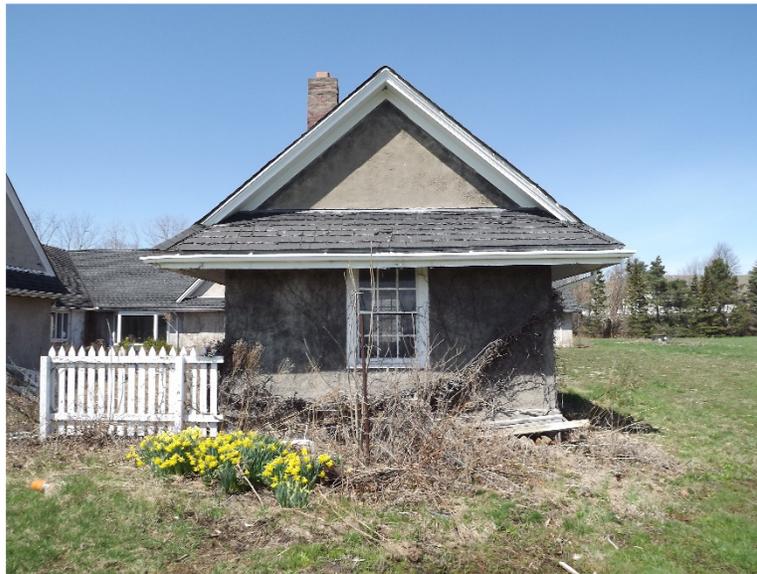
The workshop building is quite good. The asphalt shingles are in fair condition on the north side and they are newer and very good on the south side; there are no leaks. The building has PVC eavestroughs and downspouts that should be upgraded to aluminum at least, and preferably to galvanized steel. The exterior wood trims and windows are in good condition, requiring only minor repairs before scraping and painting. The doors have some minor damage and wear that must be repaired before scraping and painting. The stucco is also in good condition, requiring only minor repairs. The concrete foundation walls are in poor condition where they are visible above grade, both inside and outside the building. The interior finishes are in adequate condition although they are not up to the standard of the original building and consideration should be given to upgrading them to the level that would have originally existed. The concrete floor is severely cracked and settled and should be replaced.

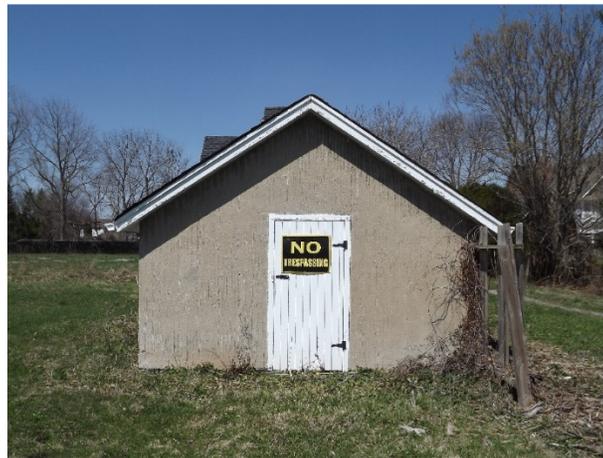
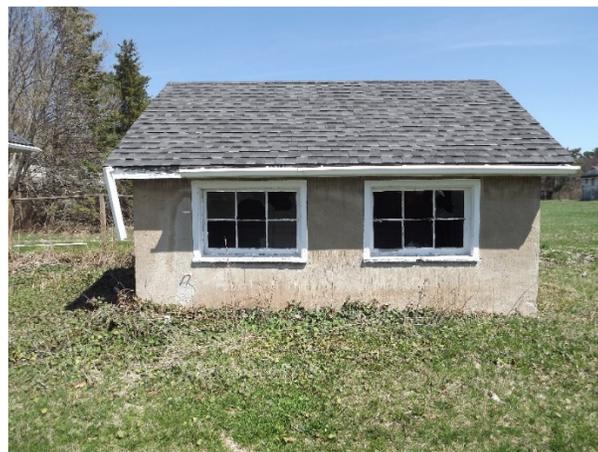
Shed C is in fair condition. The asphalt shingles are in fair condition on the north side and they are newer and very good on the south side; there are no leaks. The building has PVC eavestroughs and downspouts that are in poor condition. The exterior wood trims, door, and windows are in fairly good condition, requiring only minor repairs before scraping and painting. The stucco is in fair condition, although it requires some repairs due to deterioration and also to previous poorly-done repairs. The foundation is not visible above grade, either inside or outside the building and the soil is up on the walls in places. This has probably resulted in rot of some of the framing but it cannot be determined without cutting into the walls. The interior wood finishes on the walls and ceiling are in good condition, but the floor system of sleepers and waferboard has completely deteriorated to the point where much of the floor is exposed soil. Because of the small size and low ceiling, finding an alternative use for the building could be challenging.

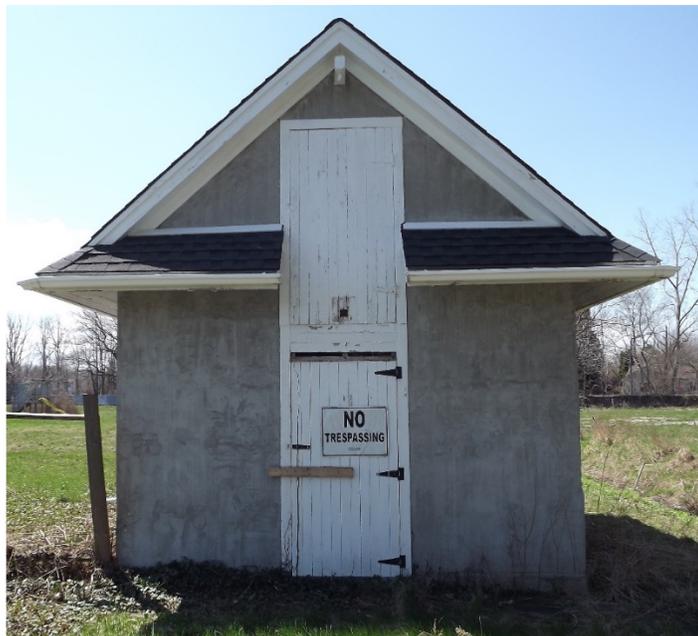
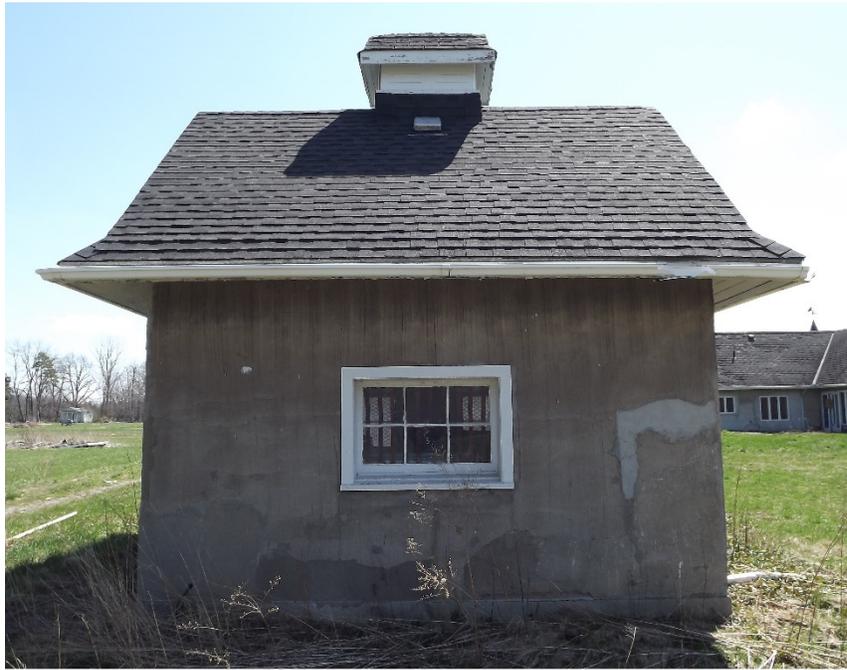
Shed D is in fair condition. The asphalt shingles are relatively new and very good condition with the exception of the cupola, which was not resingled at the same time as the roof. There are no leaks. The building has PVC eavestroughs that are in poor condition with no downspouts; the apparently intentional outlets are gaps in the troughs. The exterior wood trims, door, and windows are in good condition, requiring only minor repairs before scraping and painting. The stucco is in fair condition, although it requires some repairs due to deterioration and also to previous poorly-done repairs. The concrete foundation extends a few inches above grade, although the soil is up on the walls in places. The interior finishes are in reasonably good condition. Because of the small size and low ceilings, finding an alternative use for the building could be challenging.
