**325 King Street, Niagara-On-The-Lake, Ontario Arborist Report:  
Tree Inventory and Preservation  
Plan**

March 3, 2023

Stantec Consulting Ltd.

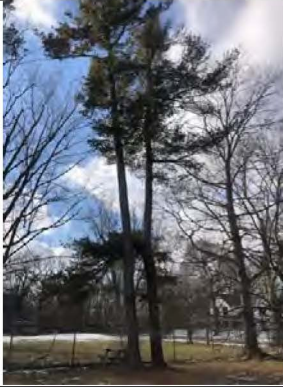
<p>10 (Right Tree)</p>	<p>White Pine</p>	<p><i>Pinus strobus</i></p>

10	White Pine	<i>Pinus strobus</i>	52	2		Private	Poor colour in foliage/low growth rate	
11	Sugar Maple	<i>Acer saccharum</i>	68	3		Private	good health	
12	White Mulberry	<i>Morus alba</i>	22	2	X	Private	volunteer - remove	
13	Red Oak	<i>Quercus rubra</i>	10	3		Private	small/tree/s transplantable with spade	
14	White Ash	<i>Fraxinus americana</i>	14	2	X	Private	volunteer (not planted) / remove	
15	Silver Maple	<i>Acer saccharinum</i>	104	1	X	Private	poor structure/major cavities/declining - remove	Ownership to be determined. Recommended removal due to health.
16	Silver Maple	<i>Acer saccharinum</i>	102	1	X	Private	poor structure/major cavities/declining - remove	Ownership to be determined. Recommended removal due to health.
17	Norway Spruce	<i>Picea abies</i>	68	3		Private	good health	
18	Norway Spruce	<i>Picea abies</i>	44	1	X	Private	good healthy/major base wound/damage remove	
19	Norway Spruce	<i>Picea abies</i>	64	3		Private	good health

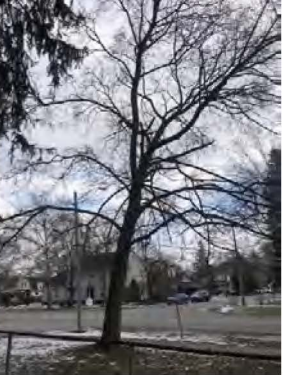
20	Norway Maple	<i>Acer platanoides</i>	46	2		Private	decent health/poor twig growth	
21	Norway Maple	<i>Acer platanoides</i>	58	2		Private	decent health/poor twig growth	
22	Norway Maple	<i>Acer platanoides</i>	90	2		Private	decent health/poor twig growth	
23	Red Oak	<i>Quercus rubra</i>	58	3		Private	good health	
24	Norway Maple	<i>Acer platanoides</i>	58	1	X	Private	poor structure/declining	Ownership to be determined. Recommended removal due to health.
25	Red Oak	<i>Quercus rubra</i>	56	3	X	Private	good health	
26	Red Oak	<i>Quercus rubra</i>	24	3	X	Private	good health	
27	Norway Maple	<i>Acer platanoides</i>	36	2		Private	poor twig growth	
28	Red Oak	<i>Quercus rubra</i>	132	1	X	Private	100yr old/major deadwood/principal/major leaders contain multi-stem/poor twig growth/long time to replace	
29	Silver Maple	<i>Acer saccharinum</i>	196	1	X	Public	major cavities/declining/poor health	
30	Few	<i>Taxus canadensis</i>	24	3		Private	healthy/cold

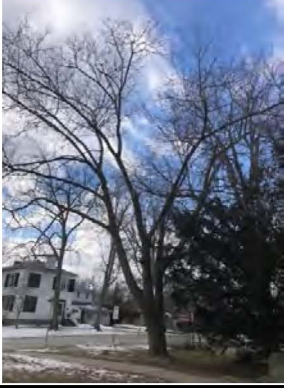
31	Norway Maple	<i>Acer platanoides</i>	66	1	X	Private	poor health/multi-stem	Ownership to be determined. Recommended removal due to health.
32	Silver Maple	<i>Acer saccharinum</i>	123	1	X	Private	declining/cavities/multi-stem/remove	Ownership to be determined. Recommended removal due to health.
33	Sycamore	<i>Platanus occidentalis</i>	60	2		Private	major trunk crack/healthy	
34	Norway Maple	<i>Acer platanoides</i>	34	1	X	Private	poor health/landscaping tree with Sycamore/remove	
35	White Ash	<i>Fraxinus americana</i>	66	0	X	Private	dead/ remove	
36	White Pine	<i>Pinus strobus</i>	52	1	X	Private	poor colour / low growth rate	
37	Silver Maple	<i>Acer saccharinum</i>	72	3	X	Private	poor structure/multi-stem	
38	Rose Sycamore	<i>Picea pungens</i>	24	3	X	Private	good health	
39	Norway Maple	<i>Acer platanoides</i>	40	2	X	Private	poor structure/multi-stem	
40	Bananaeum	<i>Tilia americana</i>	82	2		Public	multi-stem/trunk wound/poor structure
