BUILDING CONDITION ASSESSMENT  
THE TEA PAVILION  
200 JOHN STREET, NIAGARA-ON-THE-LAKE

April 27, 2022

Prepared by  
Mark Shoalts, P.Eng., CAHP

BUILDING CONDITION ASSESSMENT  
THE BATH HOUSE  
200 JOHN STREET, NIAGARA-ON-THE-LAKE

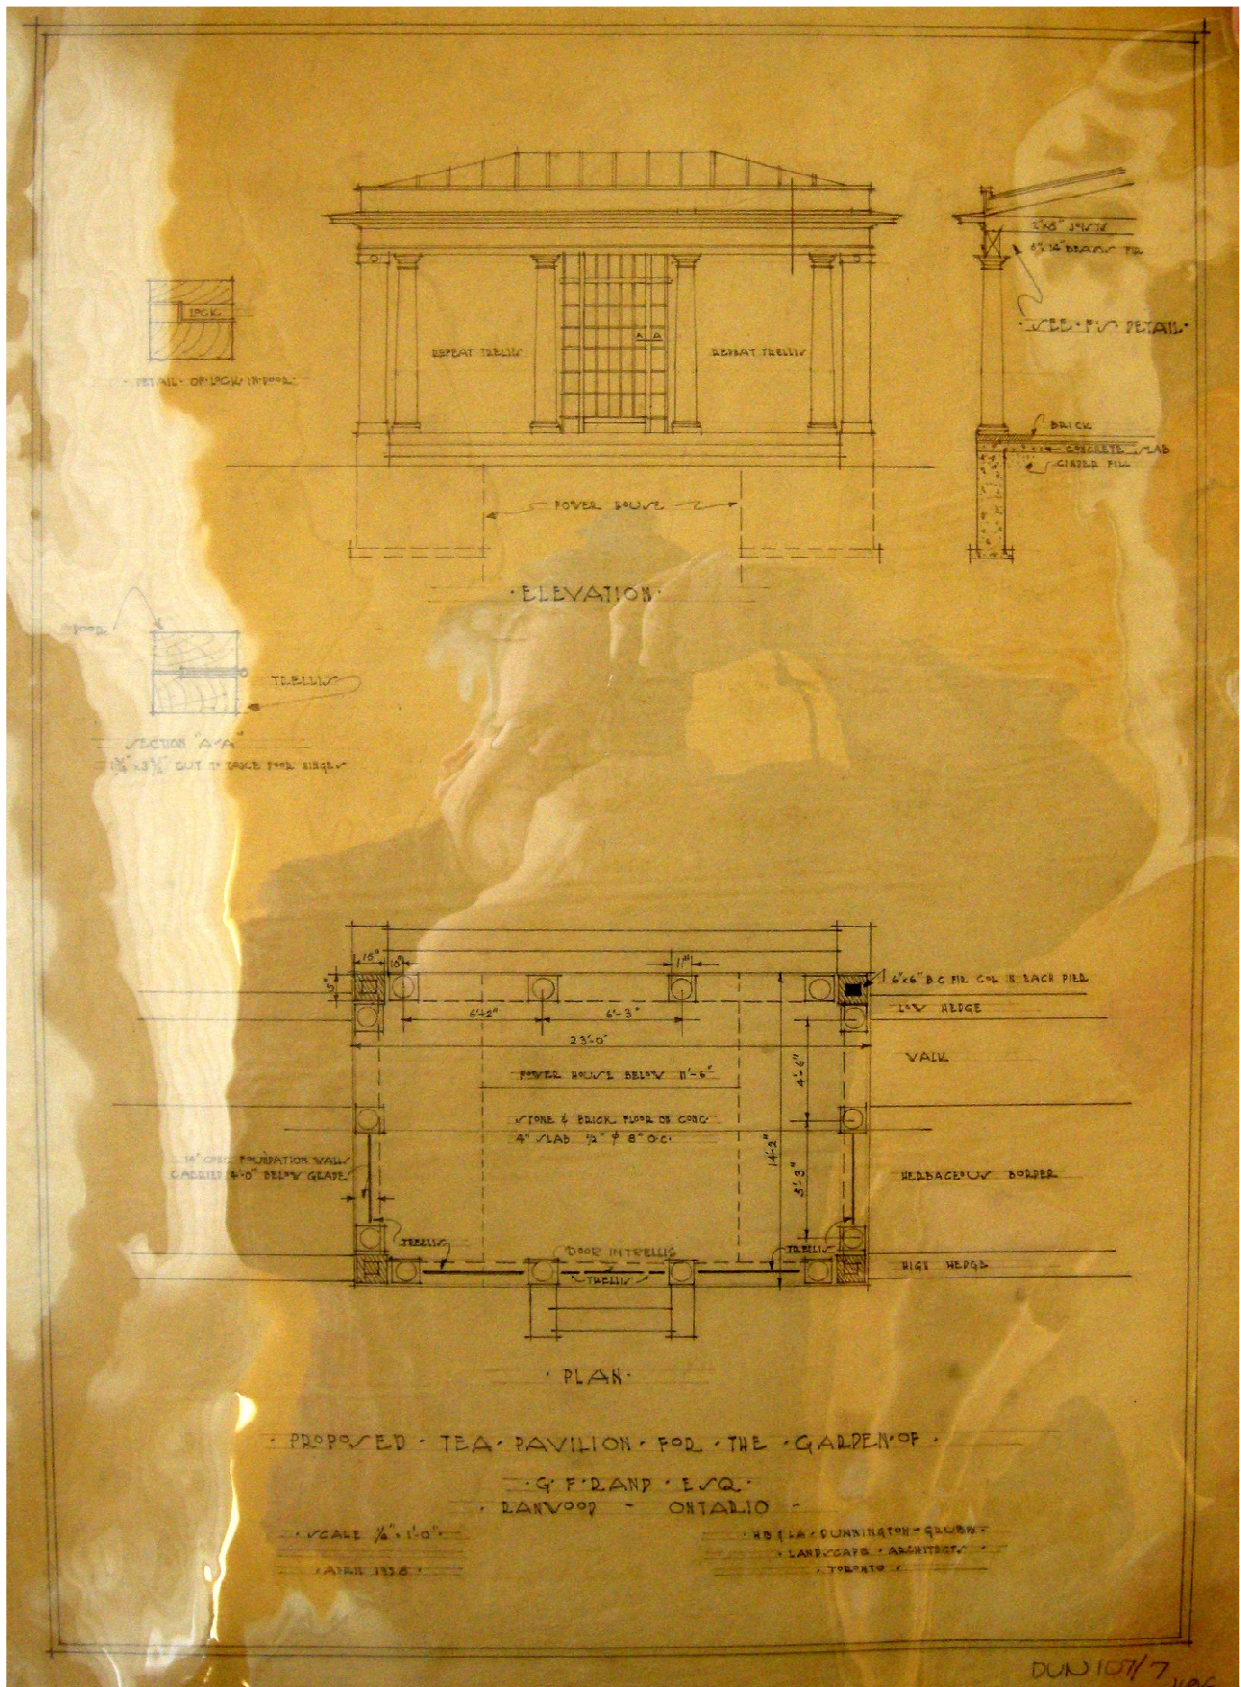
April 1928 plan for Tea Pavilion  
Trellis and power house were not executed, as-constructed eave detail is simpler.

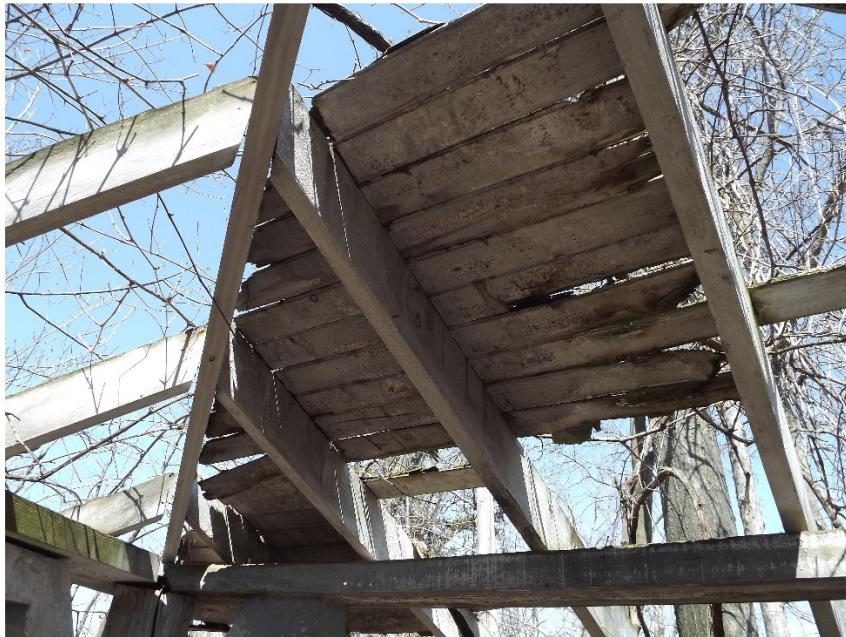
Remnant of roof sheathing, rafters, and plank beam, northwest corner

The Whistle Stop is essentially a complete ruins, but there are enough fragments of the wood structure and enough of the concrete and masonry walls and floor to enable one to replicate it. The wood structure has deteriorated to the point that with the exception of three or four brackets, none of it can be used in restoring the building. The various pieces are sufficiently intact to serve as patterns for replication. There is one small section of roof sheathing extant with a few fragments of cedar shingles; there appears to have been a fire some time in the past although the majority of the damage to the roof seems to be a consequence of failed roofing. The small amount of charred material on the ground could be from someone building a fire with collapsed pieces of the structure. It is not clear why the majority of the roof sheathing and all of the roofing is gone; the intact rafters are not charred and although the tops of some of the rafters are in poor condition with extensive rot, many appear relatively sound. There is not much roof sheathing on the ground, so it does not appear as though it simply fell off or blew off. Much of the roof may have been intentionally removed.

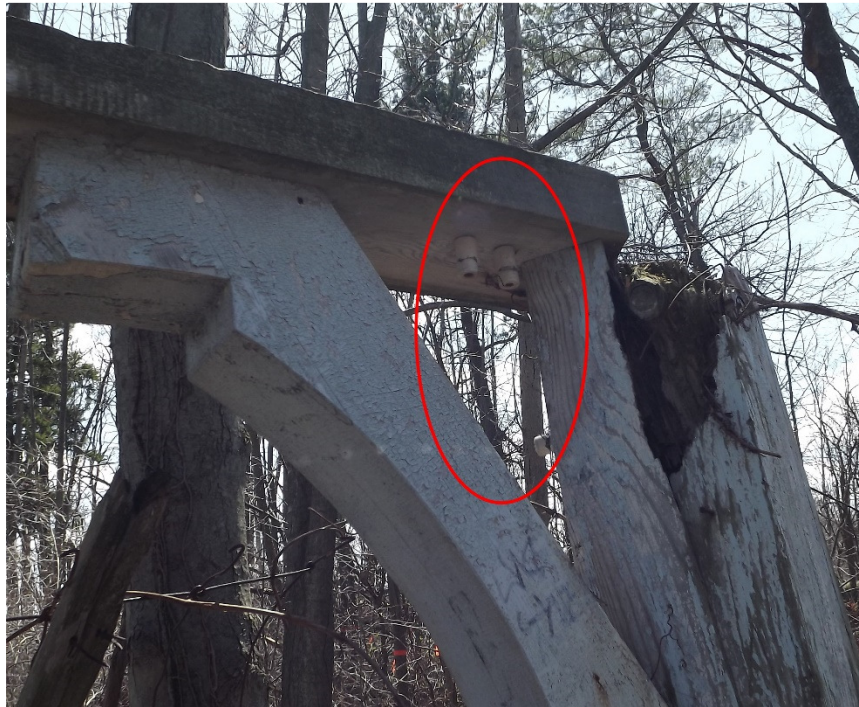
There was electrical power to the building as indicated by porcelain insulators near the entrance and a small fragment of wire, but there is no trace of the purpose for the electrical service. It may have been for interior lights only, or possibly for a light to indicate that someone was waiting for a train.

Porcelain electrical insulators beside south entrance

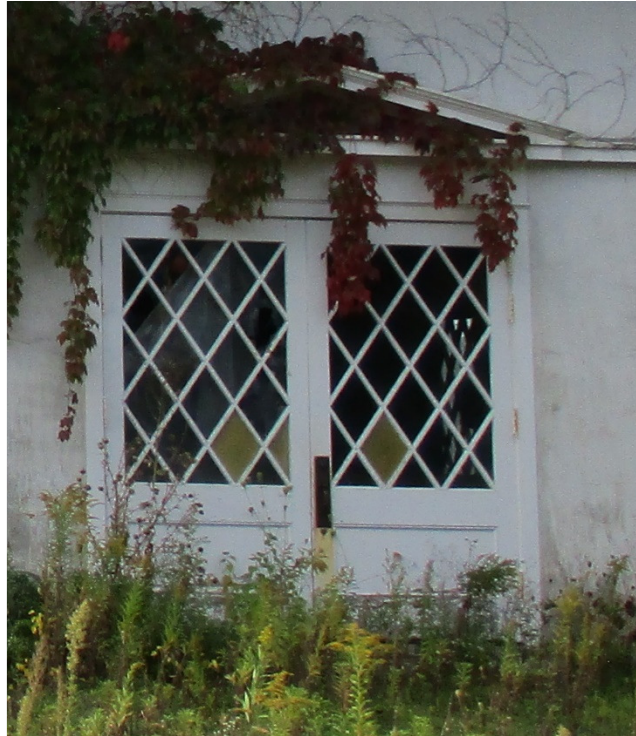
The Carriage House exterior is in fair condition with some elements poor and a few elements in quite good condition. The present asphalt shingles are past their service life and need to be replaced; some have recently blown off of the south side. The stucco is in generally good condition with some small areas of concern. The windows and doors are fairly good with the exception of some glass that has recently been smashed by vandals; the broken windows have been boarded up. The wide carriage doors have sagged a bit, which is to be expected; the hardware is original and in good condition. The doors can be restored.

Drive doors to the workshop

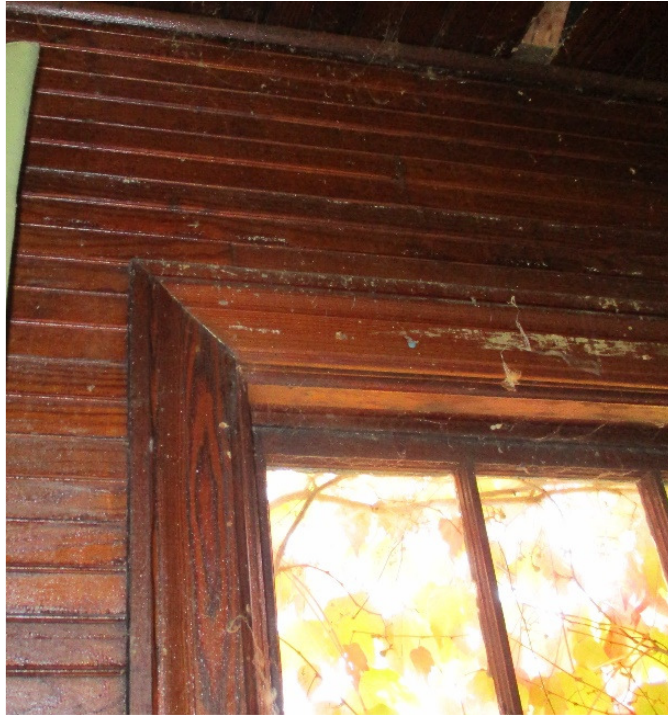
The wood finishes throughout the ground floor are in very good condition. There are a few areas where less than sympathetic installations of newer equipment has done some damage but restoration would be fairly simple. A new furnace was installed with exposed ductwork and heating outlets were cut through the ceiling for the upper apartment. Plumbing lines have been run on the surface, and some strips of T&G panelling have been removed to allow access to concealed plumbing and electrical lines. Most of the damage is relatively minor.

Detail showing fir panelling, window casing, and sash in garage

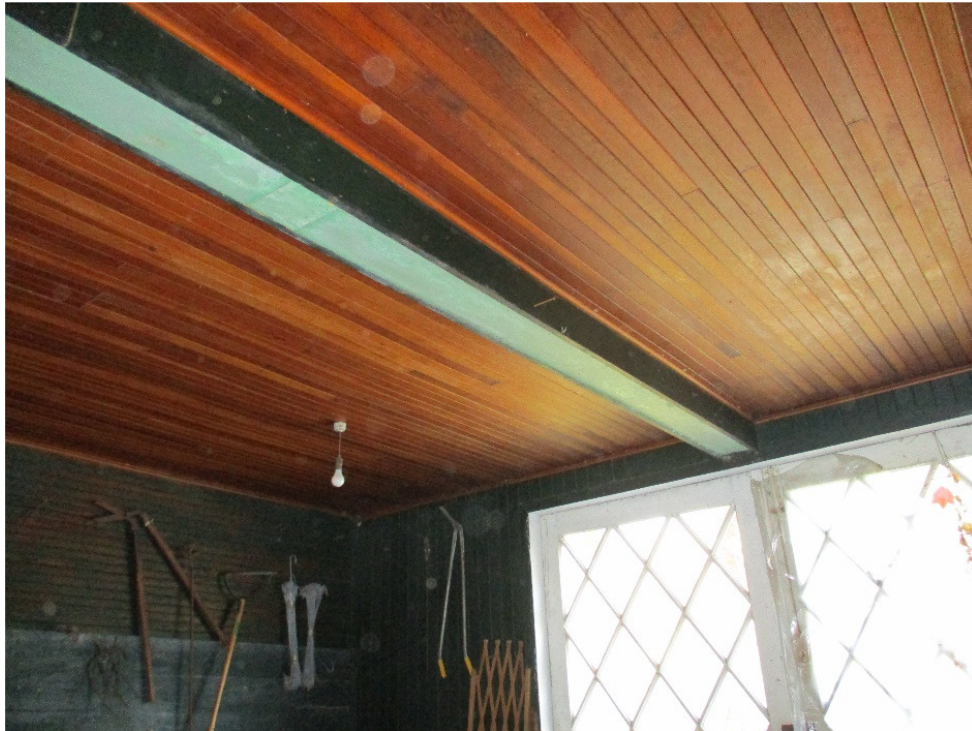
Ceiling detail in workshop

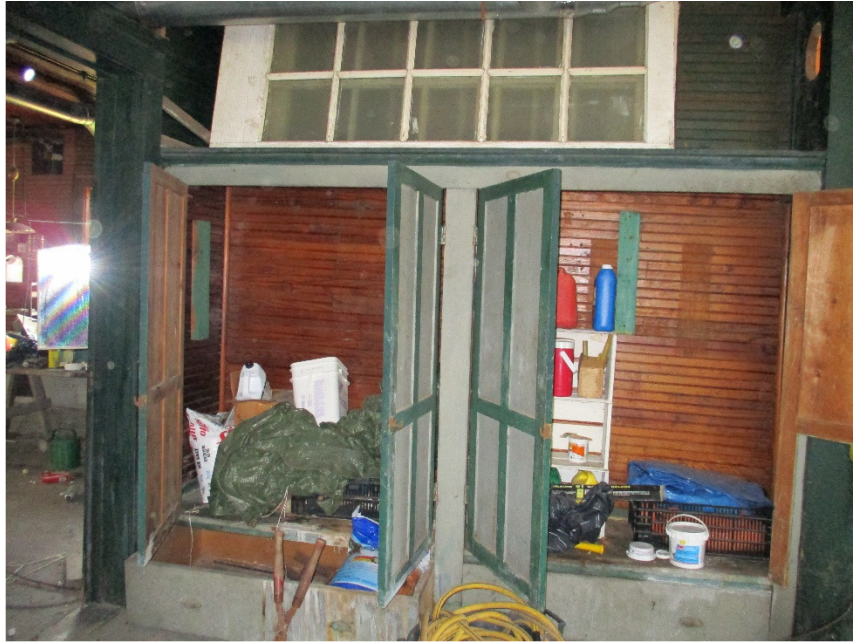
Harness storage cupboards in workshop with drawers below

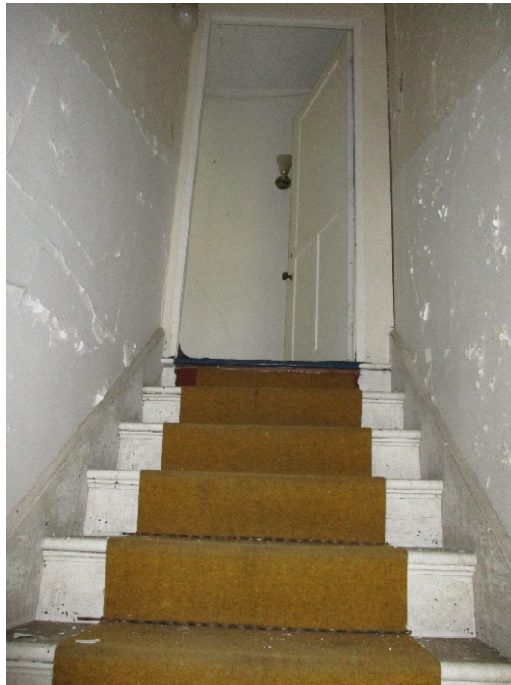
Stairs to apartment

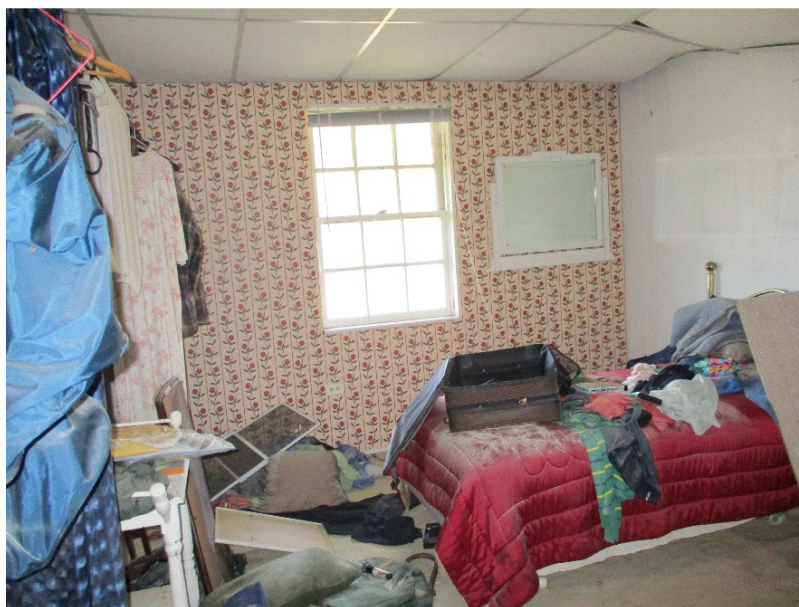
The conversion of the hayloft into living space was done very cheaply with inferior materials, indifferent workmanship, and little regard for functionality. The lack of maintenance has now made the space uninhabitable, but it was barely fit for occupancy when it was first finished. Incomplete insulation, hardboard panelling, and suspended tile ceilings in very poor condition are there at present.

Bedroom in former hay loft

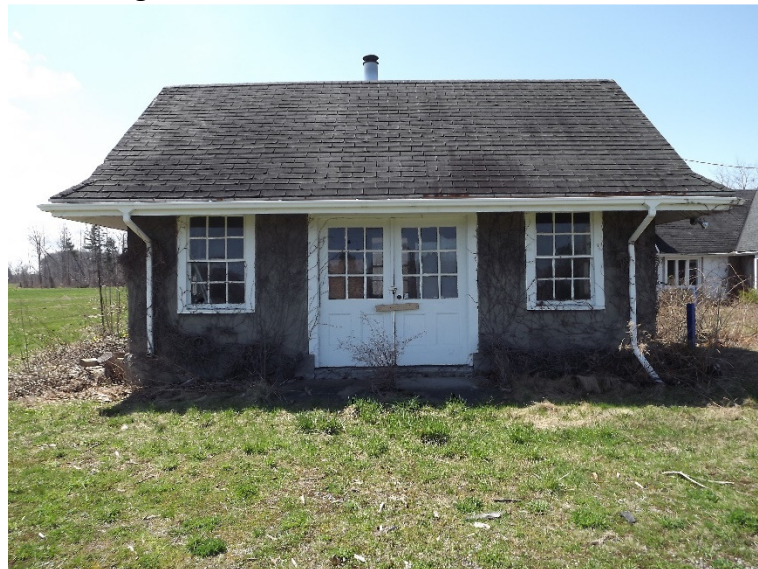
North Elevation of Building B - Workshop

The workshop building is quite good. The asphalt shingles are in fair condition on the north side and they are newer and very good on the south side; there are no leaks. The building has PVC eavestroughs and downspouts that should be upgraded to aluminum at least, and preferably to galvanized steel. The exterior wood trims and windows are in good condition, requiring only minor repairs before scraping and painting. The doors have some minor damage and wear that must be repaired before scraping and painting. The stucco is also in good condition, requiring only minor repairs. The concrete foundation walls are in poor condition where they are visible above grade, both inside and outside the building. The interior finishes are in adequate condition although they are not up to the standard of the original building and consideration should be given to upgrading them to the level that would have originally existed. The concrete floor is severely cracked and settled and should be replaced.

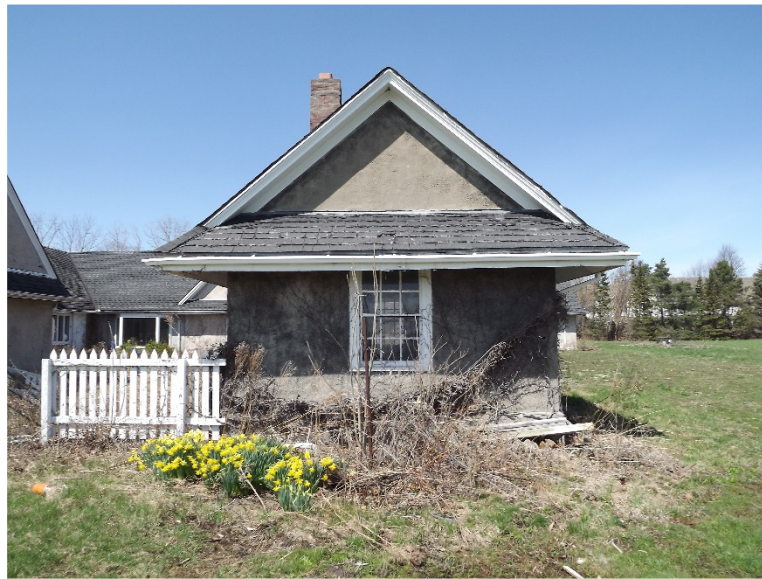
There is a shelf-mounted brick chimney with a stovepipe hole on the east wall of the workshop, and a later woodstove with metal chimney more centrally located. The walls are lined with fir plywood, and the ceiling with hardboard and wood battens; there is a concrete floor. The interior finishes are not original.

East elevation of Building B - Workshop

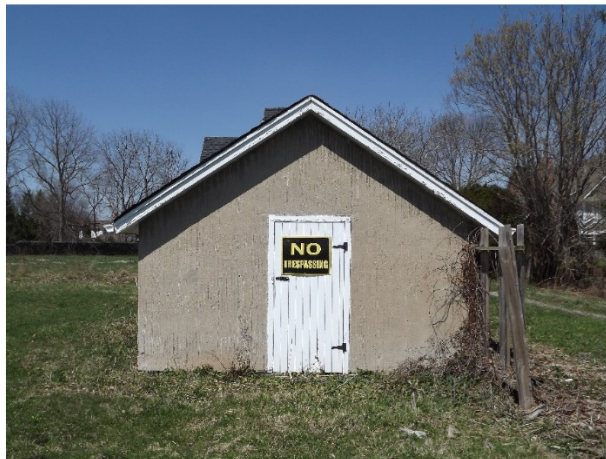
Shed C East Elevation

Shed C is in fair condition. The asphalt shingles are in fair condition on the north side and they are newer and very good on the south side; there are no leaks. The building has PVC eavestroughs and downspouts that are in poor condition. The exterior wood trims, door, and windows are in fairly good condition, requiring only minor repairs before scraping and painting. The stucco is in fair condition, although it requires some repairs due to deterioration and also to previous poorly-done repairs. The foundation is not visible above grade, either inside or outside the building and the soil is up on the walls in places. This has probably resulted in rot of some of the framing but it cannot be determined without cutting into the walls. The interior wood finishes on the walls and ceiling are in good condition, but the floor system of sleepers and waferboard has completely deteriorated to the point where much of the floor is exposed soil. Because of the small size and low ceiling, finding an alternative use for the building could be challenging.

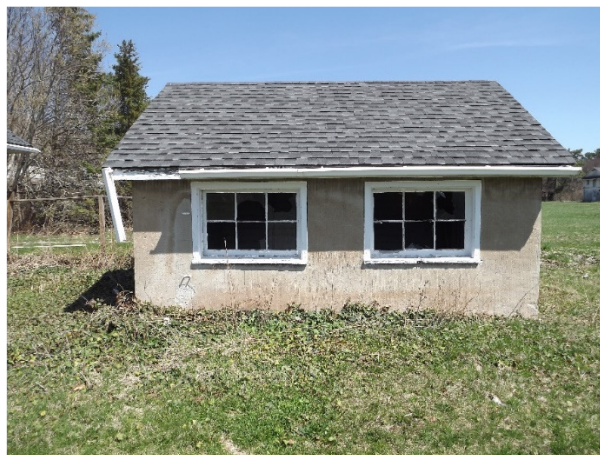
Shed C South Elevation

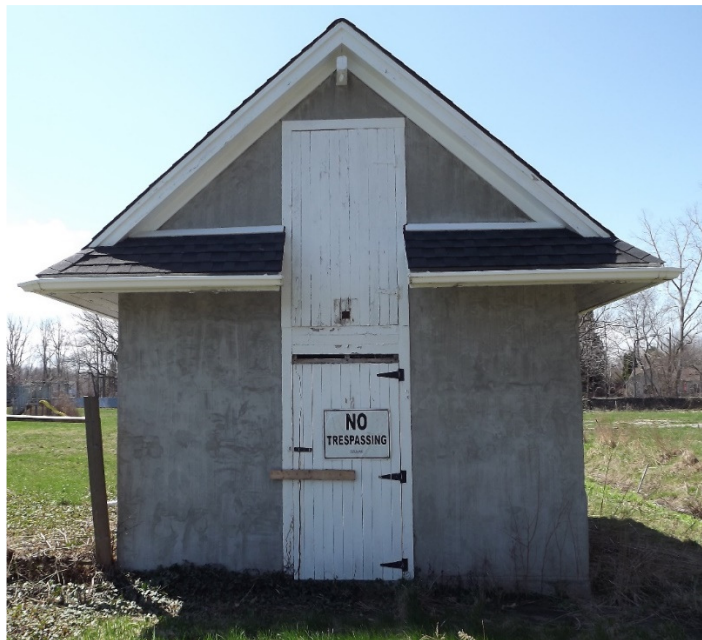
Shed D North elevation

Shed D is in fair condition. The asphalt shingles are relatively new and very good condition with the exception of the cupola, which was not resingled at the same time as the roof. There are no leaks. The building has PVC eavestroughs that are in poor condition with no downspouts; the apparently intentional outlets are gaps in the troughs. The exterior wood trims, door, and windows are in good condition, requiring only minor repairs before scraping and painting. The stucco is in fair condition, although it requires some repairs due to deterioration and also to previous poorly-done repairs. The concrete foundation extends a few inches above grade, although the soil is up on the walls in places. The interior finishes are in reasonably good condition. Because of the small size and low ceilings, finding an alternative use for the building could be challenging.

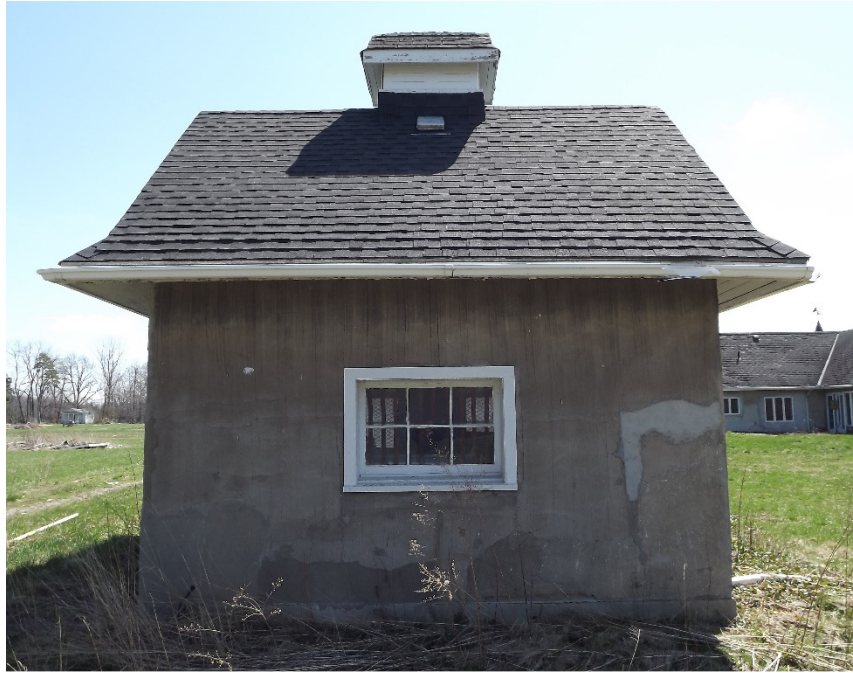
Shed D West elevation
