TOWN OF NIAGARA-ON-THE-LAKE

2023 MUNICIPAL BRIDGE APPRAISAL REHABILITATION/REPLACEMENT NEEDS

February 2024

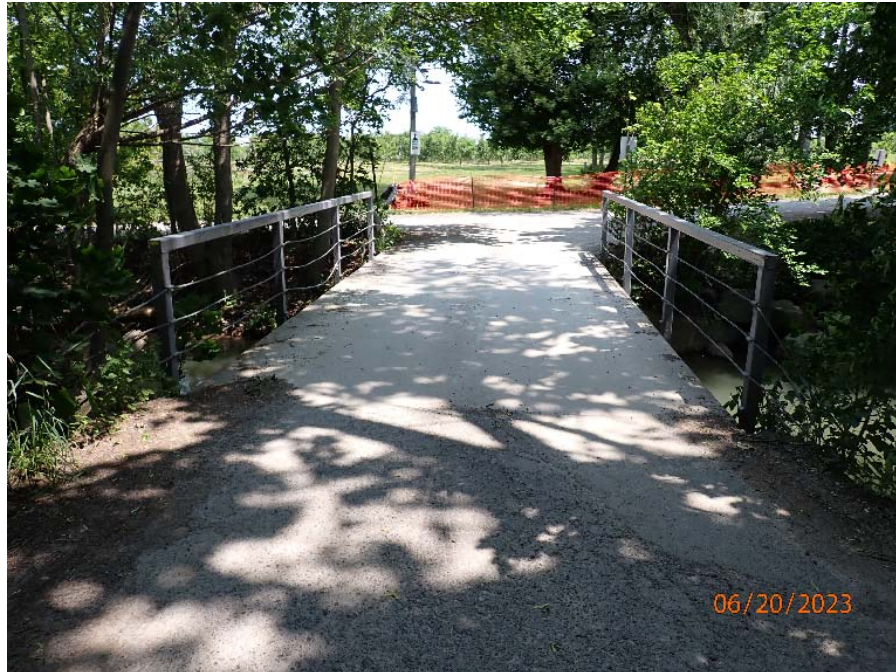
Photograph No. 1: 0766: Roadway over the structure looking east.

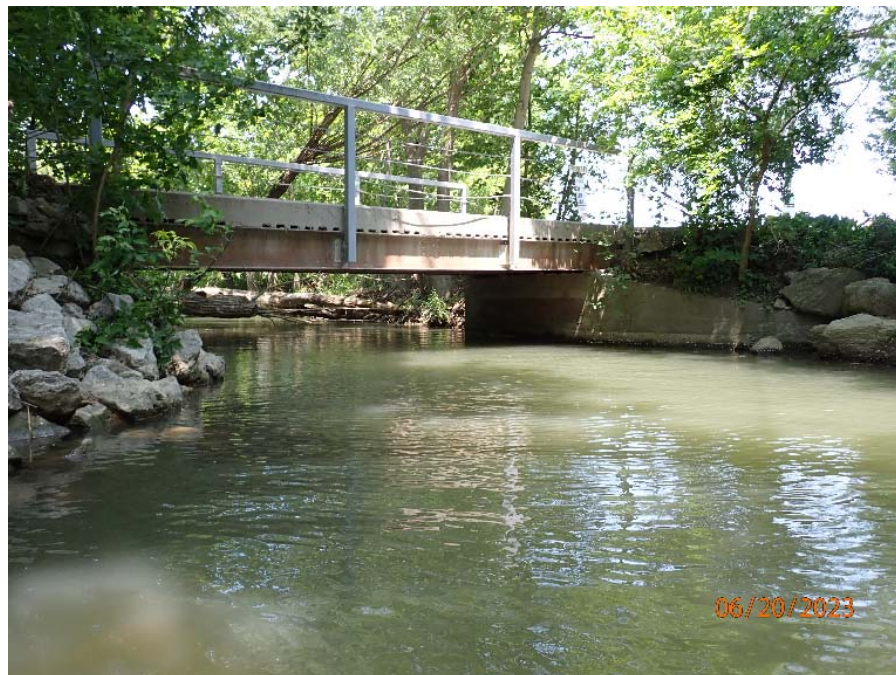
Photograph No. 2: 0771: South elevation.

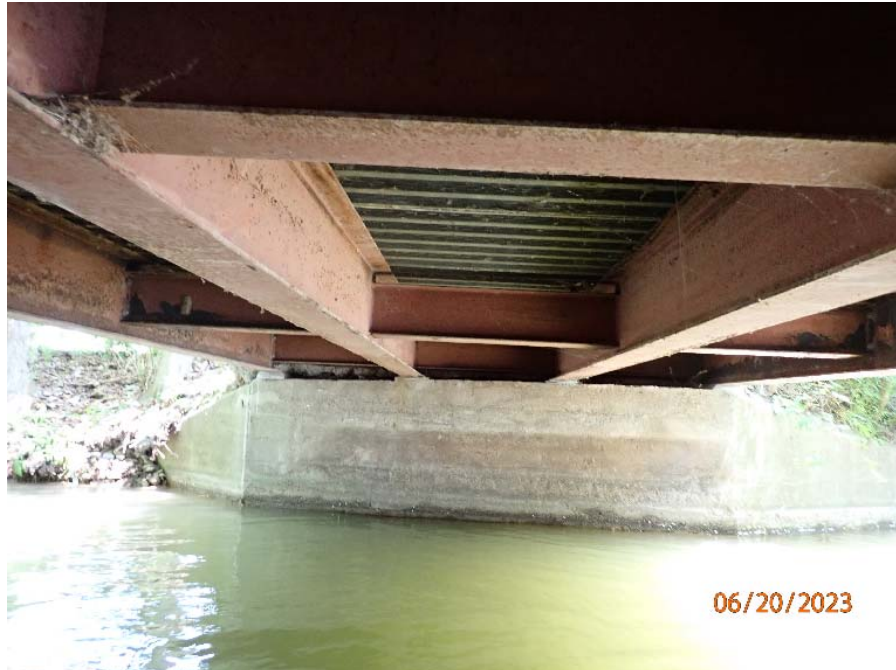
Photograph No. 3: 0788: Underside of the structure and east abutment looking east.

ID Number	Structure Name	Recommendation
B4	South Shore Lane	We recommend that the following rehabilitation work be completed NOW: excavate behind the east and west abutments, fill the voids behind the abutments, construct new ballast walls, seal the cracks in the concrete deck, replace the damaged timber posts, and re-tension the cable guiderail. Alternatively, we recommend that the Town review replacing the bridge NOW to eliminate the width and load limit deficiencies.
B21	Line 5 Road (Field Entrance)	We recommend closing the structure (with barricades or by removal) or replacing the structure NOW.
B23	Concession 3 Road (Field Entrance)	We recommend removing or replacing the structure NOW.
B2037	Line 8 Road	We recommend placing fill behind the southeast wingwall and filling the void below the southeast wingwall NOW. We also recommend placing riprap along the east and west footings and in front of the southeast wingwall NOW to prevent further erosion. We recommend replacing the portion of guiderail and timber posts over the structure NOW.

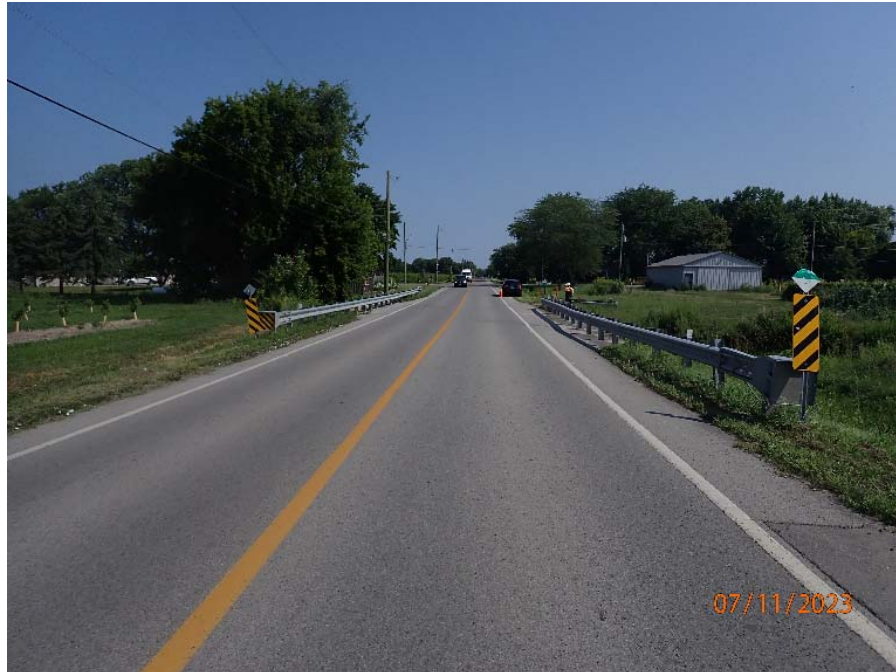
Photograph No. 1: 0227: Roadway over the structure looking north.

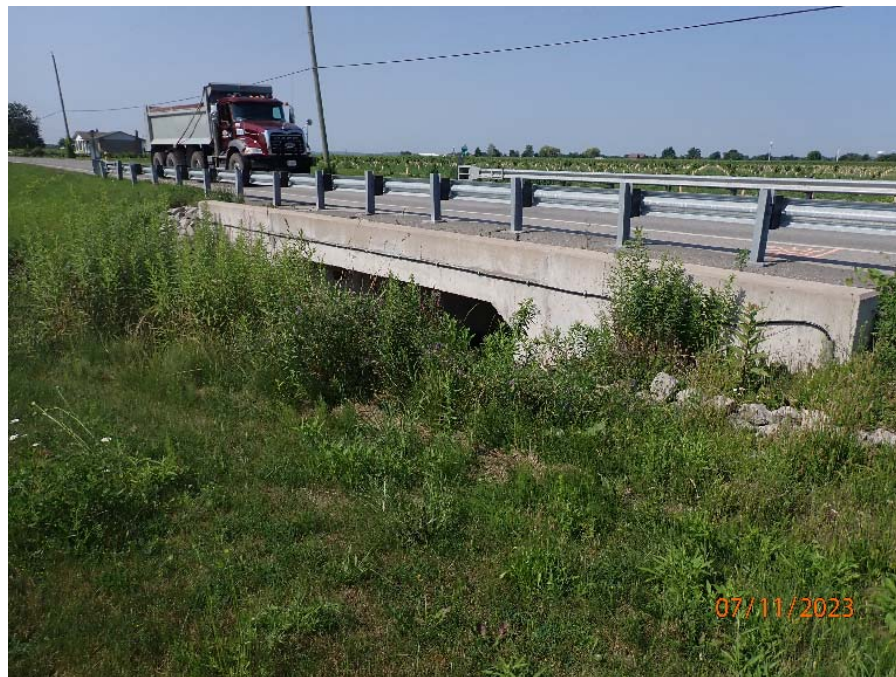
Photograph No. 2: 0248: East elevation.

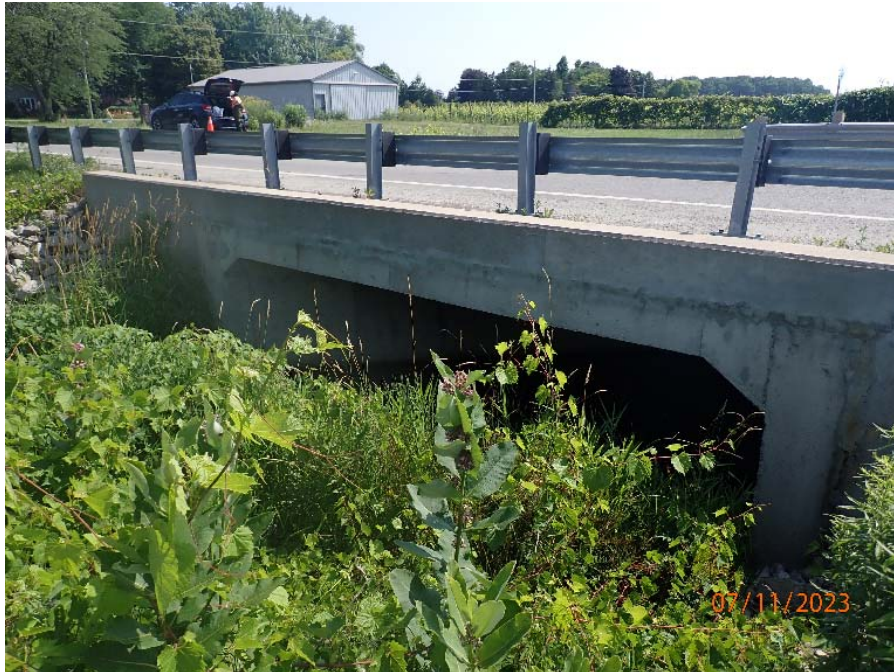
Photograph No. 3: 0285: West elevation.

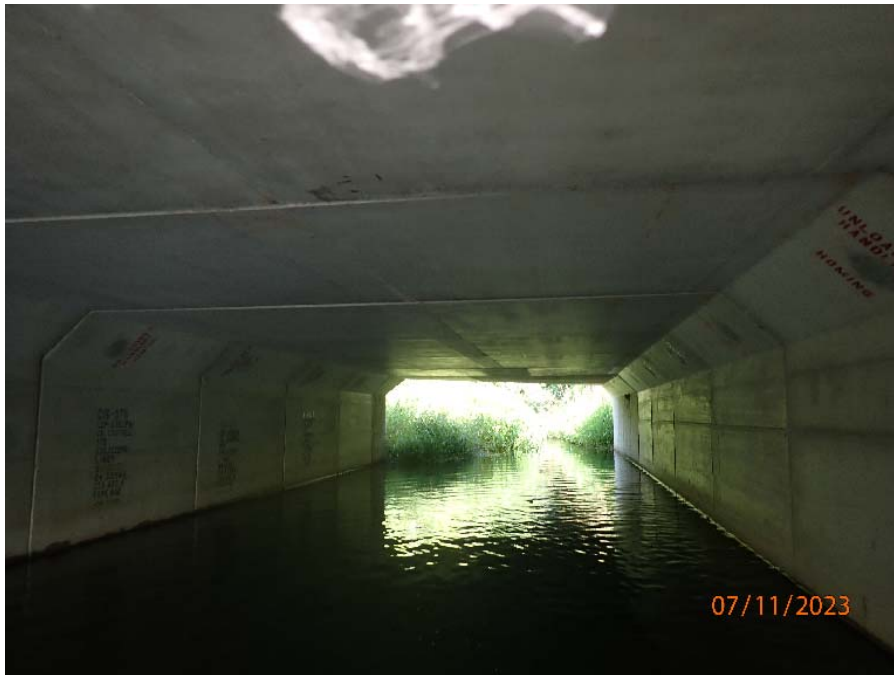
Photograph No. 4: 0258: Underside of the structure looking west.

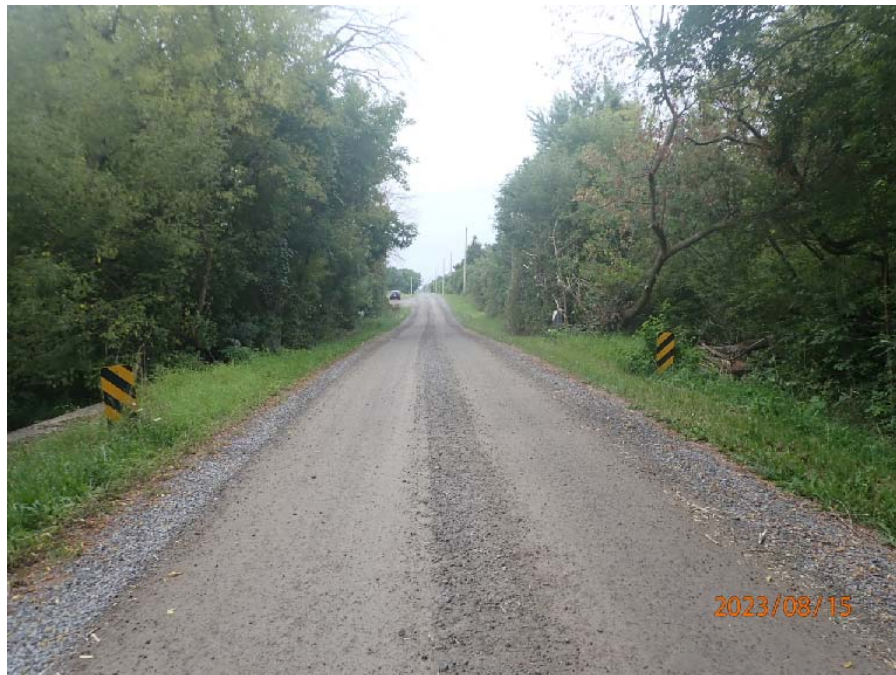
Photograph No. 1: 0662: Roadway over the structure looking west.

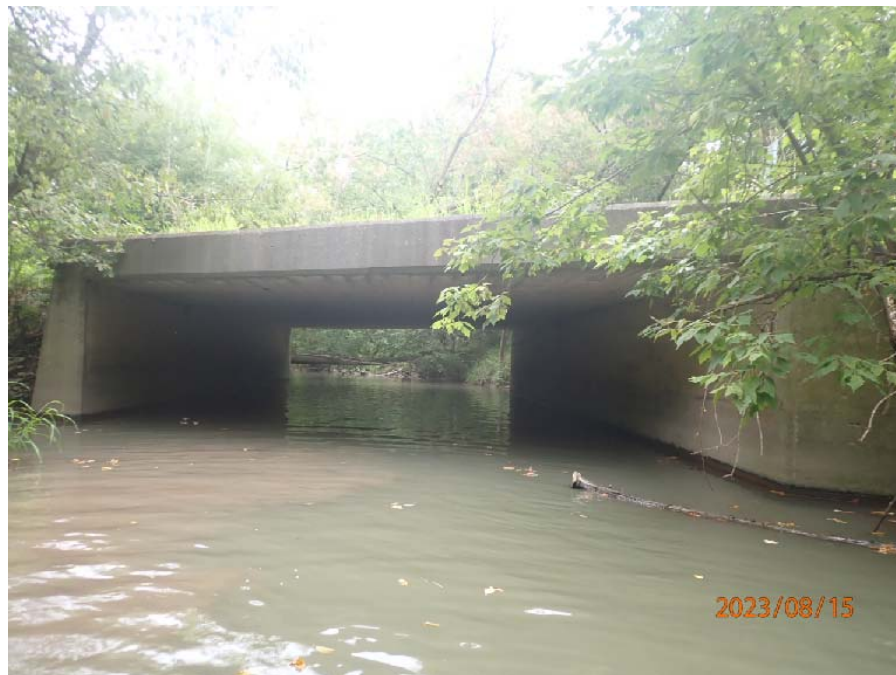
Photograph No. 2: 0674: South elevation.

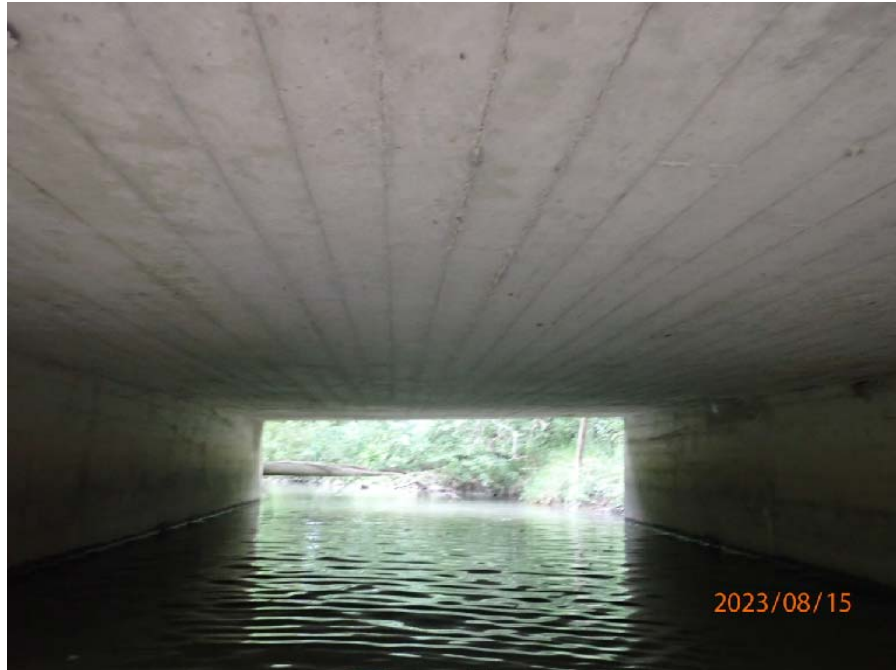
Photograph No. 3: 0679: Underside of the structure looking north.

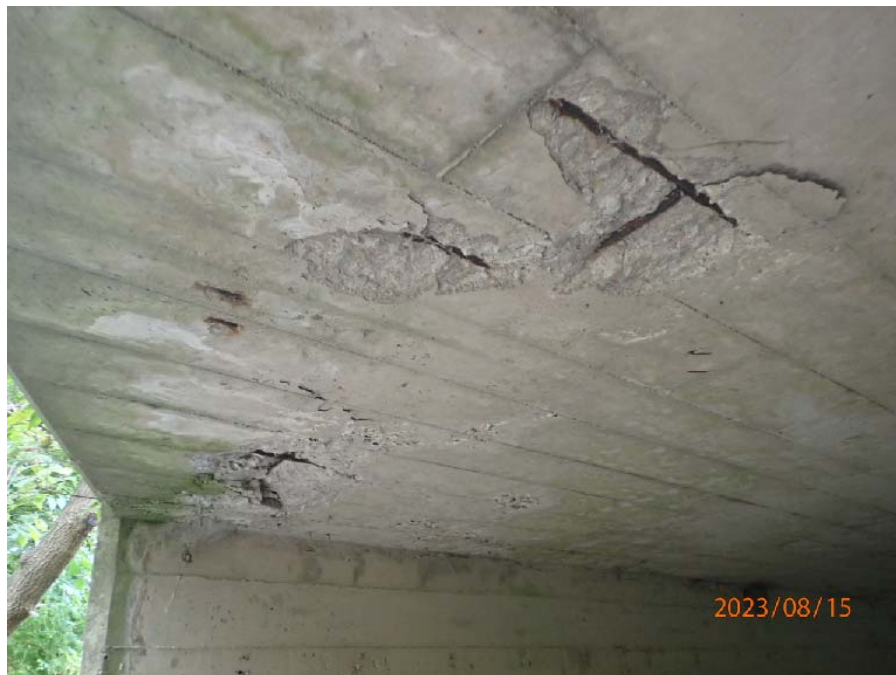
Photograph No. 4: 0678: Area of delamination, exposed corroded reinforcing steel and efflorescent staining at the south end.

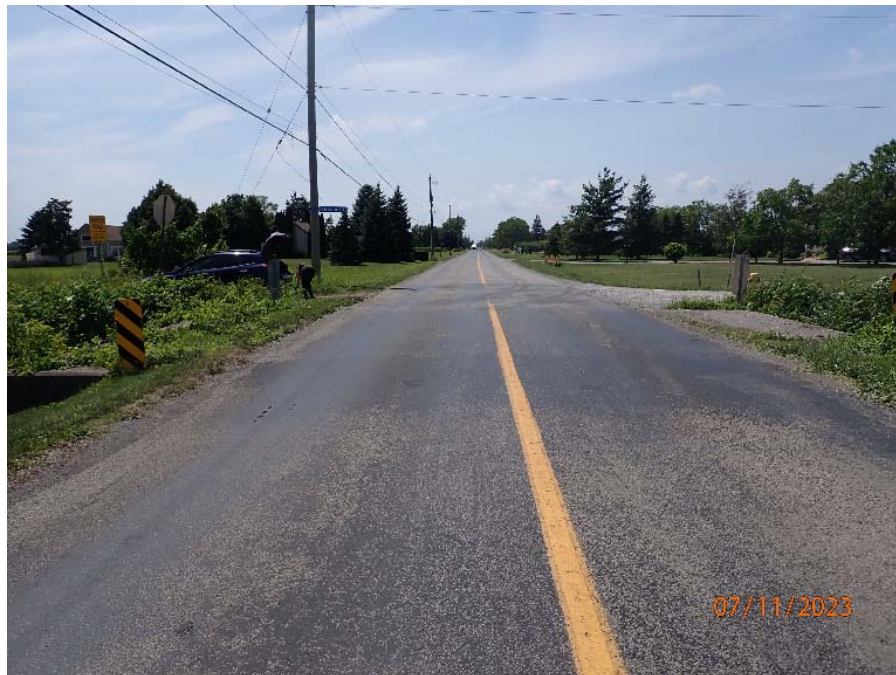
Photograph No. 1: 0741: Roadway over the structure looking west.

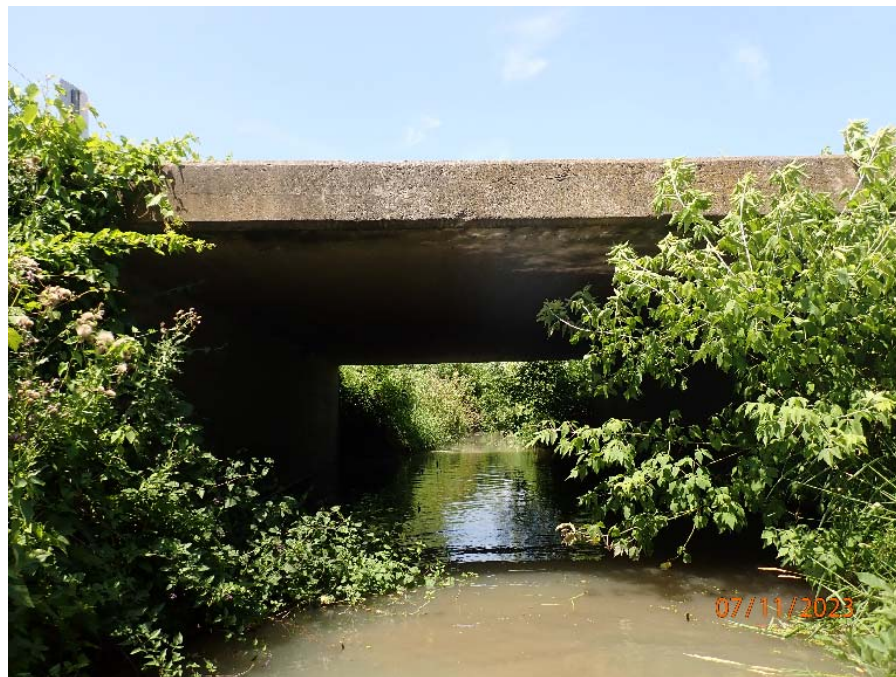
Photograph No. 2: 0744: South elevation.

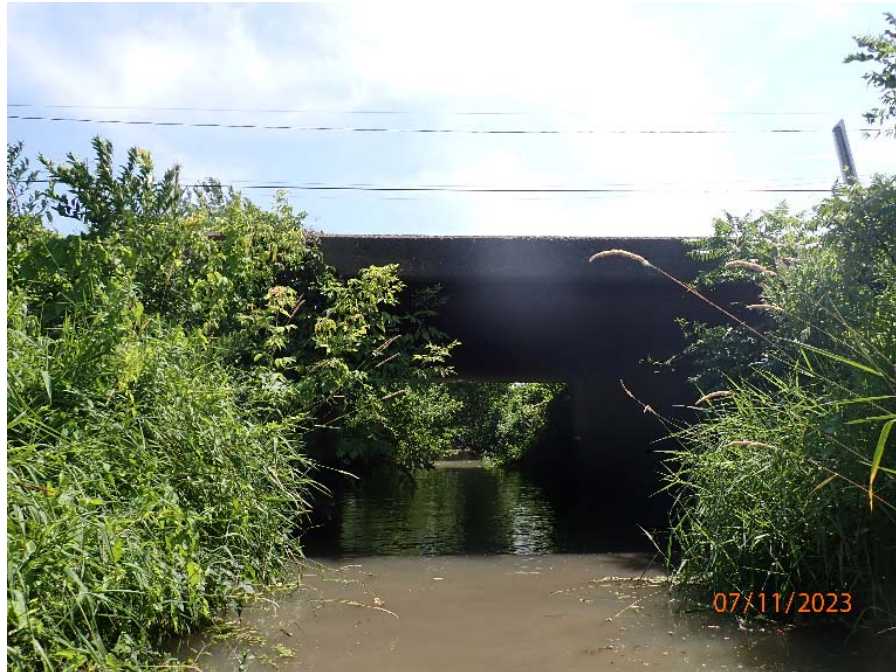
Photograph No. 3: 0782: North elevation.

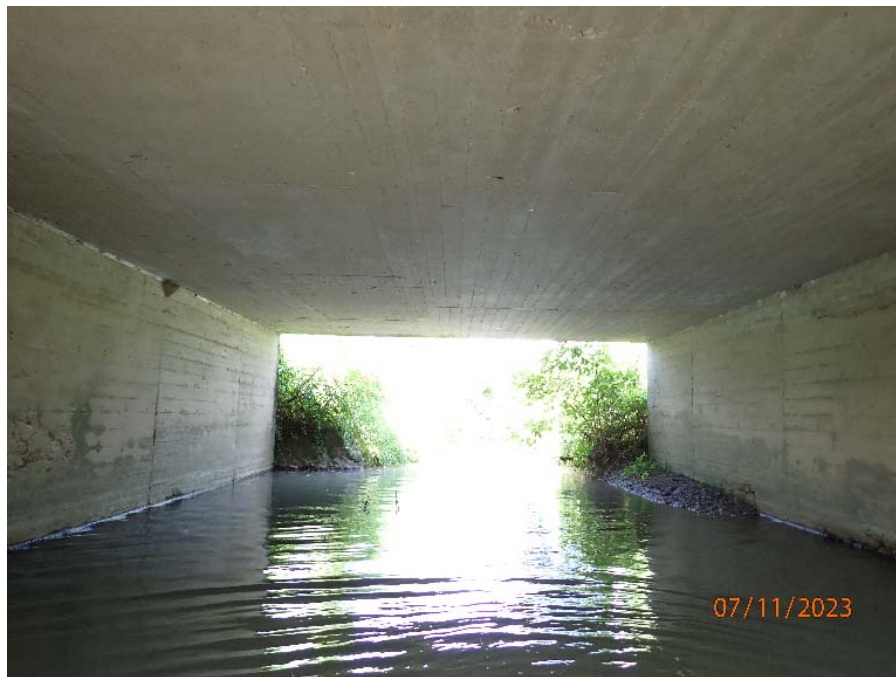
Photograph No. 4: 0748: Underside of the structure looking north.

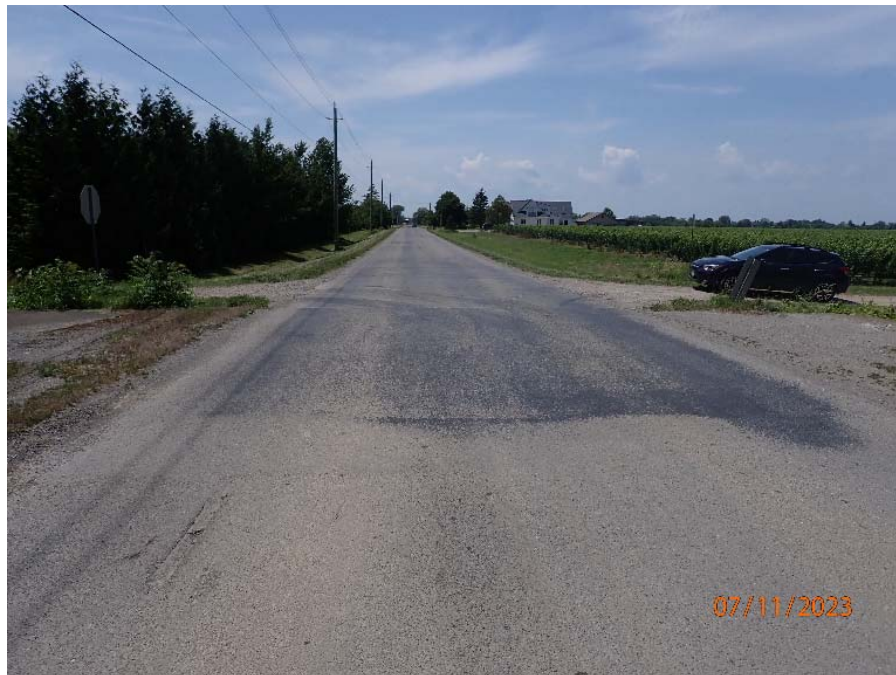
Photograph No. 1: 0660: Roadway over the structure looking west.

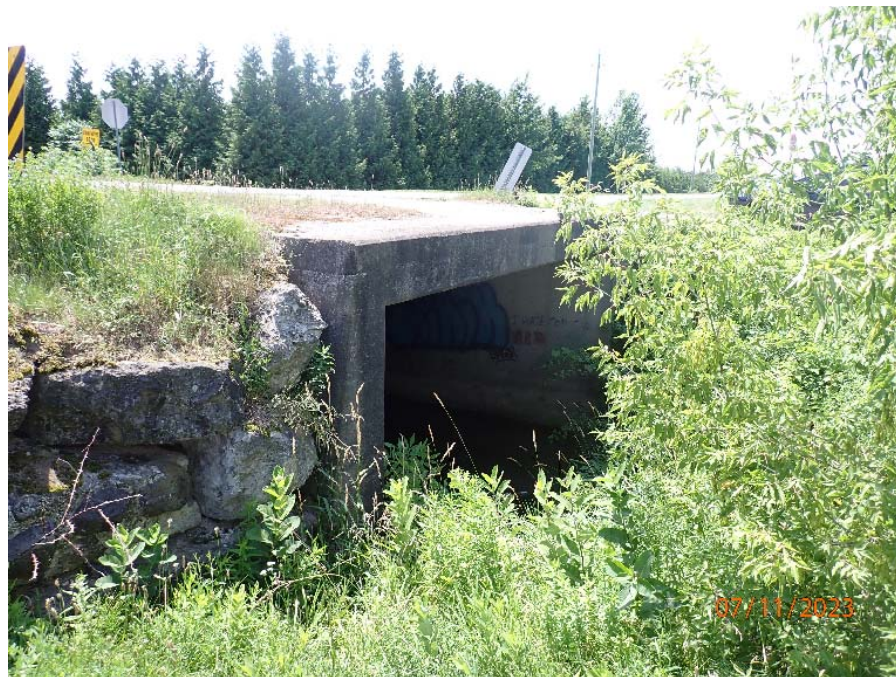
Photograph No. 2: 0670: North elevation.

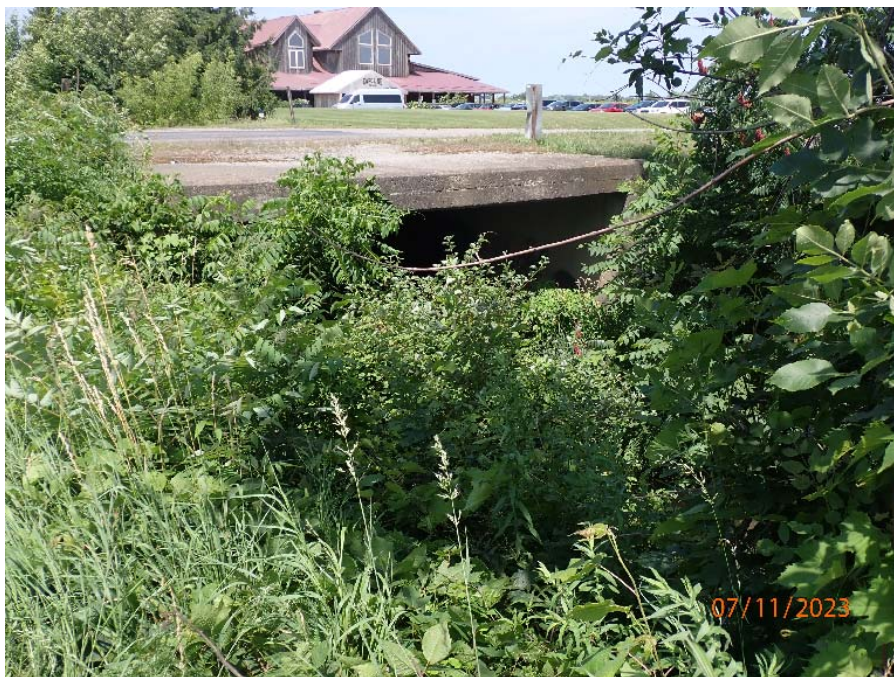
Photograph No. 3: 0717: South elevation.

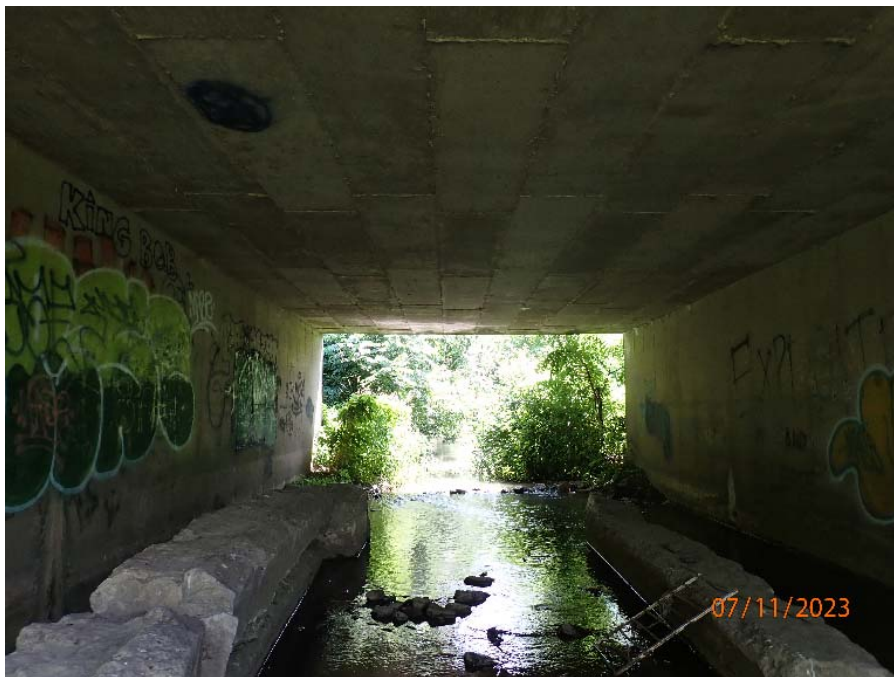
Photograph No. 4: 0680: Interior of the structure looking north.

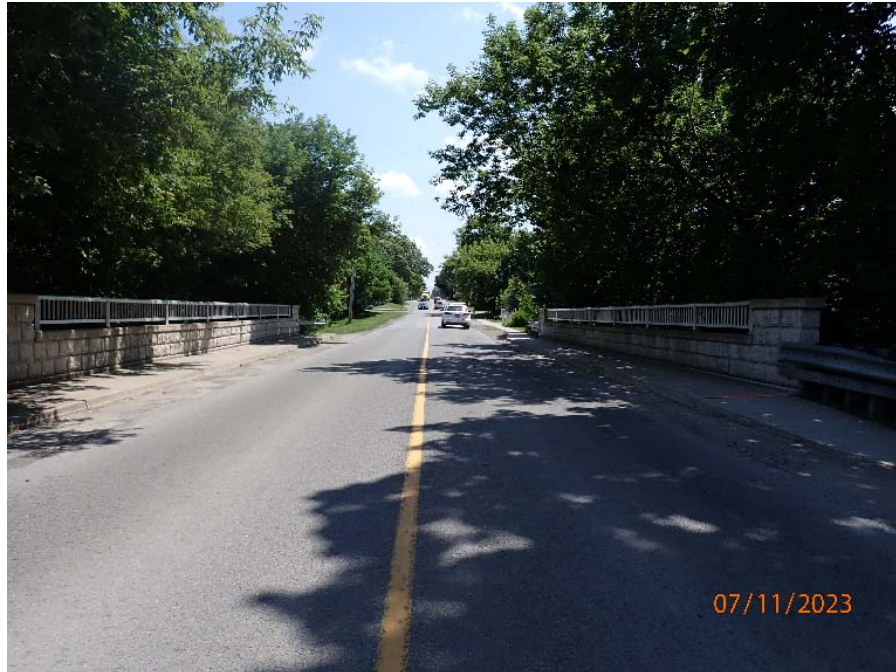
Photograph No. 1: 0470: Roadway over the structure looking south.

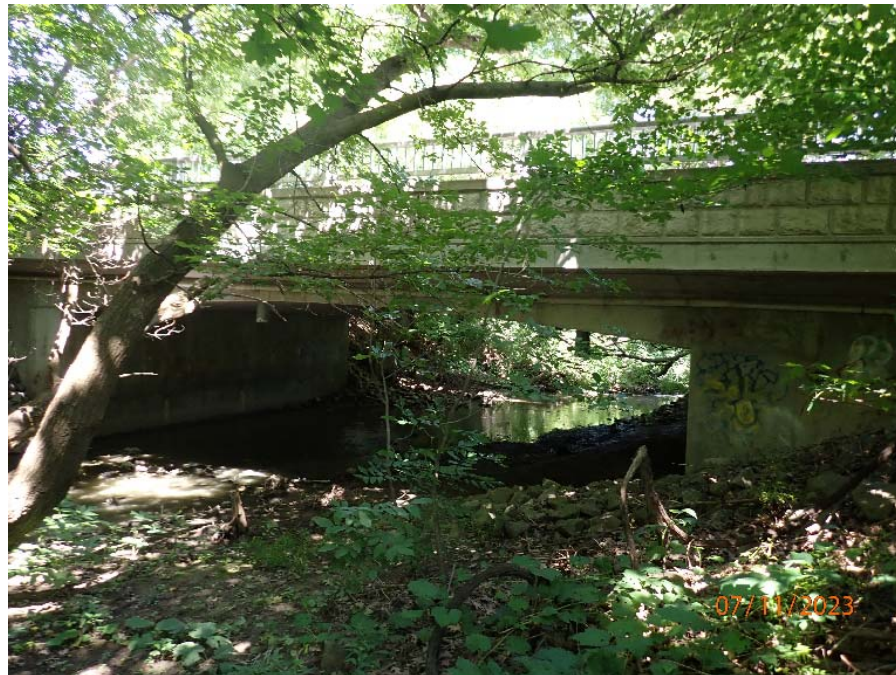
Photograph No. 2: 0571: North elevation.

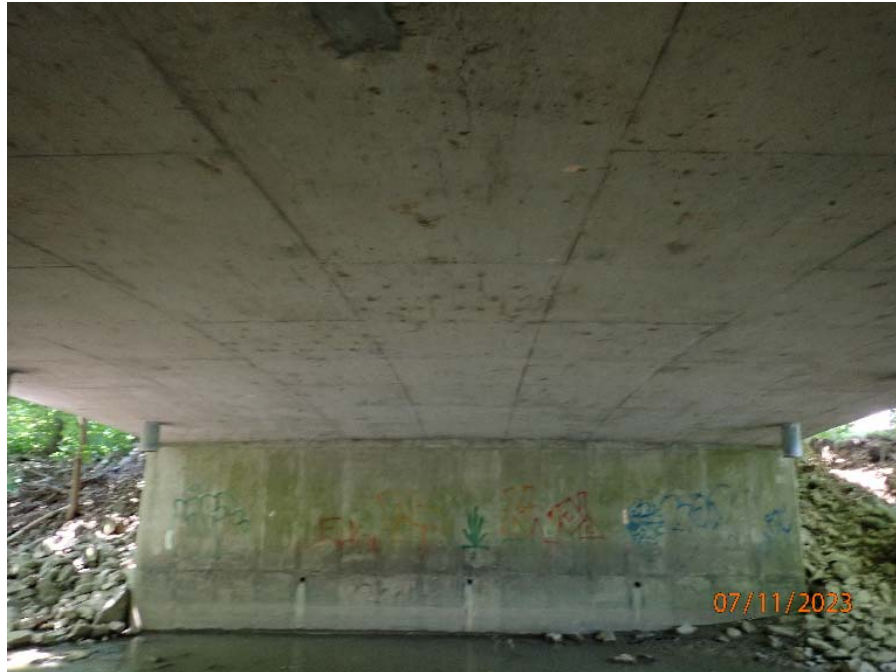
Photograph No. 3: 0534: Underside of the structure and west abutment.

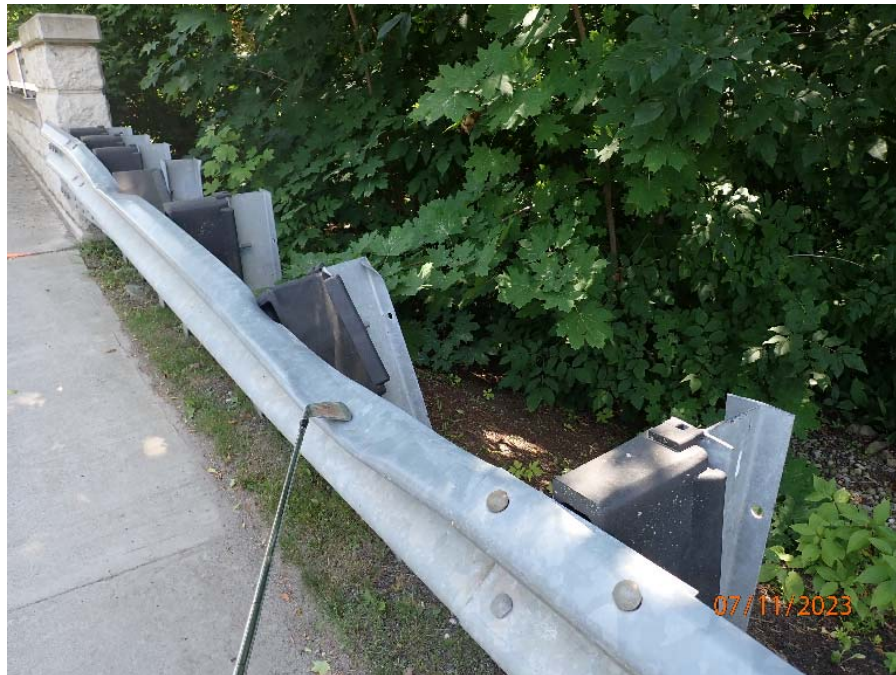
Photograph No. 4: 0472: Damage to the steel beam guiderail at southwest corner.

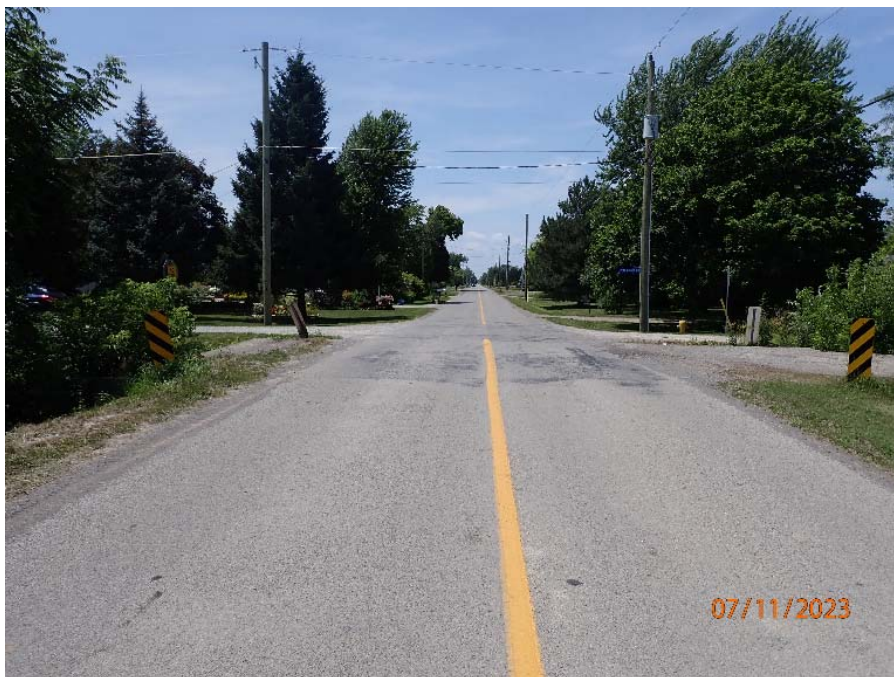
Photograph No. 1: 0596: Roadway over the structure looking west.

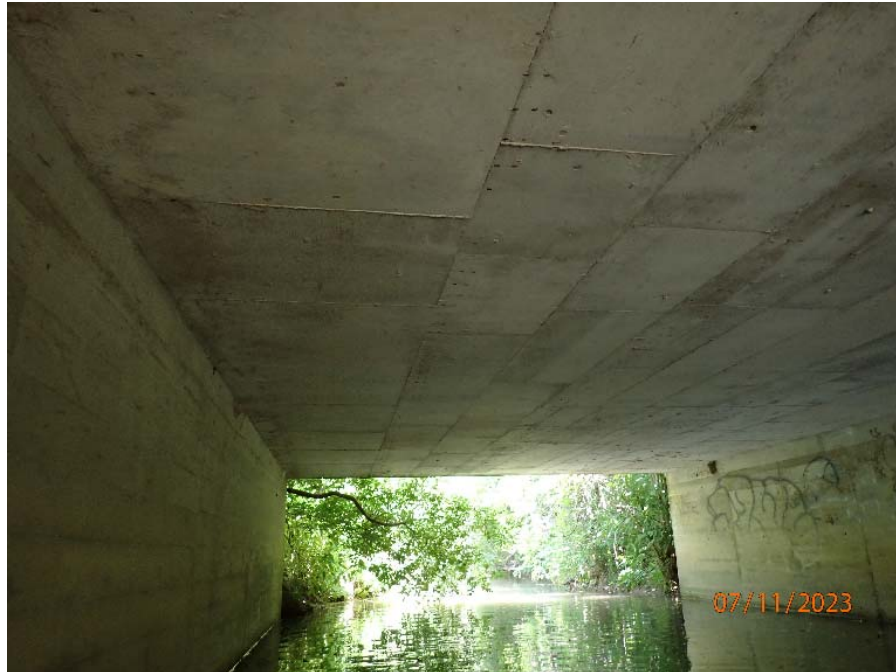
Photograph No. 3: 0628: Underside of the structure looking north.

The precast concrete box culvert units are in very good condition. There is a light spall in the soffit at the north end of the structure. There are areas of parging on the abutment sidewalls and soffit, especially at the south end and northeast corner. The concrete wingwalls are in very good condition. There is a fish channel through the structure.

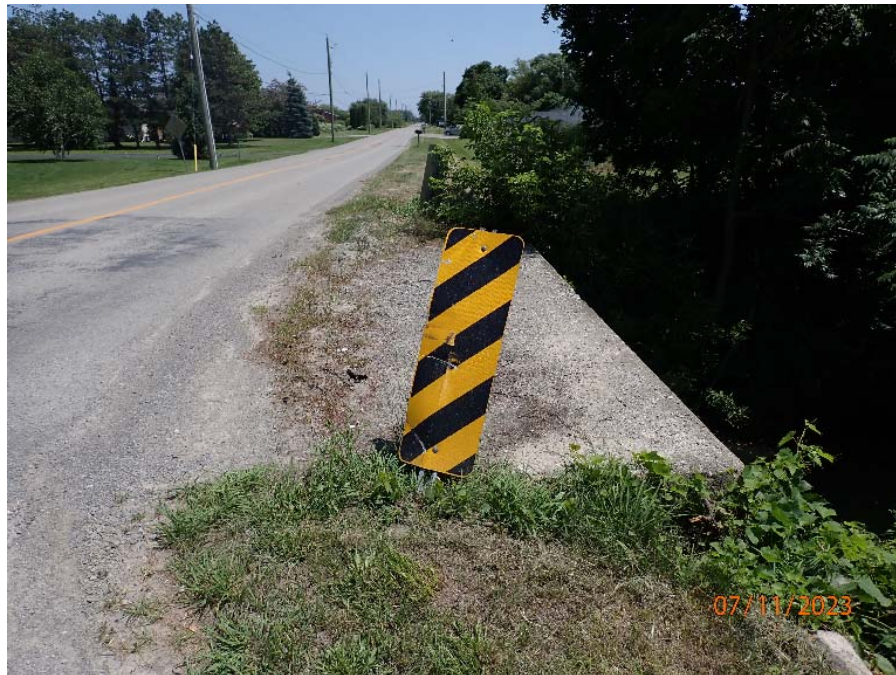
Photograph No. 4: 0582: Damaged hazard marker at southwest corner.

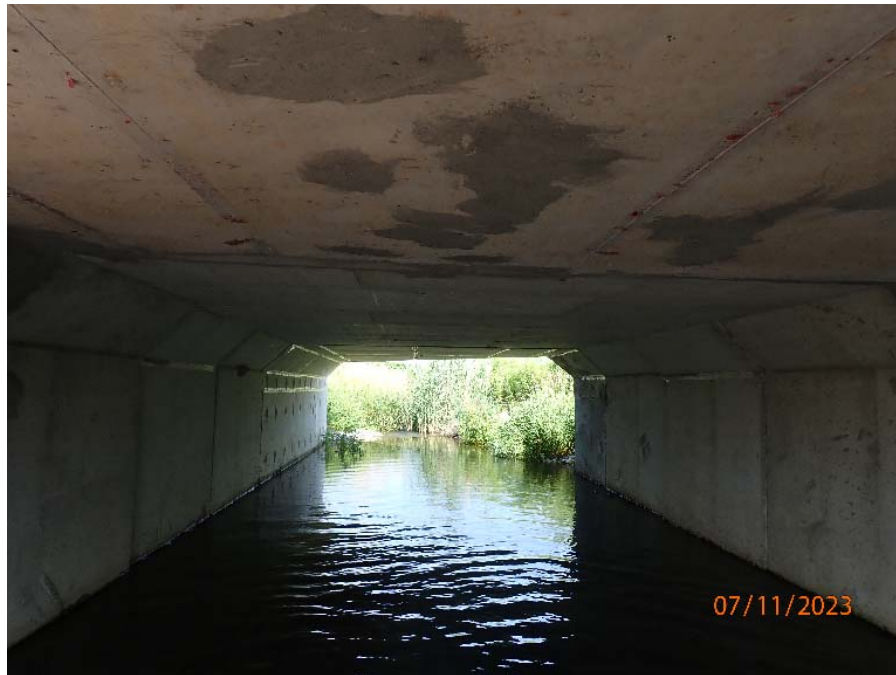
Photograph No. 4: 0322: Interior of structure looking north.

The concrete bridge deck soffit and overhangs are generally in good condition with isolated areas of narrow cracking. The structural steel girders and structural steel piers are generally in good condition with isolated areas of light to medium surface corrosion where the coating system is beginning to fail. There is an area of medium to severe corrosion at the bottom flange of the west-most girder at the south abutment. There are also isolated areas of light to medium corrosion at the connections. The elastomeric bearings are in good condition. The concrete retaining walls at the piers are generally in good condition with light scaling. The concrete abutments and bearing seats are in good condition. There is a watermain on the east side of the structure. There is light to medium surface corrosion on several of the watermain hanger brackets.

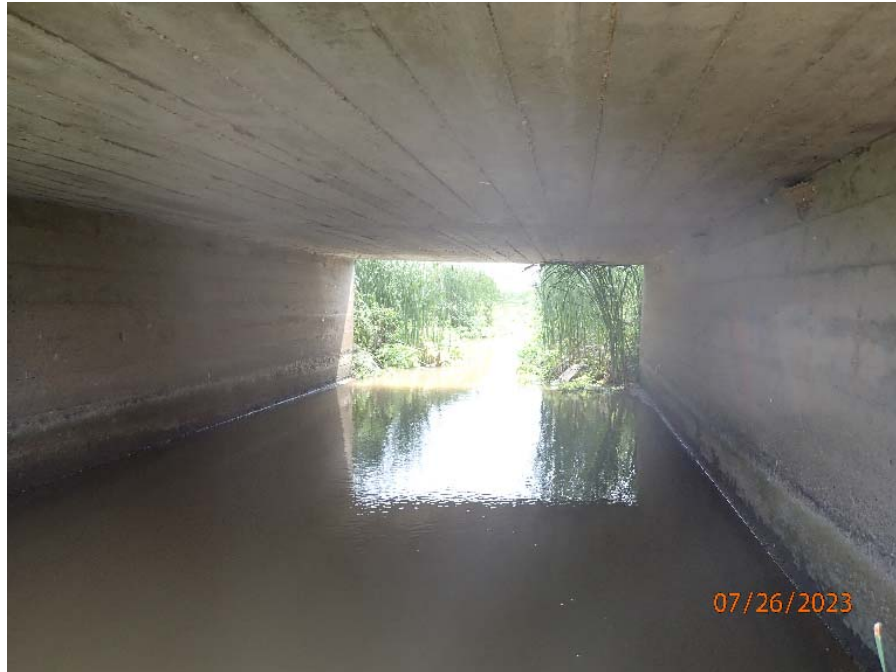
Photograph No. 3: 0609: Interior of structure looking south.

The structure has been widened by 6m to the south. The exposed portions of the bridge deck top are generally in good condition with light scaling. The concrete curbs and headwalls are in good condition. The original portion of the bridge deck soffit is generally in good condition with localized areas of light delamination and light to medium spalls with exposed corroded reinforcing steel (approximately 0.2m², poor). The widened portion of the bridge deck soffit is in good condition. The concrete abutments of the original portion of the structure are generally in good condition with light to medium scaling throughout. There are areas of light honeycombing and light scour along the footings of the original portions of the abutments. The widened portions of the concrete abutments are in good condition with areas of light honeycombing above the waterline. The abutment footings are exposed by approximately 0.5m throughout the structure. The concrete wingwalls are in good condition.

We recommend placing riprap along the footings in 1-5 Years to prevent further erosion.

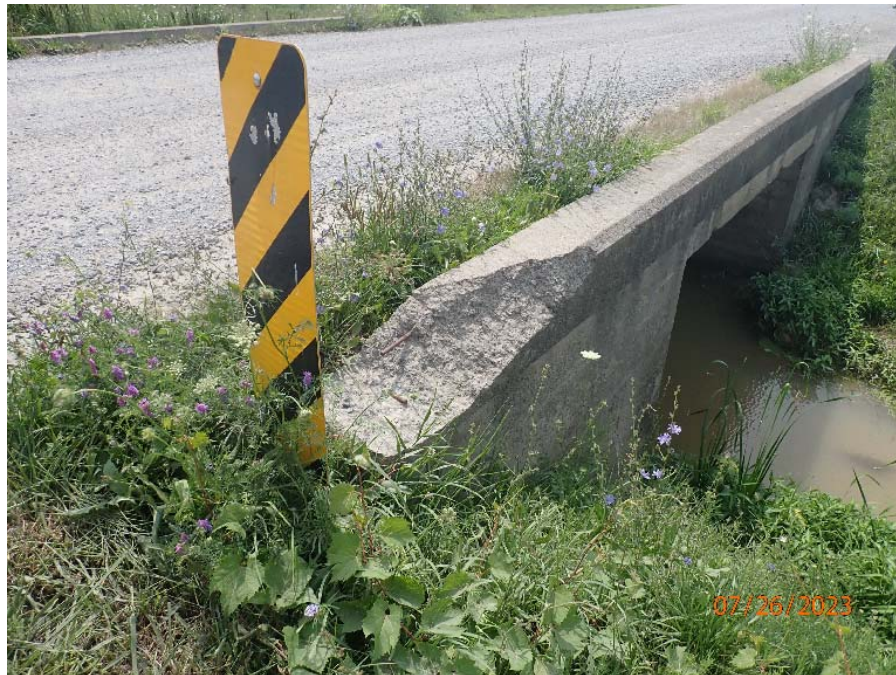
Photograph No. 4: 0626: Severe vehicular damage to northeast corner of concrete curb.

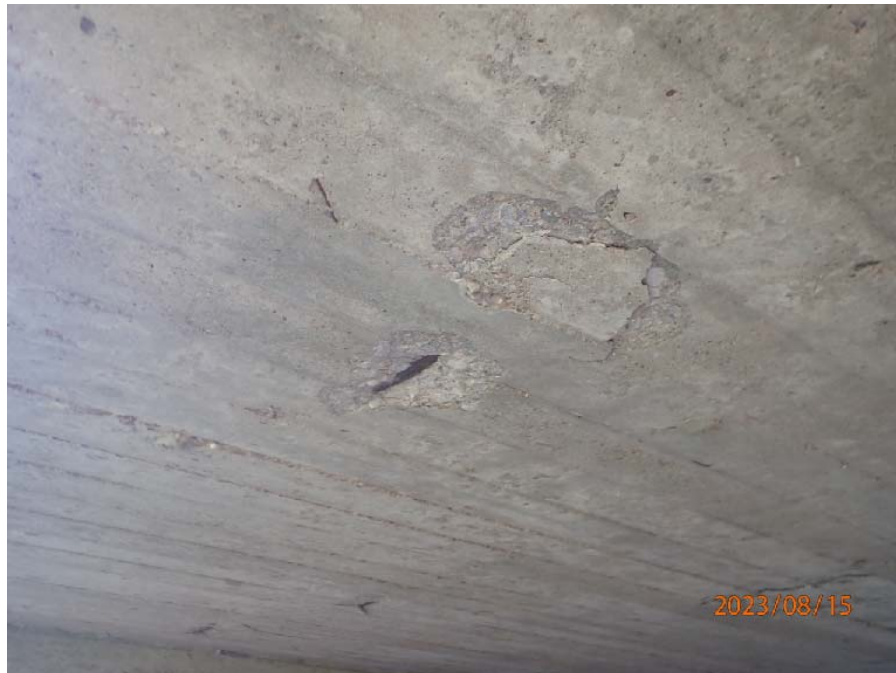
Photograph No. 4: 0512: Spalling and delaminations with exposed corroded reinforcing steel in soffit.

The structural steel girders consist of rail sections and are generally in fair condition with light to medium corrosion throughout. There is a small isolated perforation along the second interior girder from the east at the south abutment. There is a light sag in the steel rail section girders. The south abutment is generally in poor condition with severe forward rotation (approximately 150-200mm at maximum). There are several narrow vertical and horizontal cracks with efflorescent staining on the south abutment. The north abutment is generally in good condition with light to medium scaling. The top of the abutments are severely scaled. The concrete wingwalls are in fair condition with light to medium concrete disintegration and scaling.

We recommend closing the structure (with barricades or by removal) and/or replacing the structure NOW. This report does not include a recommendation for traffic protection because the structure is located on a private field entrance.

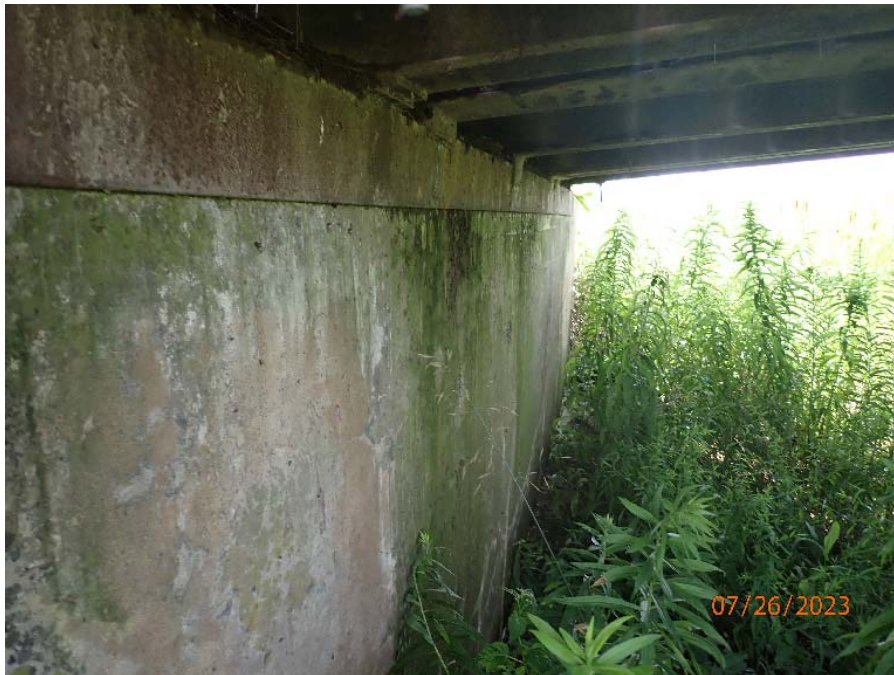
Photograph No. 4: 0698: Outward rotation in south abutment.

We recommend scheduling for a Patch, Waterproof, and Pave (PWP) in 1-5 Years. We recommend placing riprap along the footings in 1-5 Years to prevent further erosion.

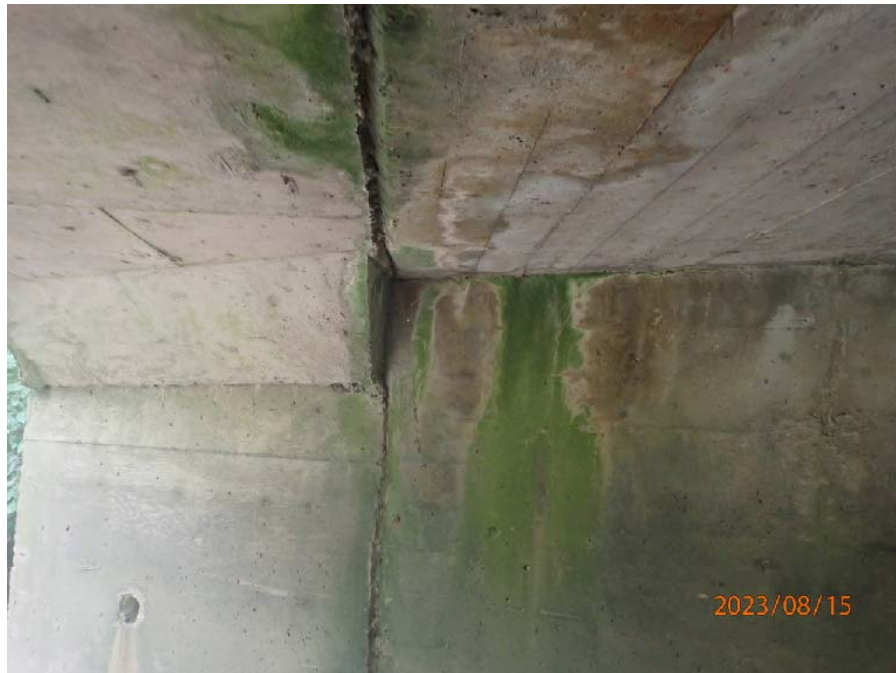
Photograph No. 4: 0551: Evidence of leakage and staining at the construction joint (typical).

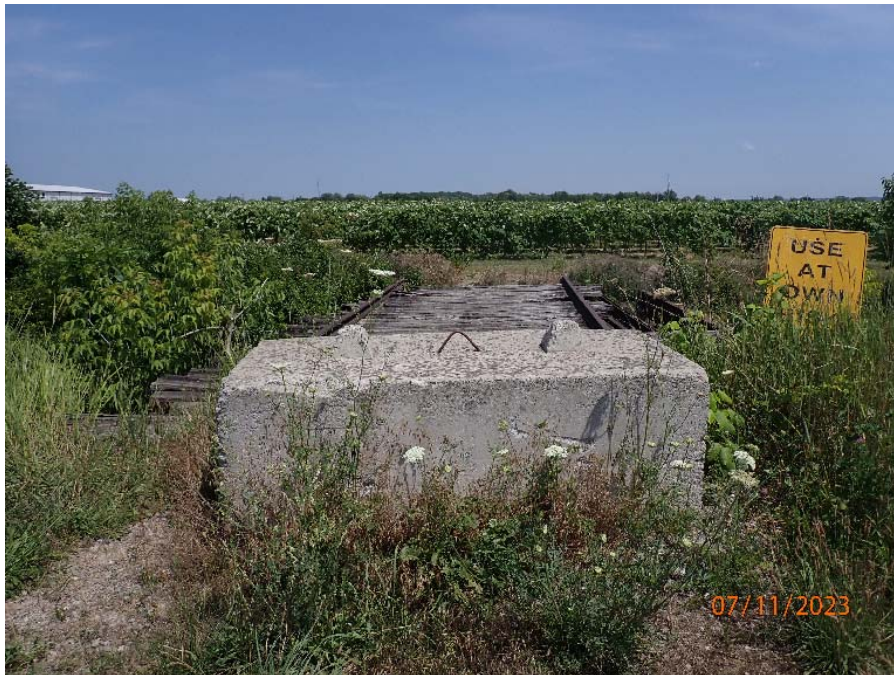
Photograph No. 4: 0722: Concrete barrier at west end.

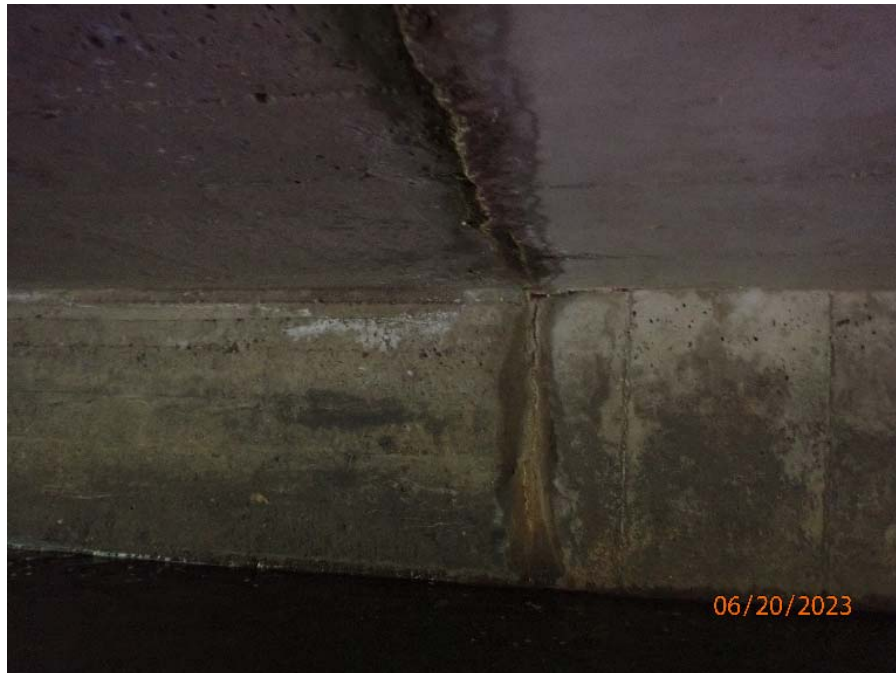
Photograph No. 4: 0103: Leakage, cracking and efflorescent staining along joint between the original structure and the east extension, looking south..

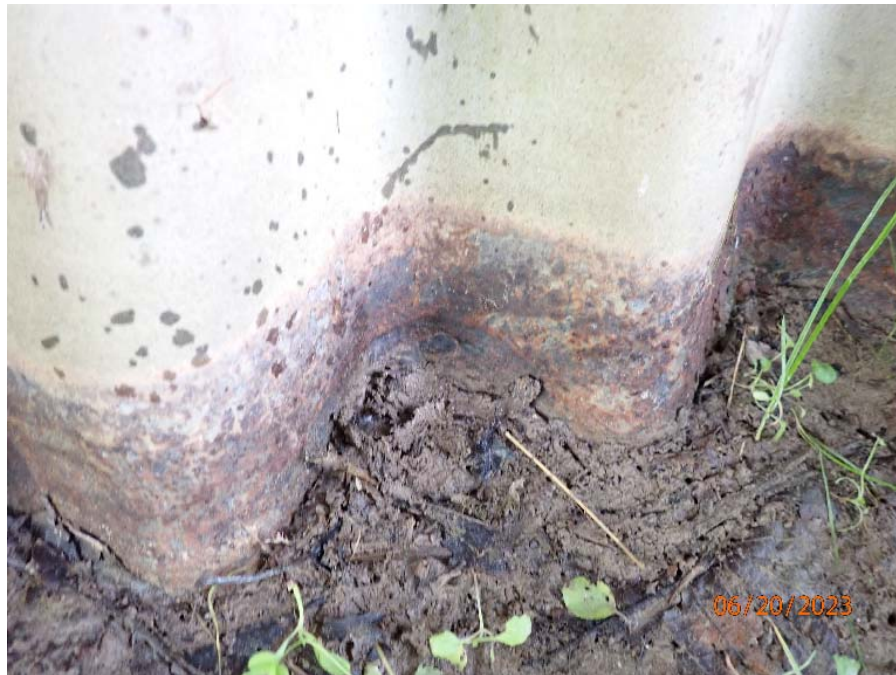
Photograph No. 4: 0277: Area of medium corrosion at the waterline (typical).
