TOWN OF NIAGARA-ON-THE-LAKE

2023 MUNICIPAL BRIDGE APPRAISAL REHABILITATION/REPLACEMENT NEEDS

February 2024

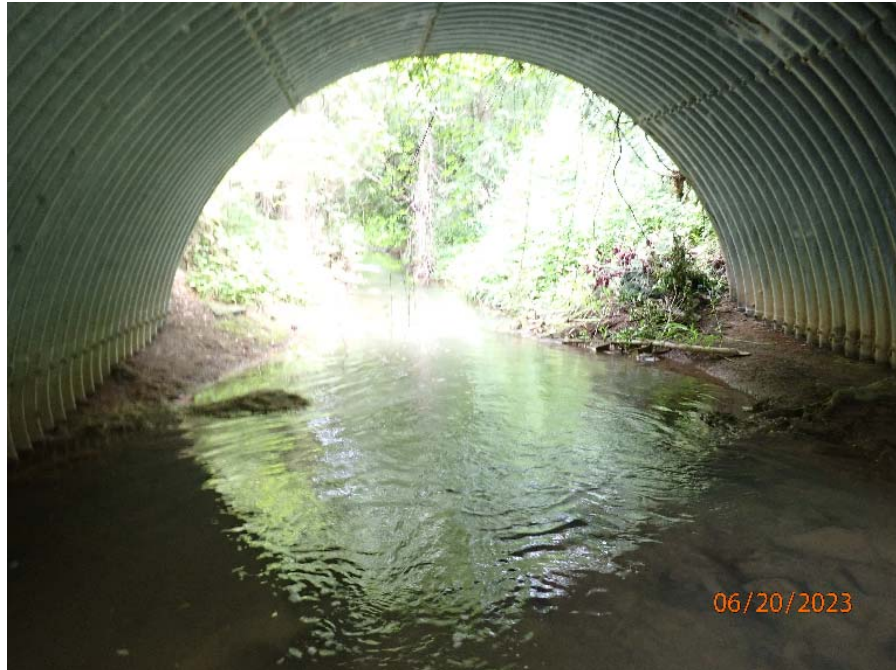
Photograph No. 3: 0330: Underside of the structure looking north.

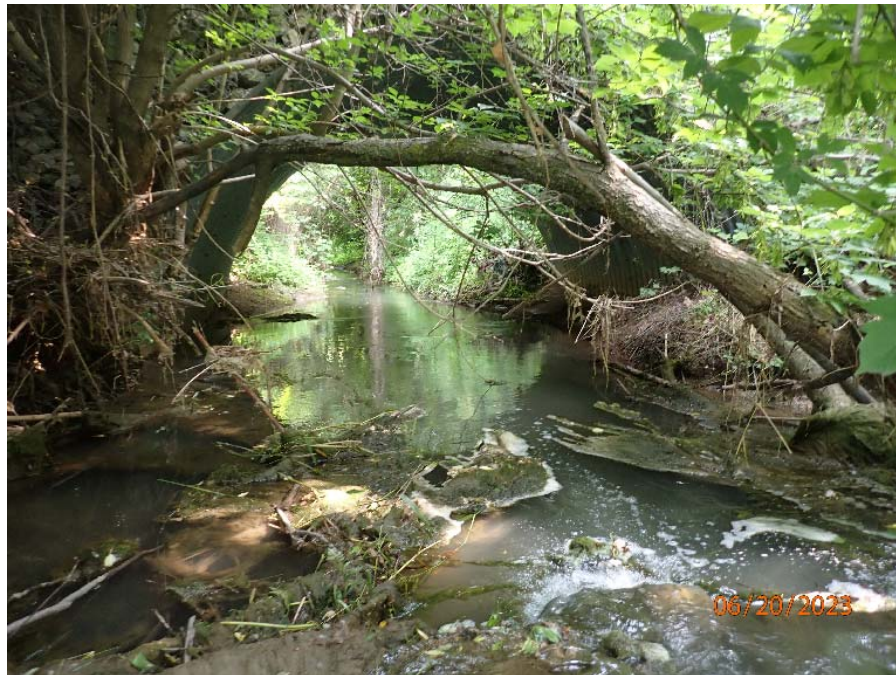
Photograph No. 4: 0315: Vegetation and debris at north end of structure, looking south.

The steel multi-plate pipe arch culvert is in fair to good condition with light to medium corrosion at the waterline. There is a perforation/damage above the waterline and rust staining at the northwest corner of the structure which may have occurred during installation. There is sediment buildup along the east side of the cell.

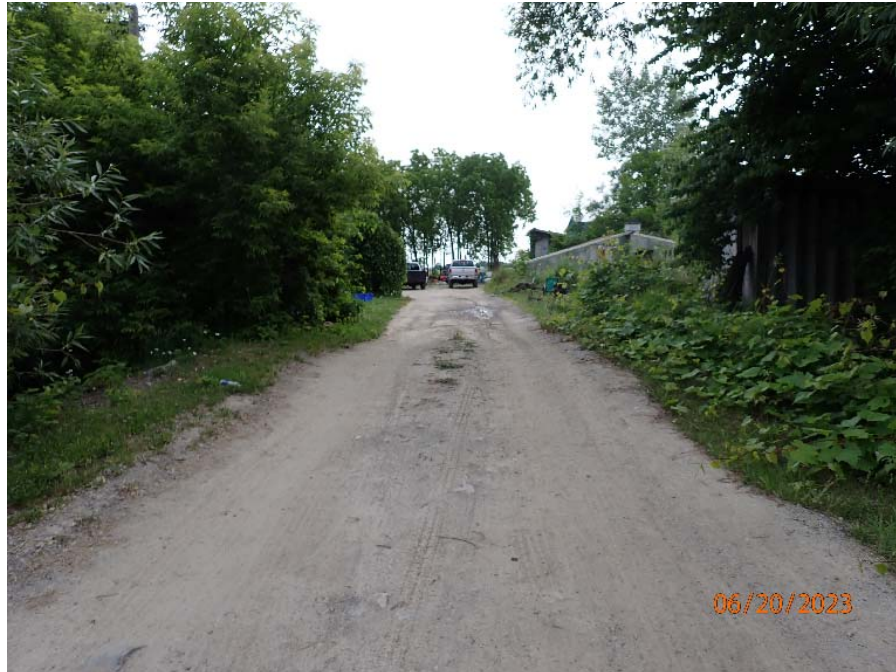
Photograph No. 1: 0355: Driveway over the structure looking east.

The gravel roadway approaches are in fair to good condition. The gravel roadway over the structure is generally in good condition. There is no traffic protection provided over the structure or on the approaches. There are hazard markers at all four corners. The concrete curbs and headwalls are generally in good condition with localized spalls in the northeast and southwest corners.

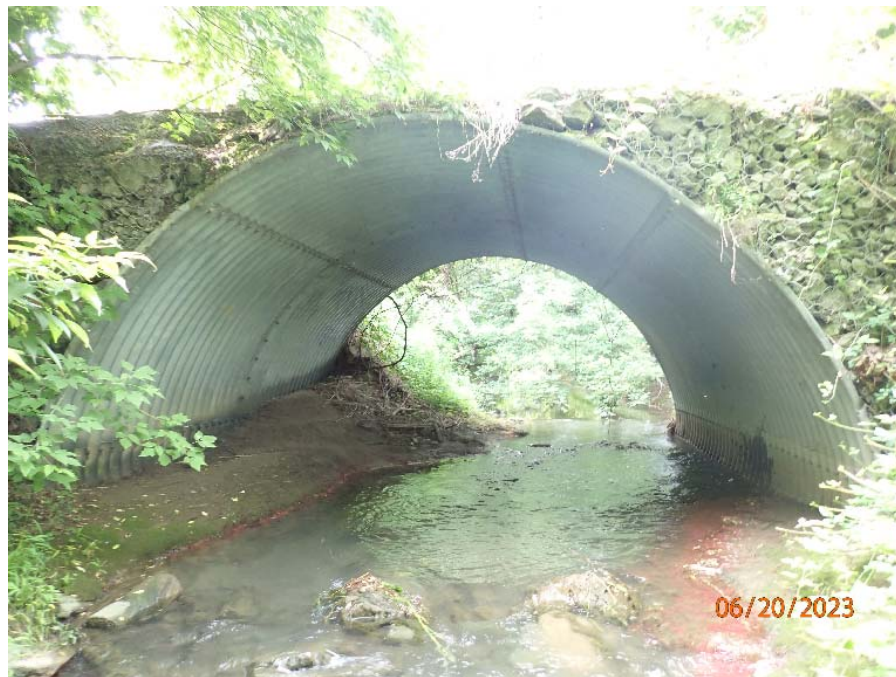
Photograph No. 2: 0397: North elevation.

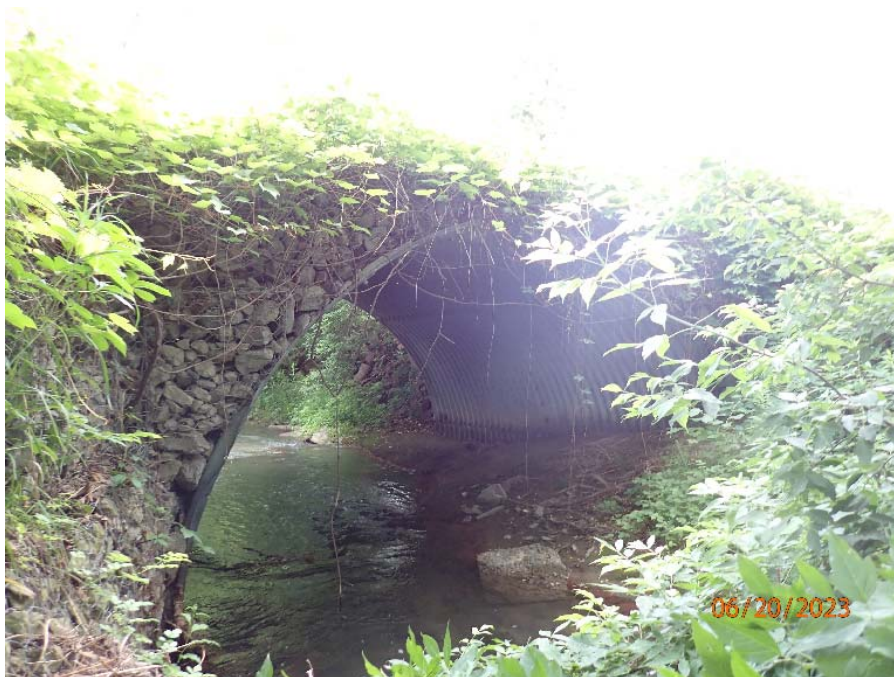
Photograph No. 3: 0366: South elevation.

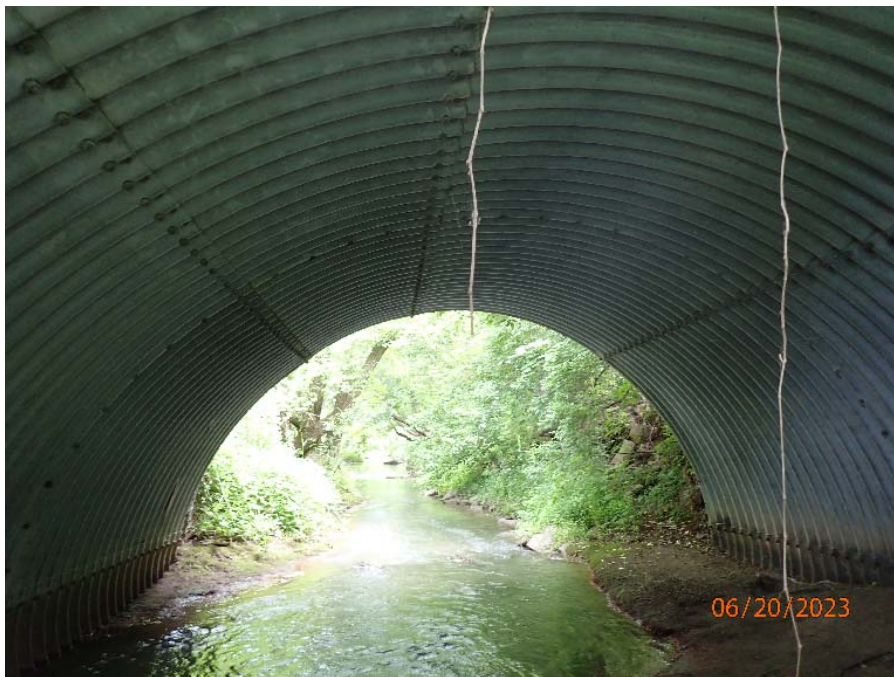
Photograph No. 4: 0376: Underside of the structure looking north.

The concrete deck soffit is generally in good condition with localized areas of light scaling and stained narrow transverse cracks with efflorescent staining. There is a medium delamination in the soffit approximately 3m from the north end (0.2m² poor). The concrete abutments are generally in good condition with isolated narrow to very wide vertical cracks. There is severe scour and a wide crack on the abutment footings. A vertical crack approximately +/-10mm wide extends through the full depth of the east abutment sidewall and into the footing. The footings are exposed with medium scour, approximately 600mm in depth, most notably at the south end.

The concrete invert slab below the structure is fair condition with medium to severe scaling throughout and localized narrow to medium cracking. The concrete invert slab extends 2m past the north and south ends of the structure. There is an area of localized light to medium undermining, approximately 150mm in depth at the north end of the structure. The concrete wingwalls are generally in good condition with a crack on top of the northeast wingwall and disintegration of the top of the southeast wingwall (0.1m², poor).

We recommend placing riprap along the footings NOW to prevent further erosion. We also recommend that the Town review their Roadside Safety Policy NOW to determine if steel beam guiderails are required to provide traffic protection over the structure.

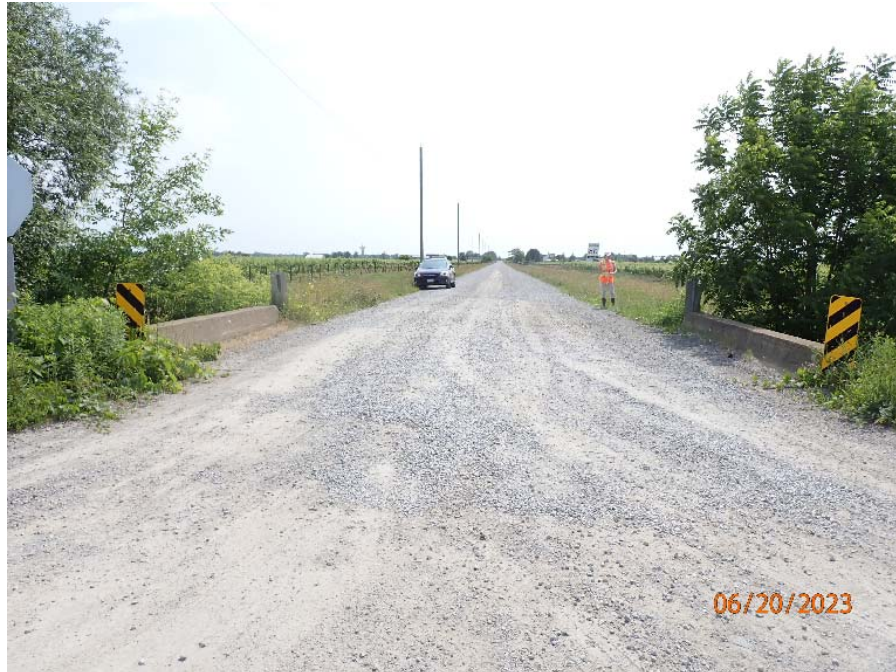
Photograph No. 1: 0421: Roadway over the structure looking east.

The surface treated roadway over the structure and on the approaches is in fair condition. There is medium to severe settlement at all four corners of the structure. There are isolated medium potholes along the east and west approach shoulders. The steel beam guiderails over the structure is generally in good condition with extruder end treatments at all four corners. The northwest end treatment has been damaged and is no longer properly functioning. There are several guiderail posts over the east side of the structure with rotated or missing offset blocks. The exposed ends of the bridge deck top are in good condition with light scaling.

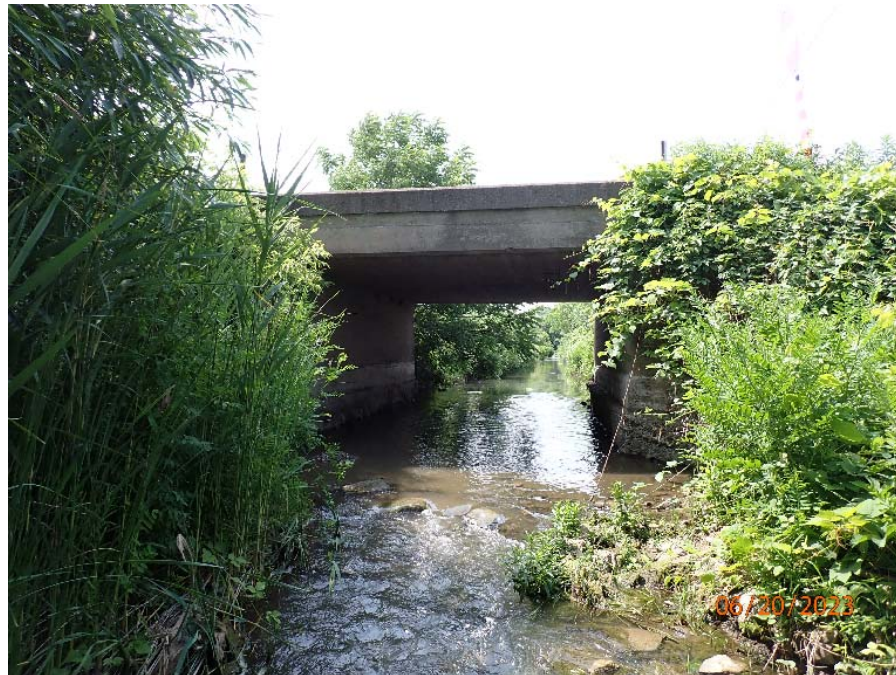
Photograph No. 2: 0463: North elevation.

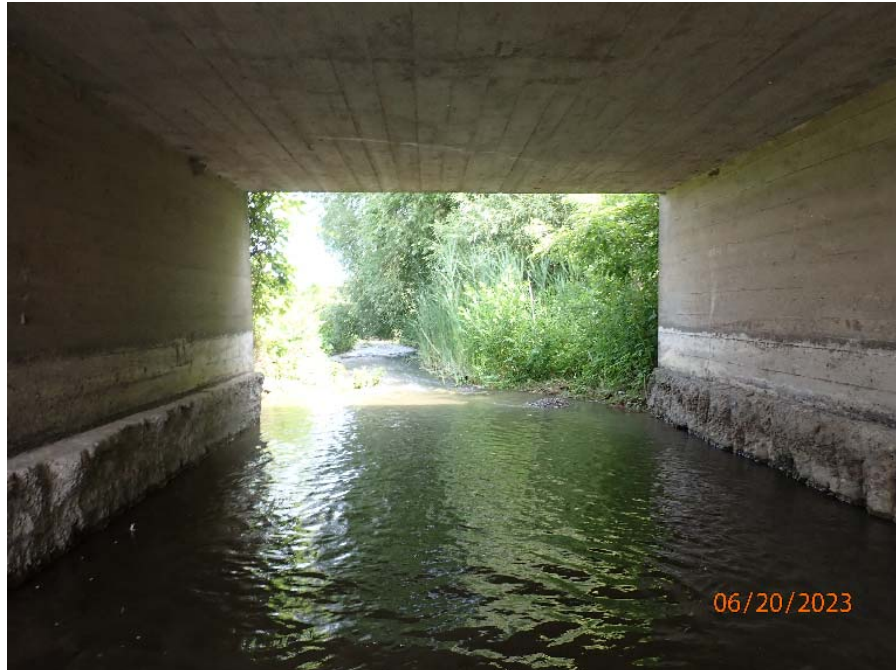
Photograph No. 3: 0436: Underside of the structure looking north.

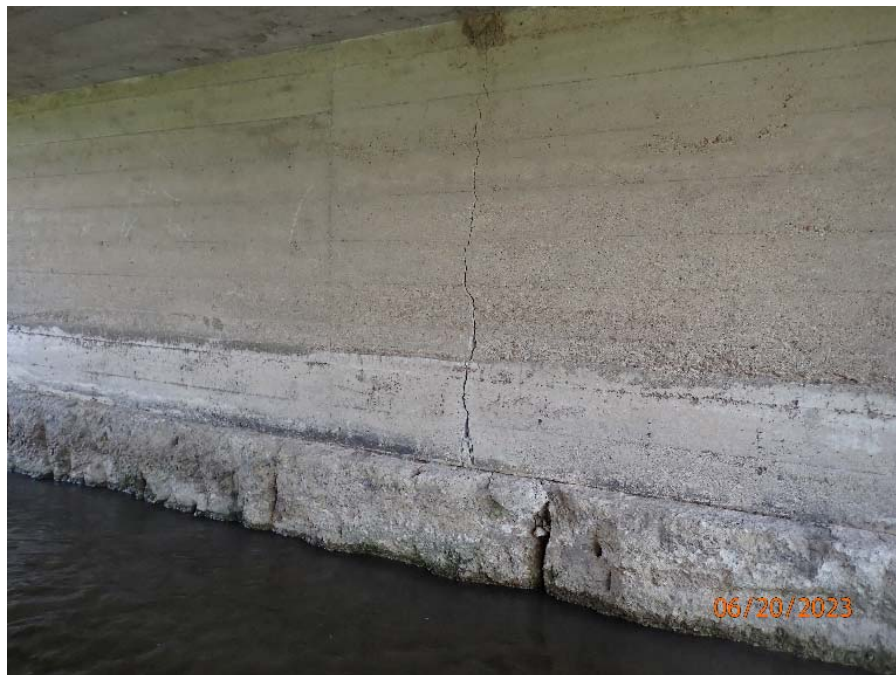
Photograph No. 4: 0441: Wide crack and exposed footings in east abutment.

The concrete deck soffit is in good condition with water staining at the ends. The abutment sidewalls are generally in good condition with narrow to wide vertical cracks at the centre of the structure with efflorescent staining. The footings are exposed by approximately 0.75m throughout the structure. There is light to medium scour along the waterline. The gabion basket retaining walls at the northeast and southeast corners are in fair condition. The northeast gabion basket has rotated outwards and is bulging. The west side slopes are generally in fair condition with minor erosion at both corners. There is a utility along the west fascia of the structure.

We recommend replacing the damaged end treatment at the northwest corner NOW. We recommend placing riprap along the footings NOW to prevent further erosion. We recommend vegetation and tree removal NOW. We also recommend monitoring the northeast gabion baskets for further rotation.

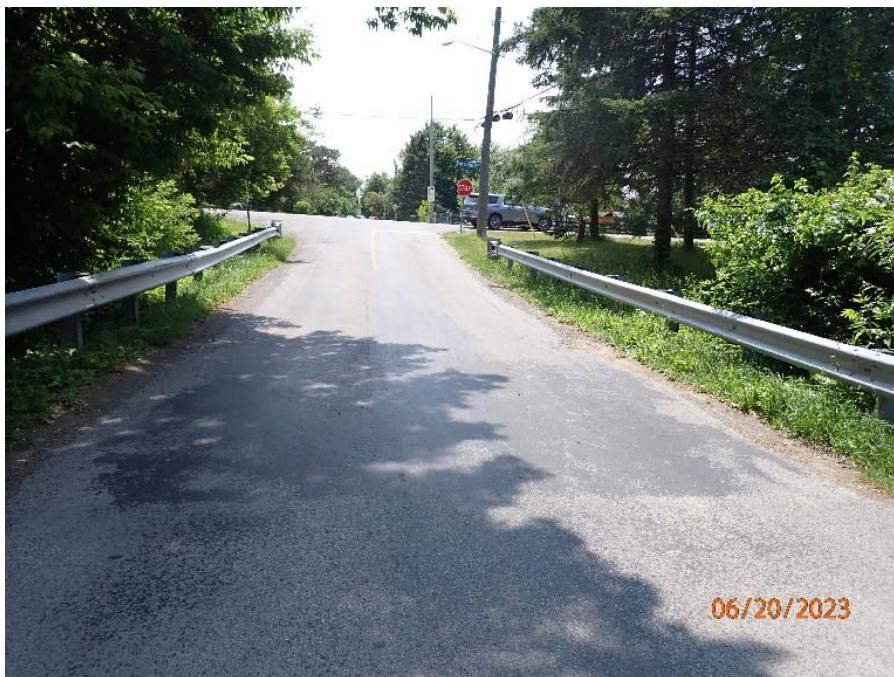
Photograph No. 1: 0672: Roadway over the structure looking south.

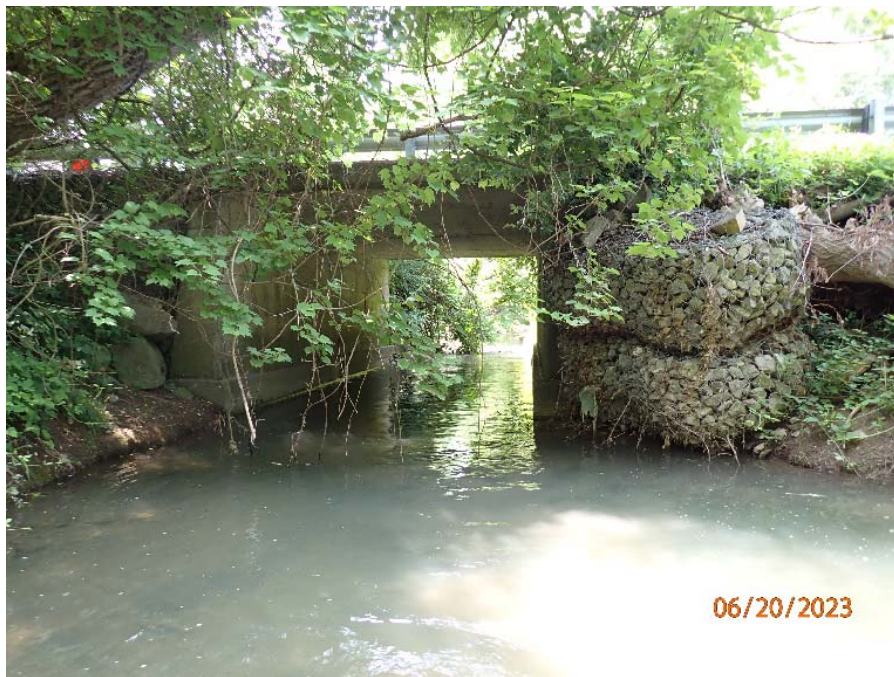
Photograph No. 2: 0738: East elevation.

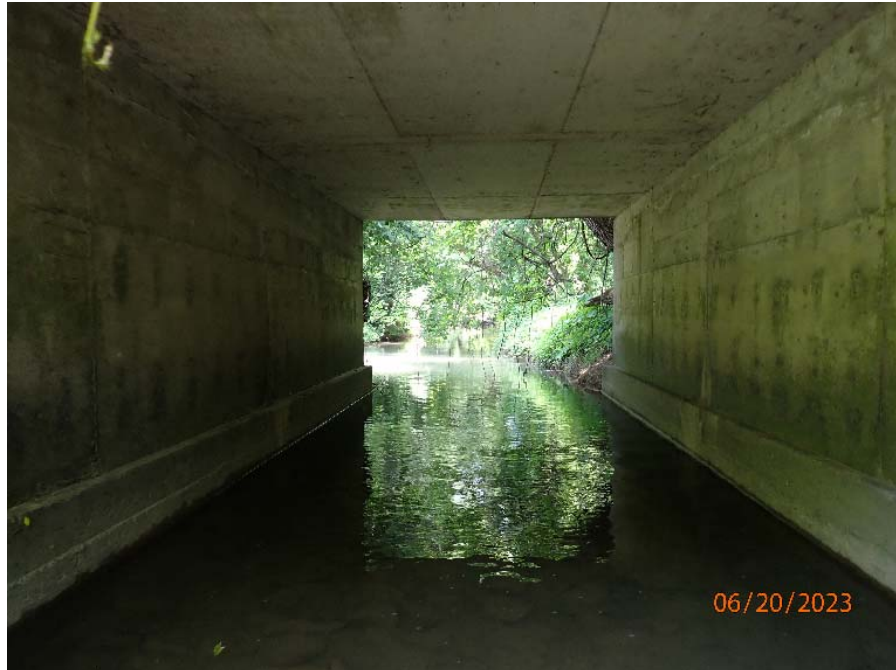
Photograph No. 3: 0701: Underside of the structure looking east.

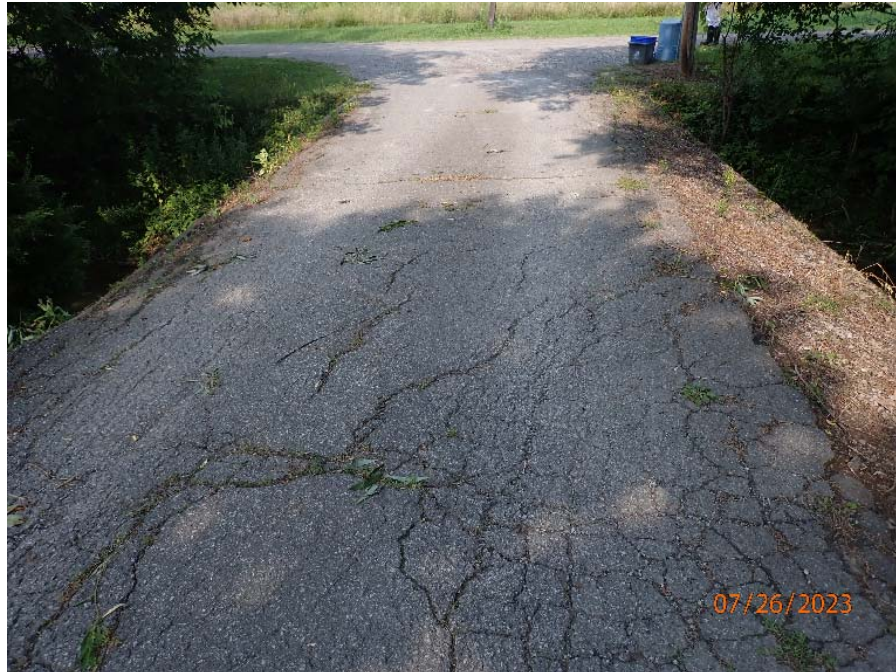
Photograph No. 1: 0131: Driveway over the structure looking west.

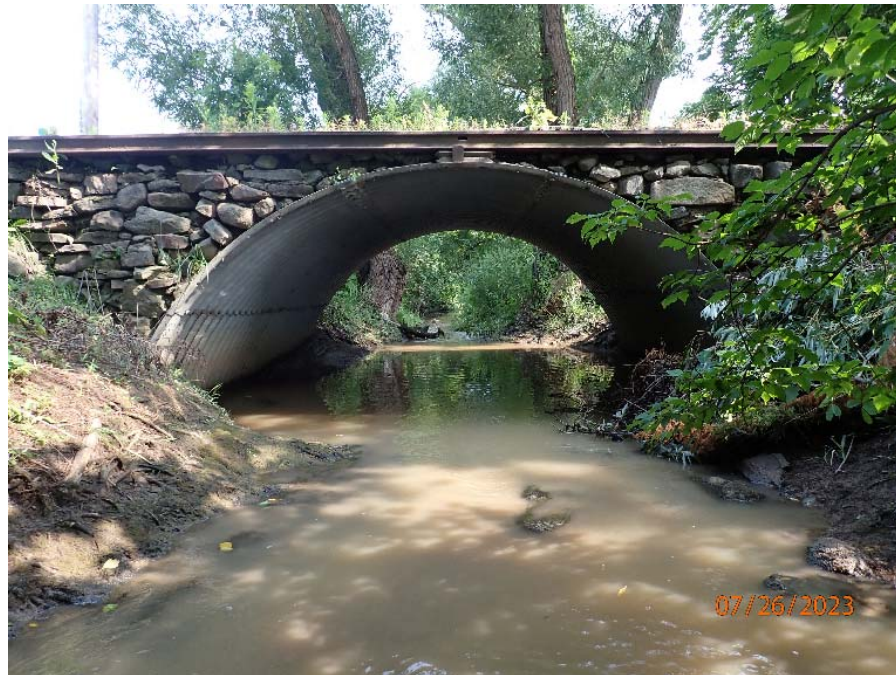
Photograph No. 2: 0171: South elevation.

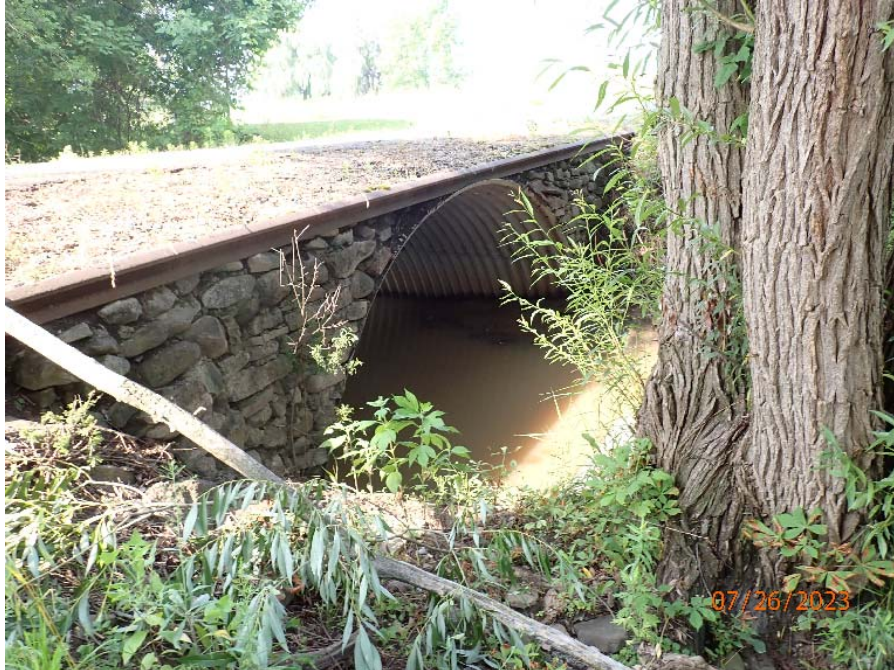
Photograph No. 3: 0143: North elevation.

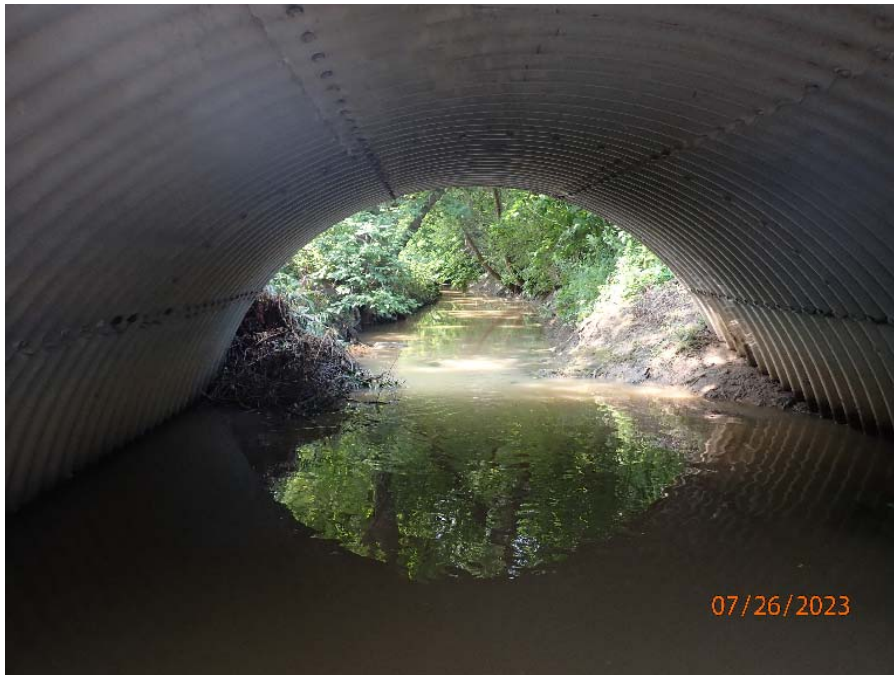
Photograph No. 4: 0155: Underside of the structure looking north.

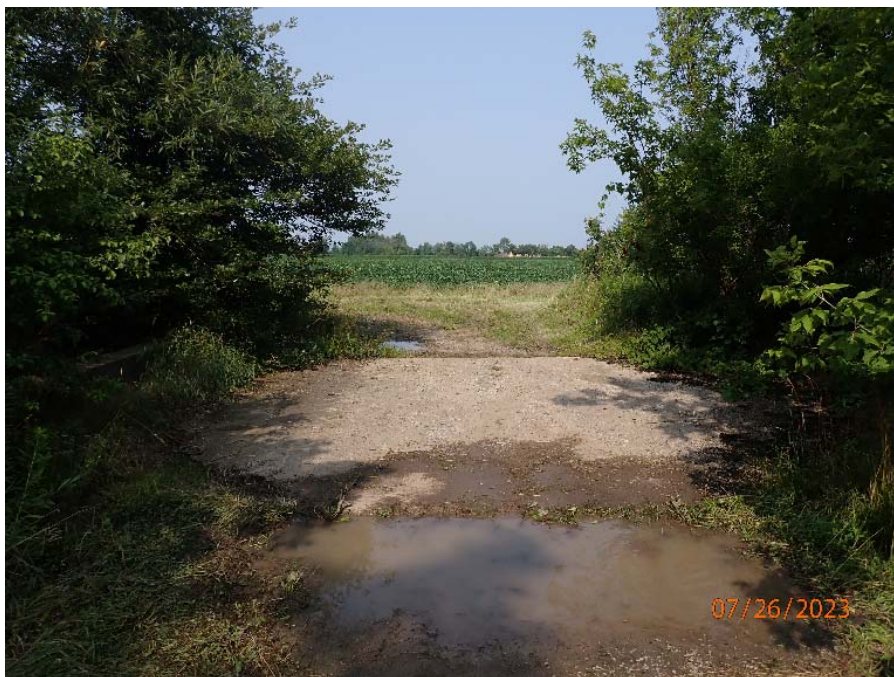
Photograph No. 1: 0194: Roadway over the structure looking east.

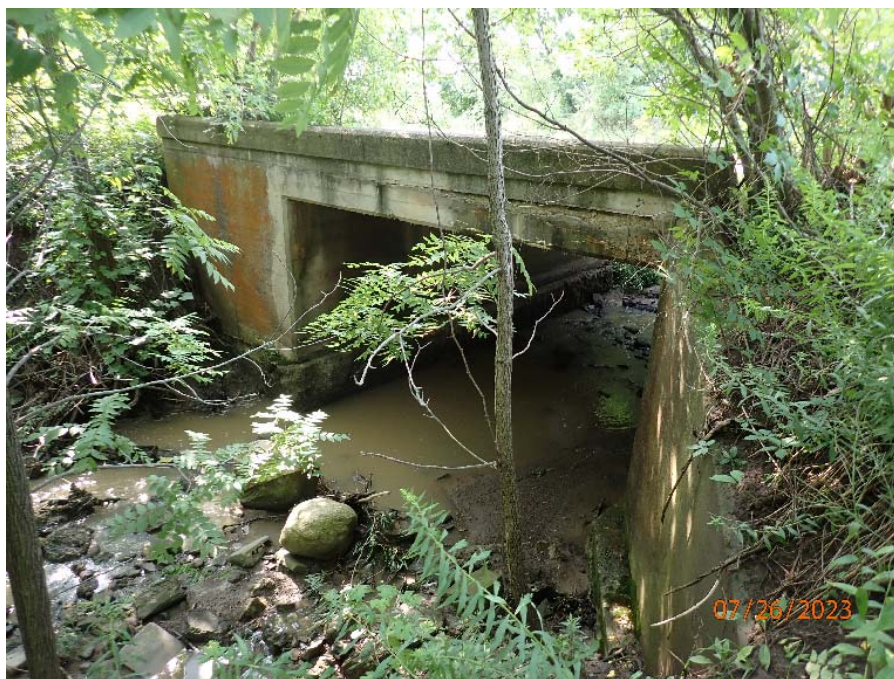
Photograph No. 2: 0200: North elevation.

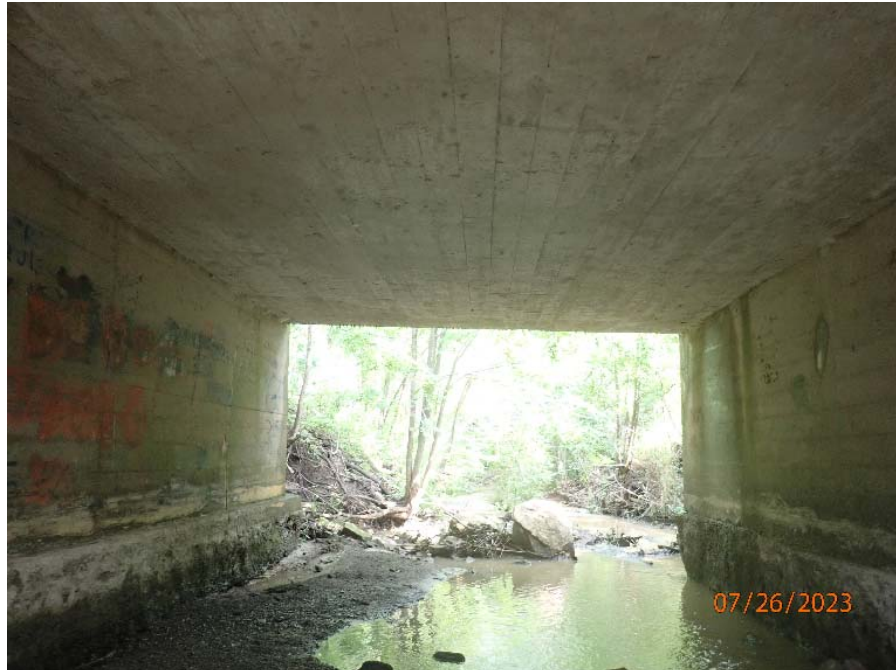
Photograph No. 3: 0270: Underside of the structure looking north.

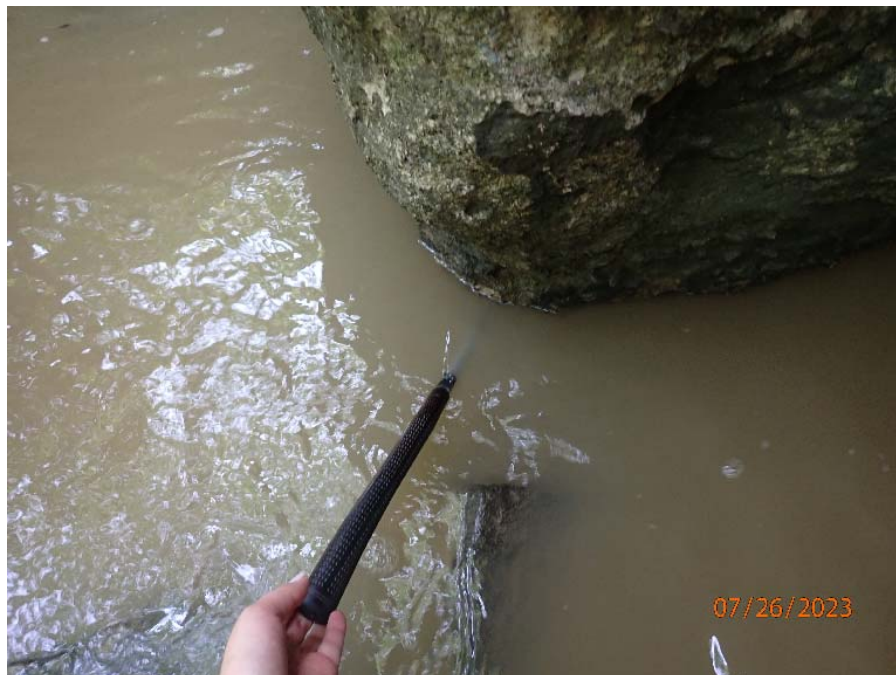
Photograph No. 4: 0290: Undermining at northeast corner.

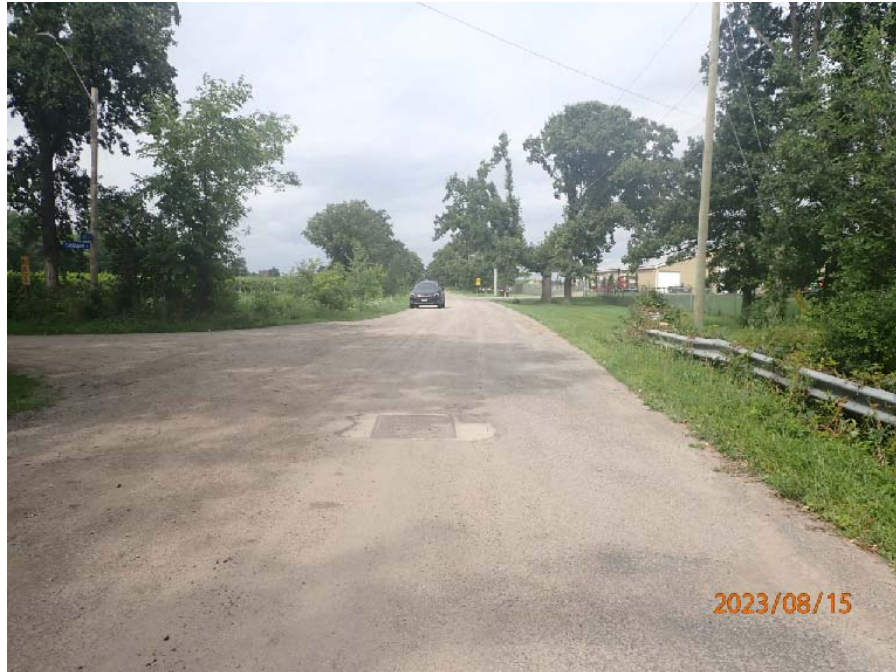
Photograph No. 1: 0234: Roadway over the structure looking west.

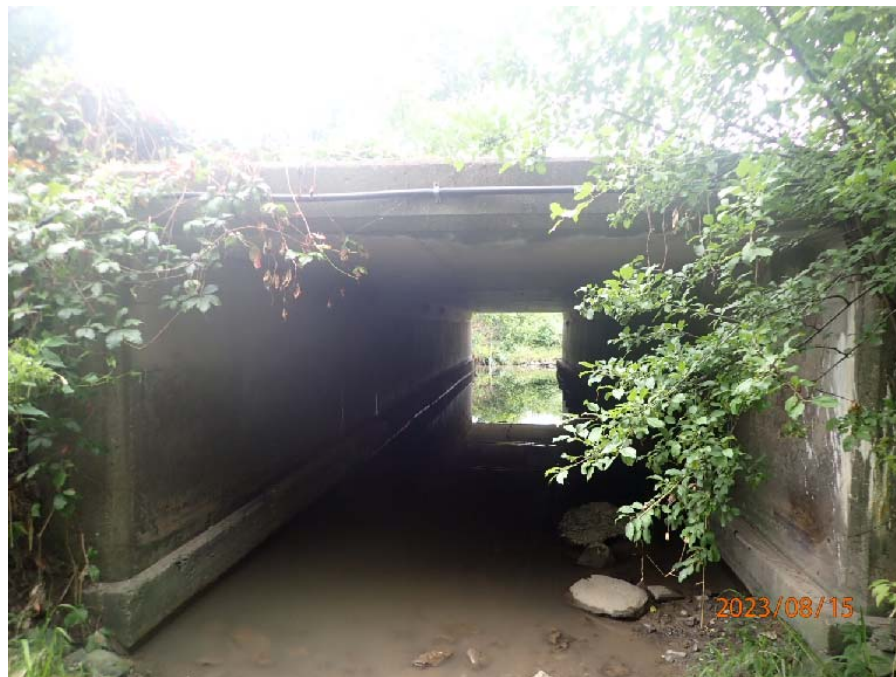
Photograph No. 2: 0301: North elevation.

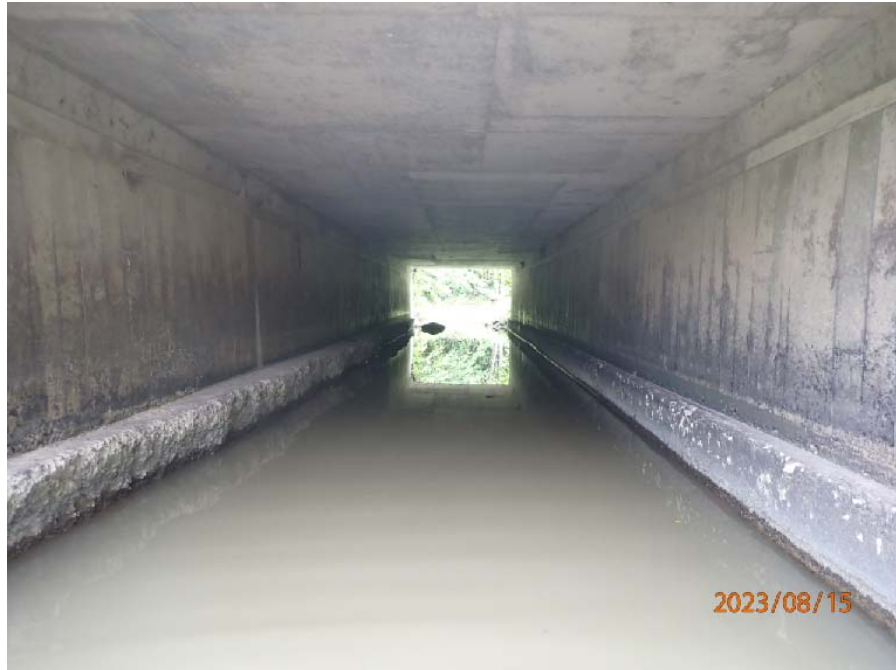
Photograph No. 3: 0250: Underside of the structure looking north.

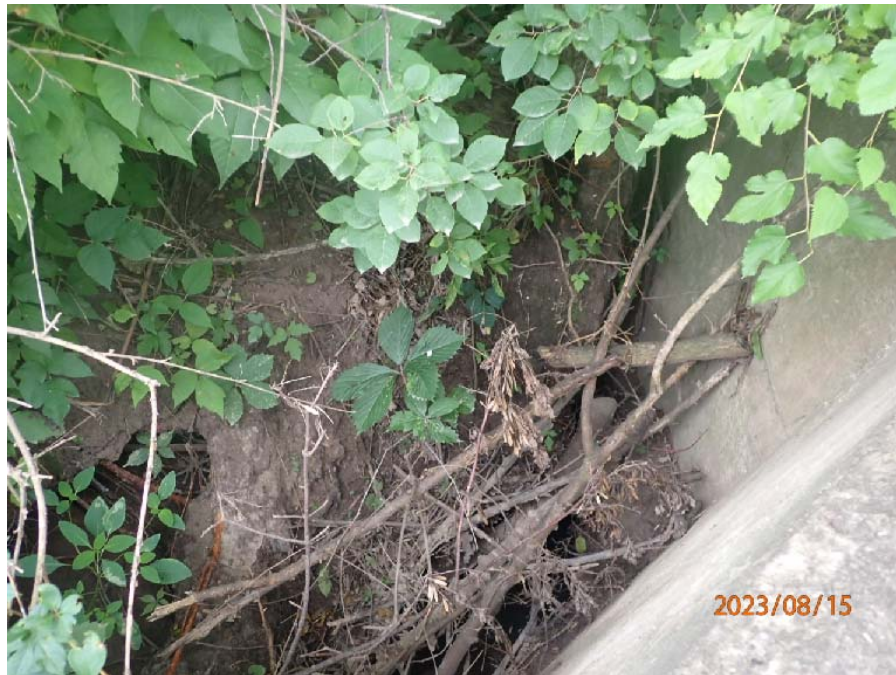
Photograph No. 4: 0286: Severe erosion behind southeast wingwall.

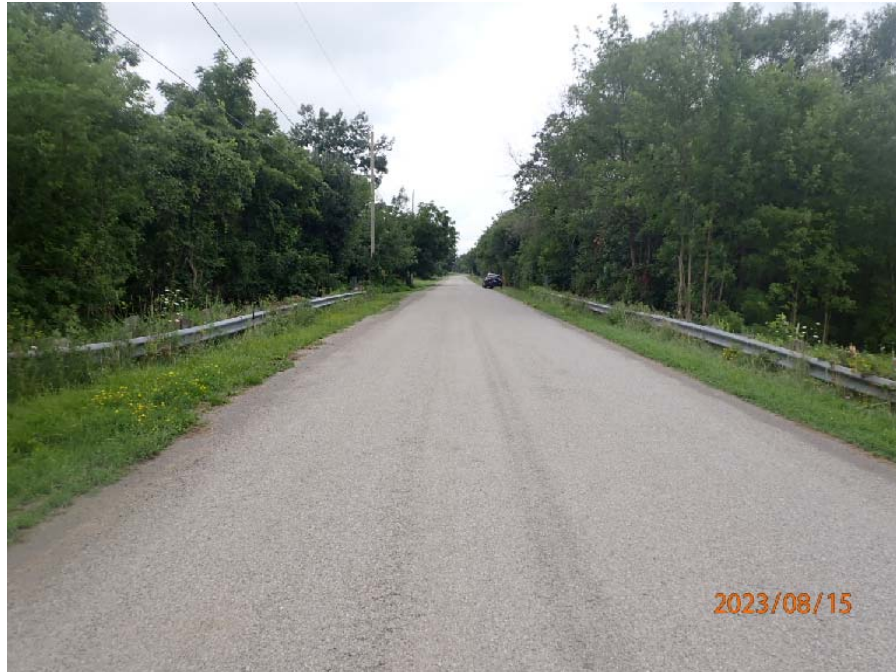
Photograph No. 1: 0124: Roadway over the structure looking west.

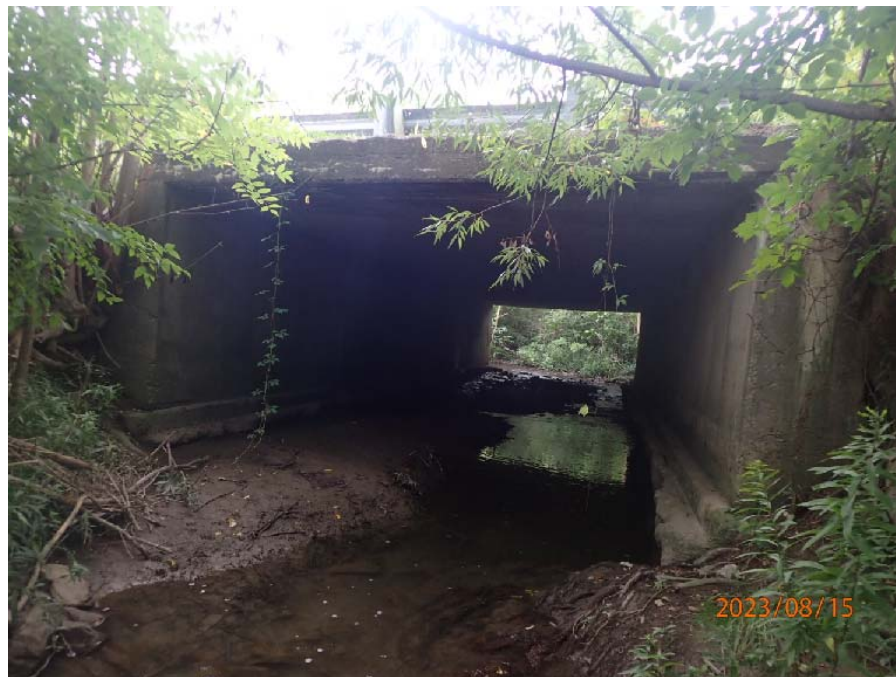
Photograph No. 2: 0141: South elevation.

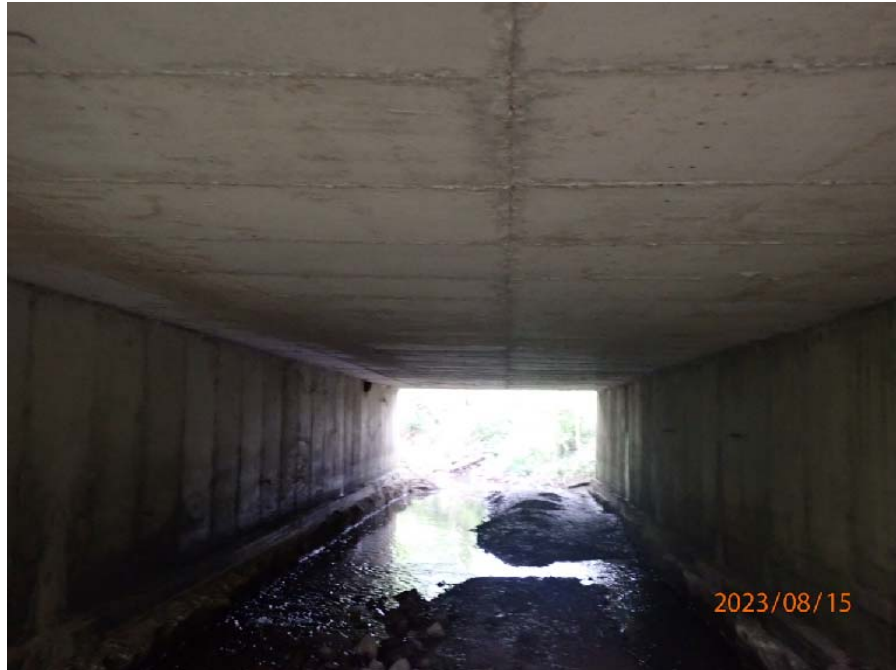
Photograph No. 3: 0182: Underside of the structure looking north.

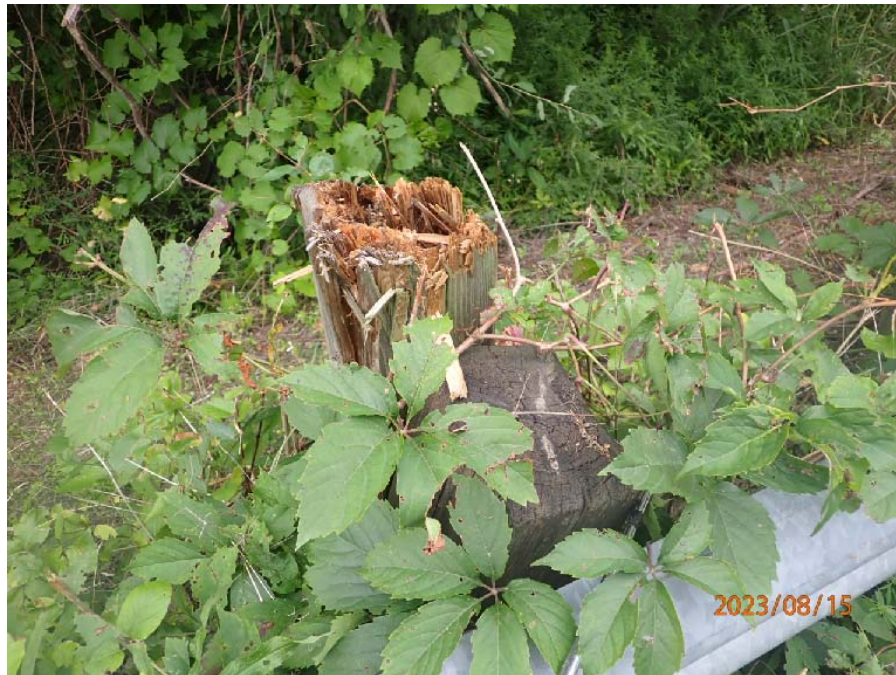
Photograph No. 4: 0211: Rotted and rotated timber posts (typical).

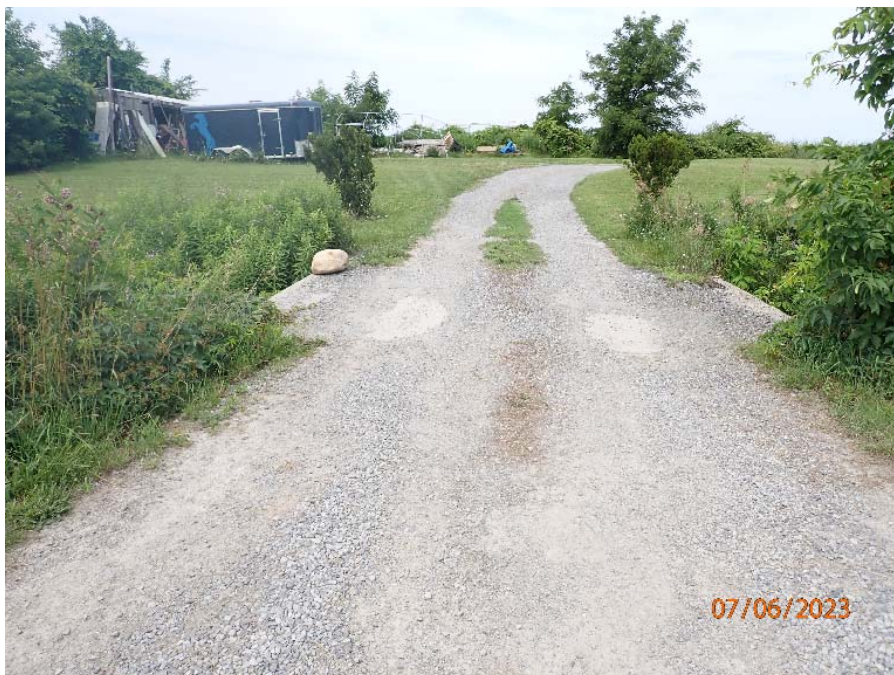
Photograph No. 1: 0424: Driveway over the structure looking west.

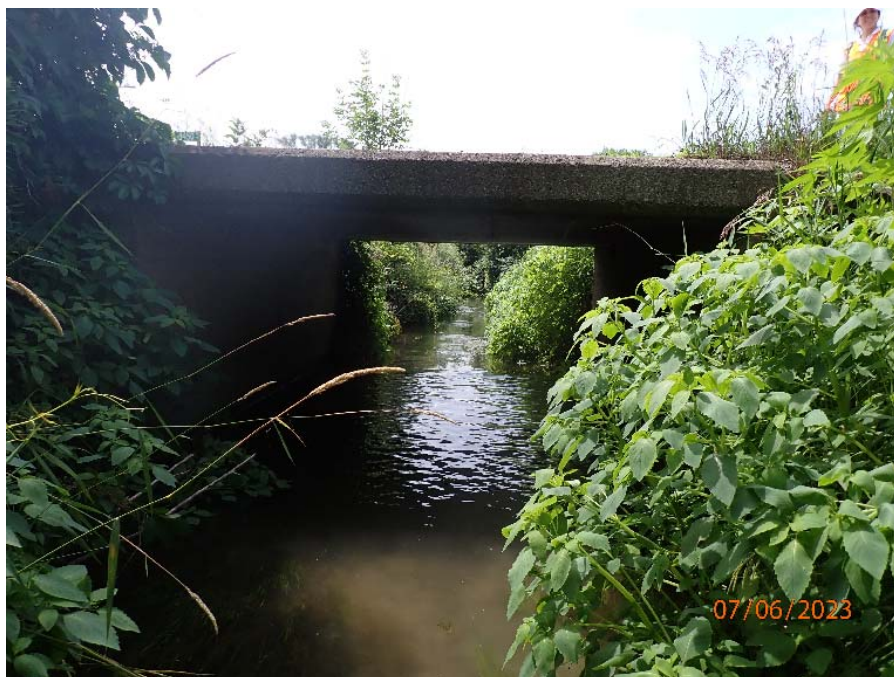
Photograph No. 2: 0469: North elevation.

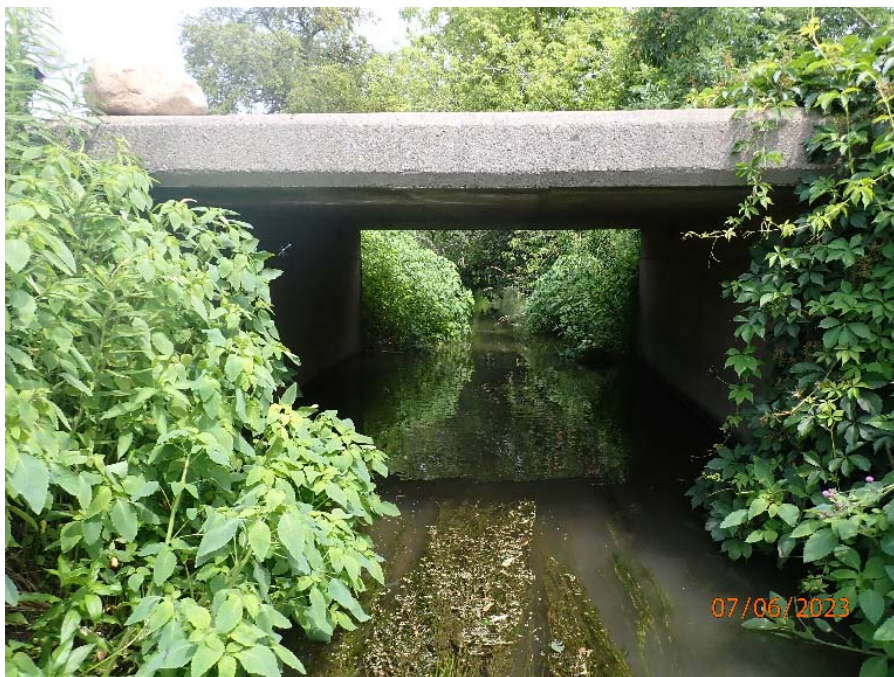
Photograph No. 3: 0440: South elevation.

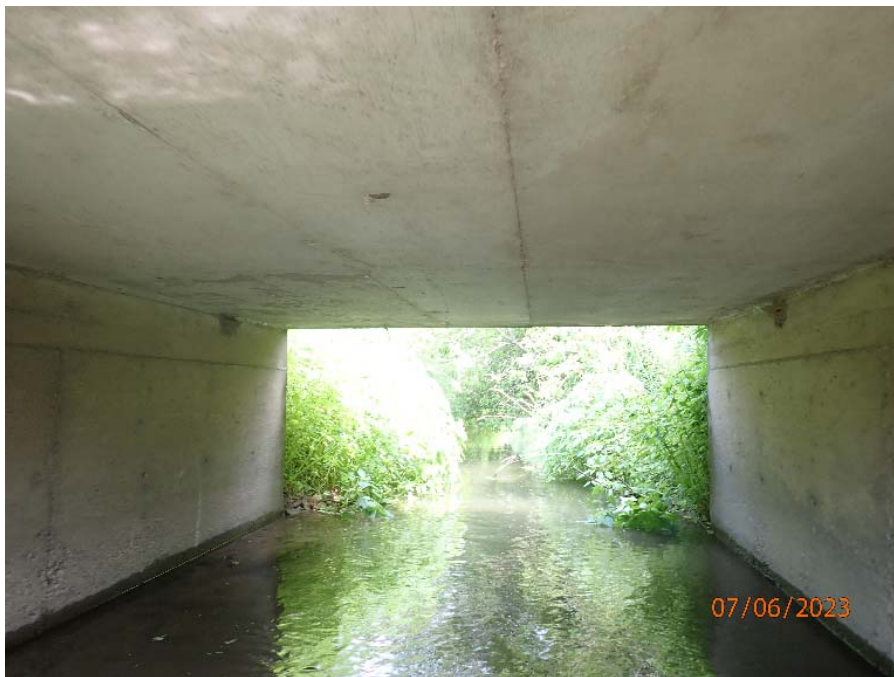
Photograph No. 4: 0444: Underside of the structure looking north.

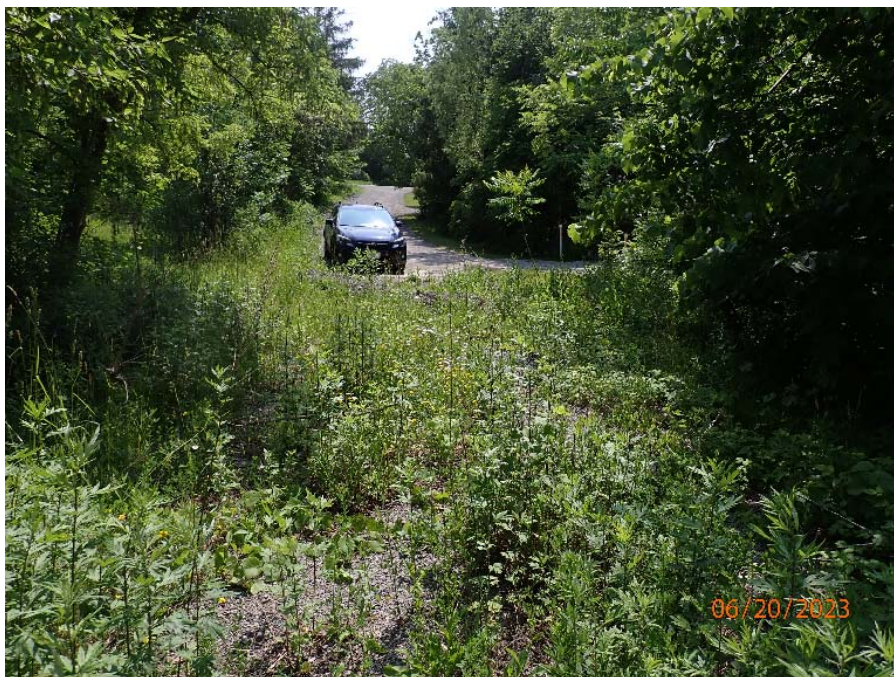
Photograph No. 1: 0866: Roadway over the structure looking west.

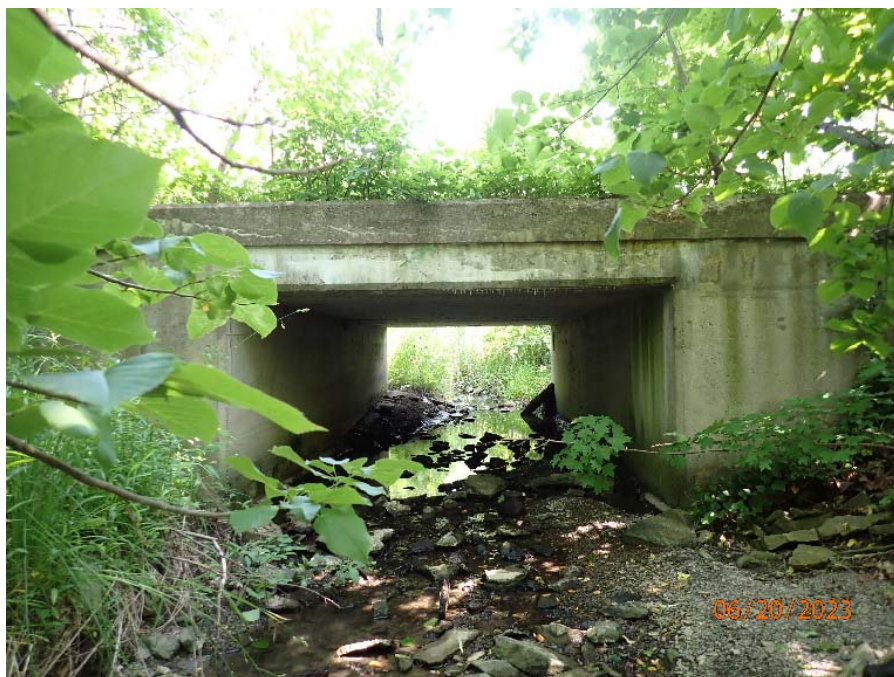
Photograph No. 2: 0895: North elevation.
