TOWN OF NIAGARA-ON-THE-LAKE

2023 MUNICIPAL BRIDGE APPRAISAL REHABILITATION/REPLACEMENT NEEDS

February 2024

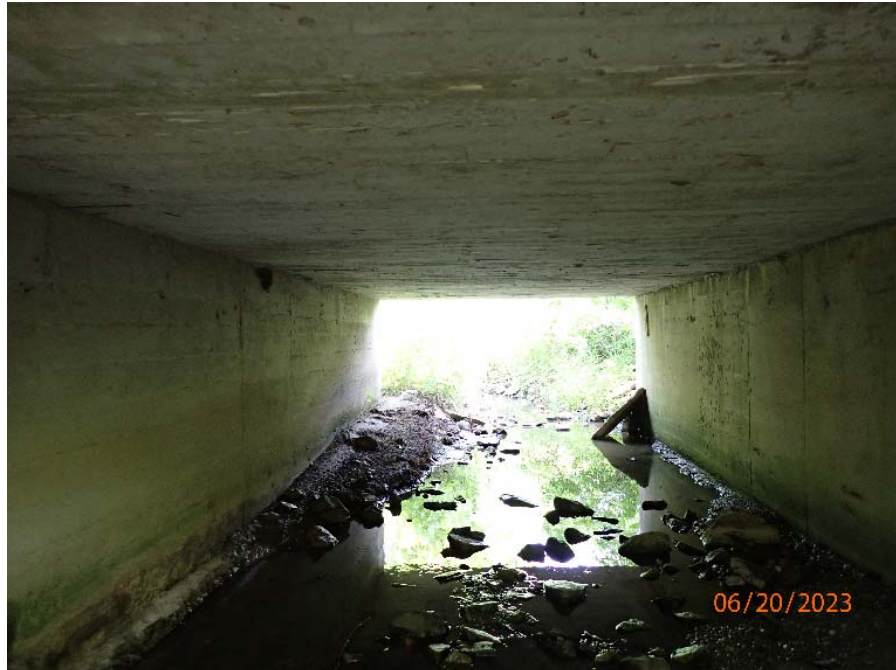
Photograph No. 3: 0894: Underside of structure looking south.

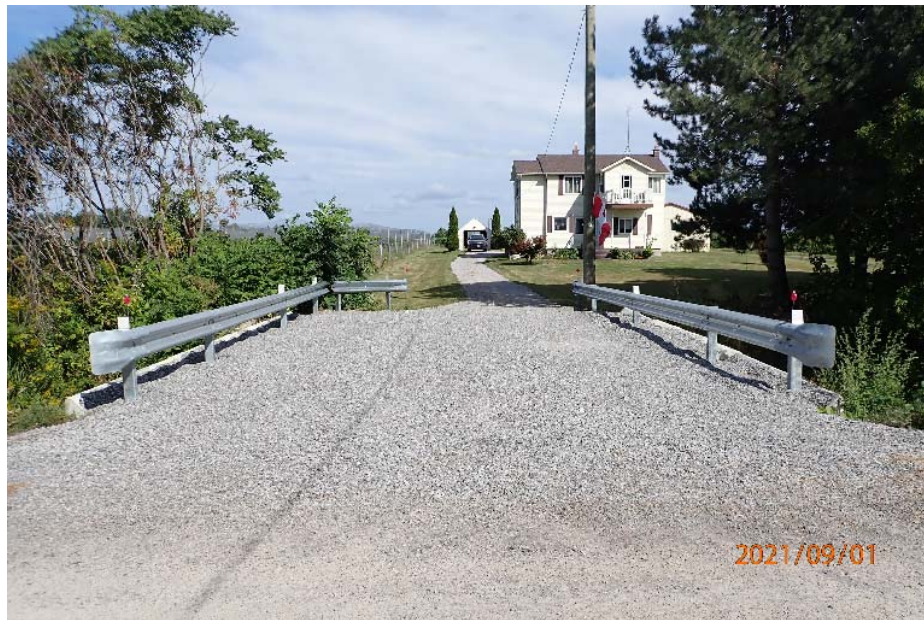
Photograph No. 1: 0710: Driveway over the structure looking east.

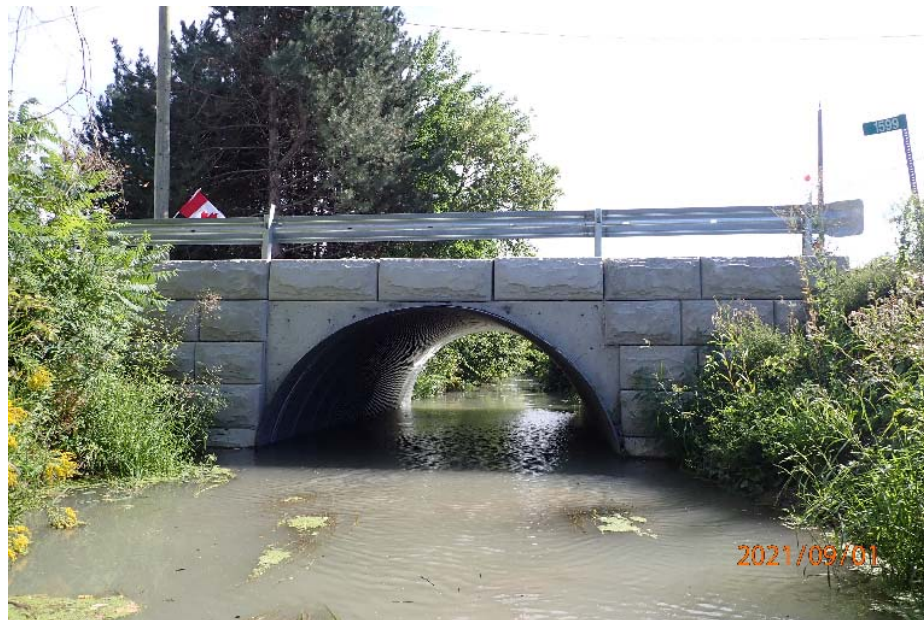
Photograph No. 2: 0735: North elevation.

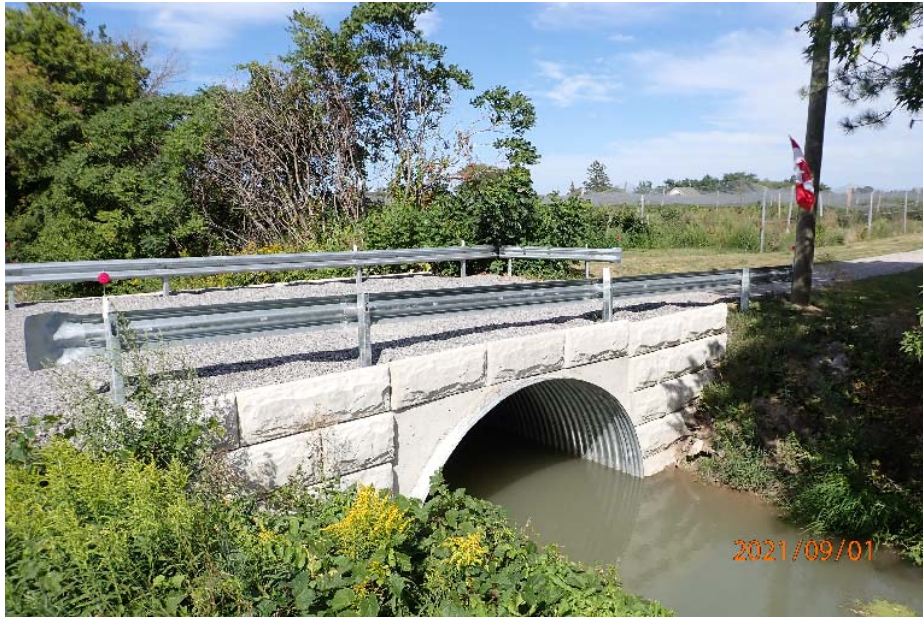
Photograph No. 3: 0709: South elevation.

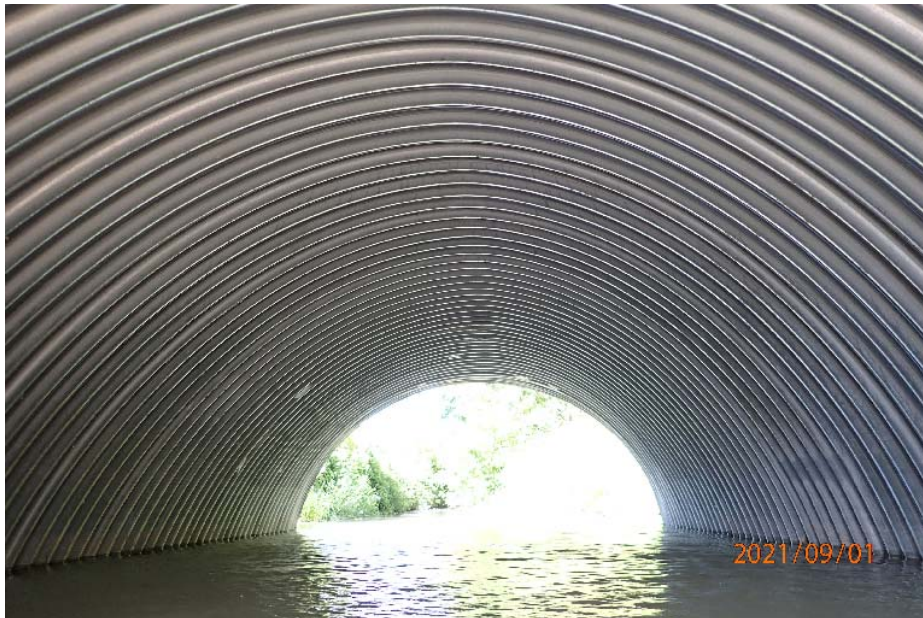
Photograph No. 4: 0726: Underside of structure looking north.

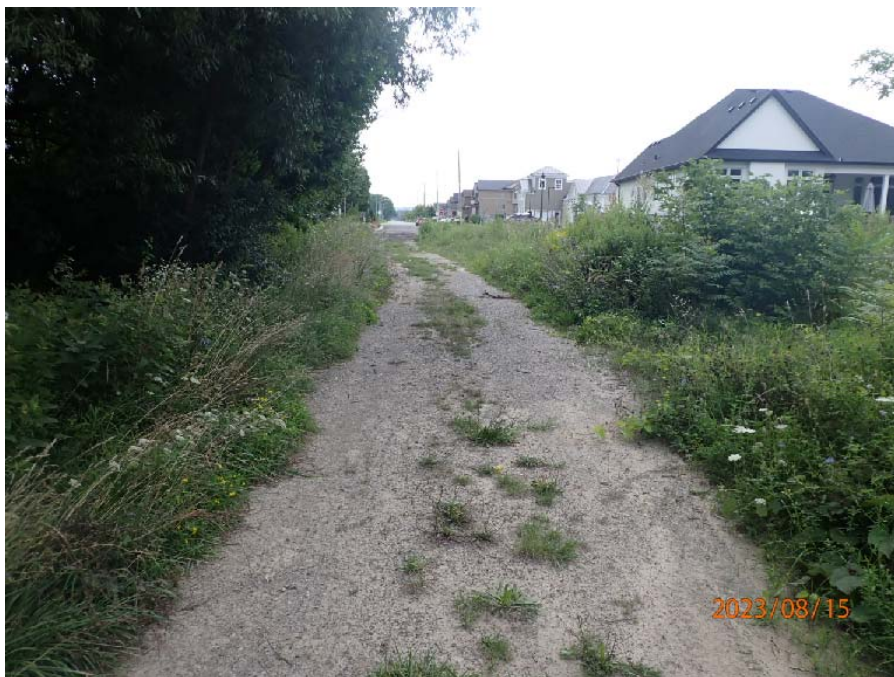
Photograph No. 1: 0017: Roadway over the structure looking east.

The surface treated roadway over the structure is in good condition with light settlement at the extents. There is no traffic protection provided over the structure or on the approaches. Delineators are provided on the south side of the roadway. The vegetated roadway embankments are in good condition. There are stone boulders at the northeast corner of the structure, providing sufficient slope protection. The exposed concrete deck top is in good condition with light scaling.

We recommend placing riprap along both footings in 1-5 Years to prevent further erosion. We also recommend that the Town review their Roadside Safety Policy NOW to determine if steel beam guiderails are required to provide traffic protection over the structure.

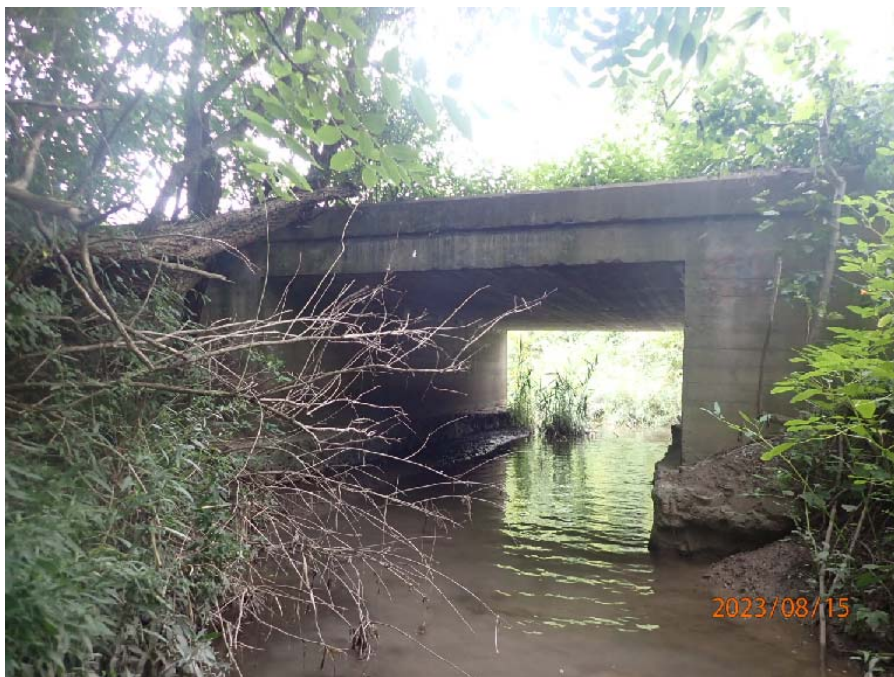
Photograph No. 3: 0032: North elevation.

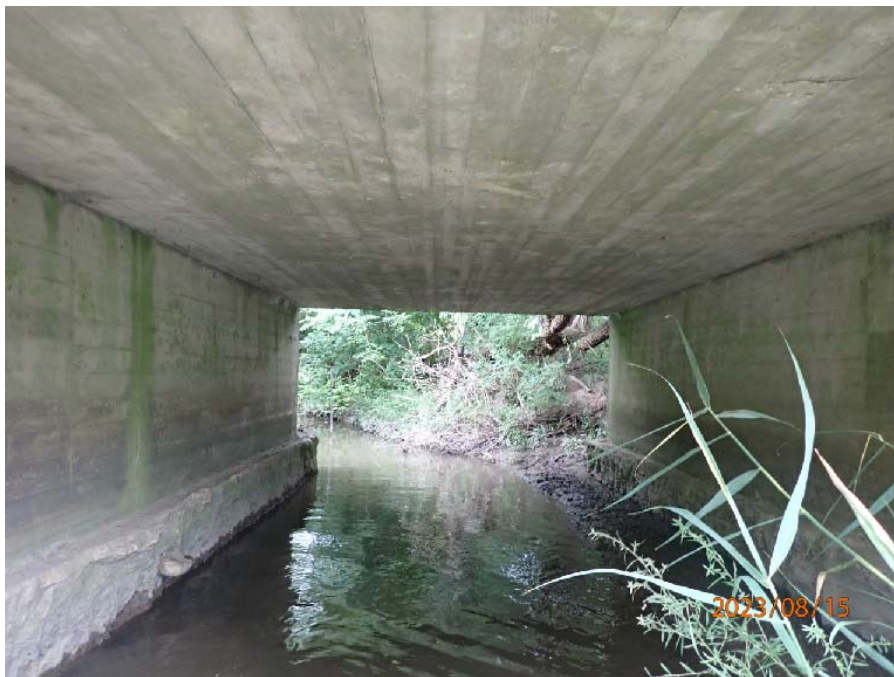
Photograph No. 4: 0073: Underside of the structure looking north.

The concrete deck soffit exhibits extensive light to medium honeycombing with minor scaling of the north fascia. The concrete abutment sidewalls are generally in good condition with isolated narrow vertical cracks. There are two vertical cracks in the east abutment with active leakage and staining. There is isolated light honeycombing in both abutment sidewalls. There is severe scour on the east abutment footing. Erosion of the streambed within the structure has resulted in exposure of approximately 0.4m to 0.6m of the east footing. The watercourse is partially obstructed by approximately 1.0m of siltation at the west abutment wall. There is a utility attached to the north fascia.

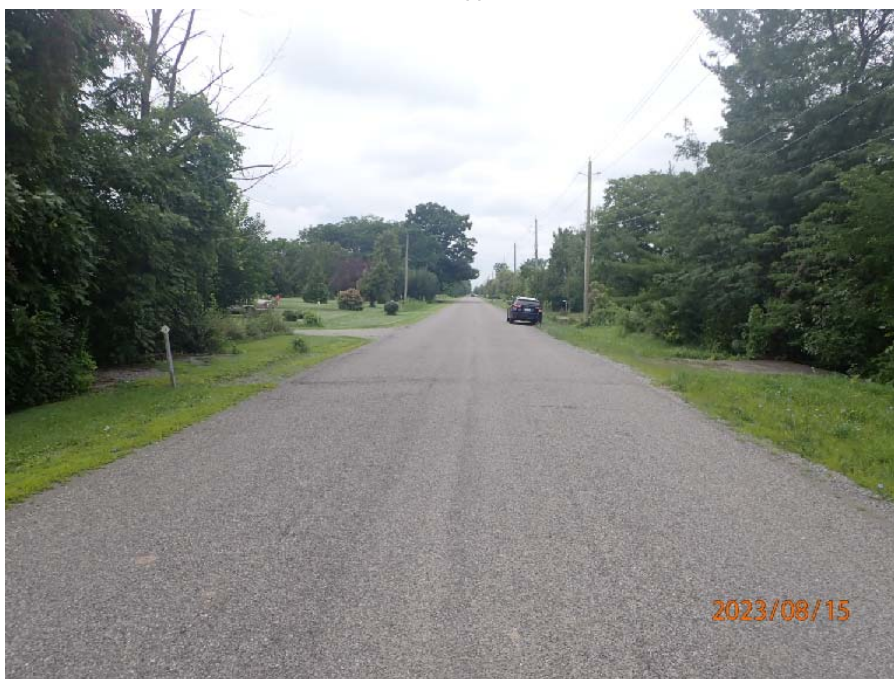
Photograph No. 1: 0345: Roadway over the structure looking west.

The surface treated roadway over the structure is generally in good condition with light to medium settlement at the extents of the structure. There are steel beam guiderails over the structure, which are in good condition. There are extruders at the northeast, southeast, and southwest corners with hazard markers, and a driveway rounding at the northwest corner. The hazard marker at the southwest corner is damaged. There is a CPP drainage pipe with a punch-through at the northwest corner of the structure, resulting in loss of fill at this location. The concrete headwalls are in fair condition with cracking, scaling, light spalling and delamination (approximately 1.5m², poor) on the north headwall.

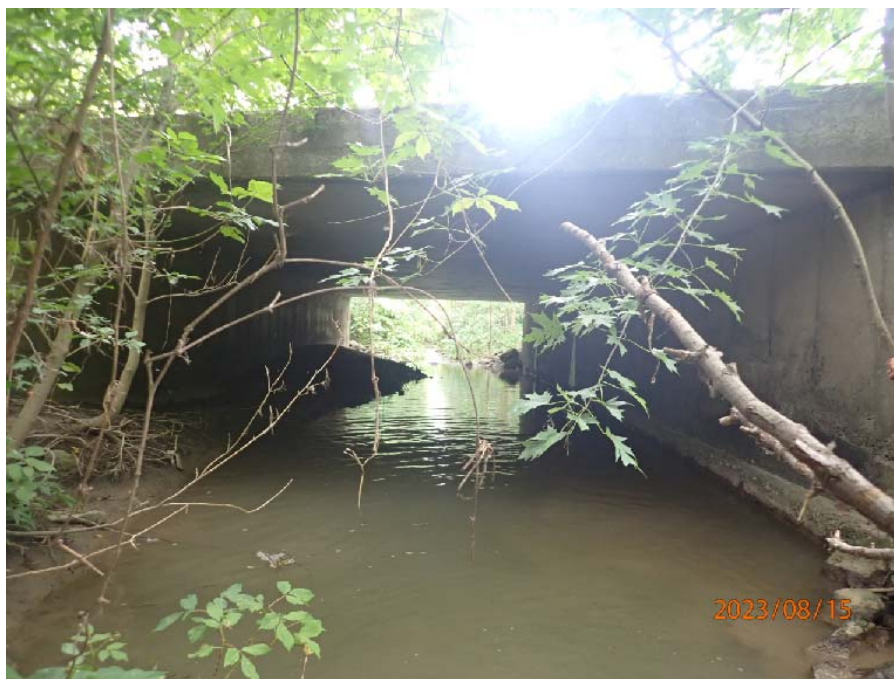
Photograph No. 2: 0409: South elevation.

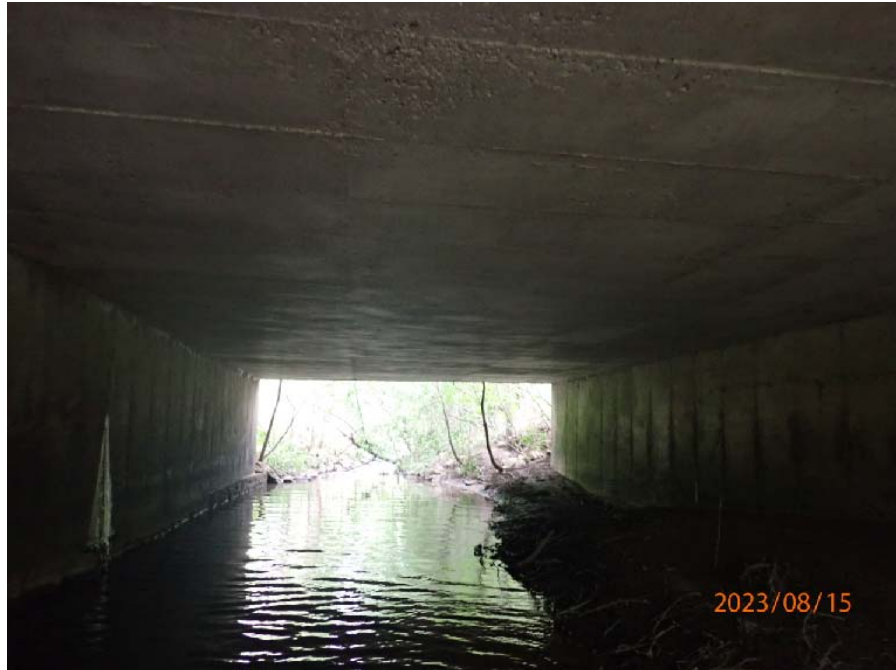
Photograph No. 3: 0368: Underside of the structure looking south

The concrete deck soffit is in fair to good condition with localized minor honeycombing and narrow to wide cracking with efflorescent staining. There are also isolated areas of severe delamination and spalling at the north and south ends of the soffit (approximately 1.5m², poor on each end). The north fascia exhibits cracking, efflorescent staining, and delamination (approximately 2m², poor). There is also cracking, delamination, leakage, and efflorescent staining of the deck soffit and fascia at this location. The concrete abutments are generally in fair condition with localized vertical wide cracking and efflorescent staining. There is a bulge in the west abutment sidewall; however, it may have been constructed this way. Severe scour of the abutment footings has caused minor undermining in the northwest corner. Erosion within the structure has exposed the footings by a maximum of 0.5m.

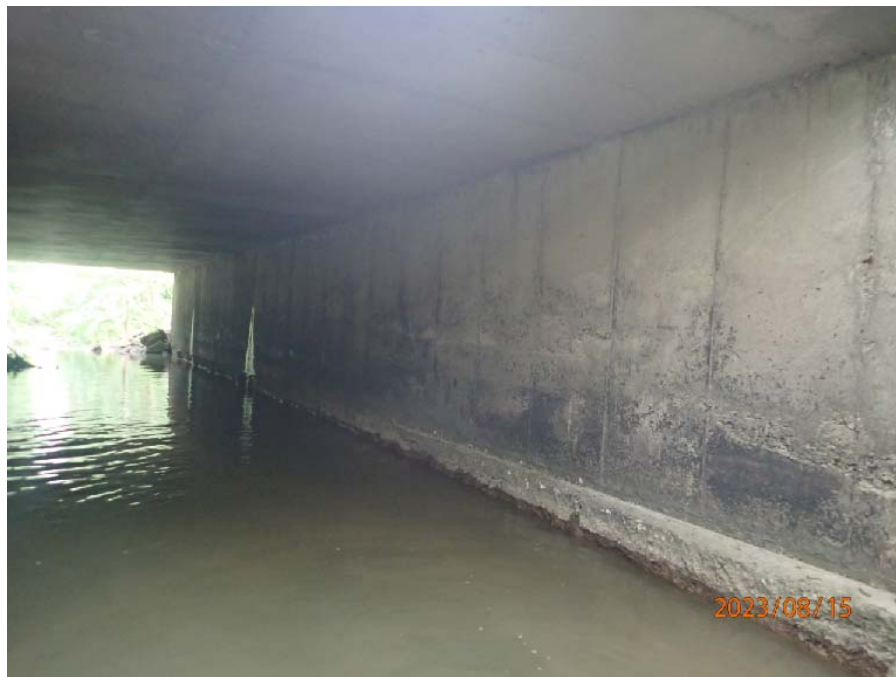
Photograph No. 4: 0407: East abutment sidewall and scour along east footing.

We recommend scheduling the structure for replacement in 6-10 Years.

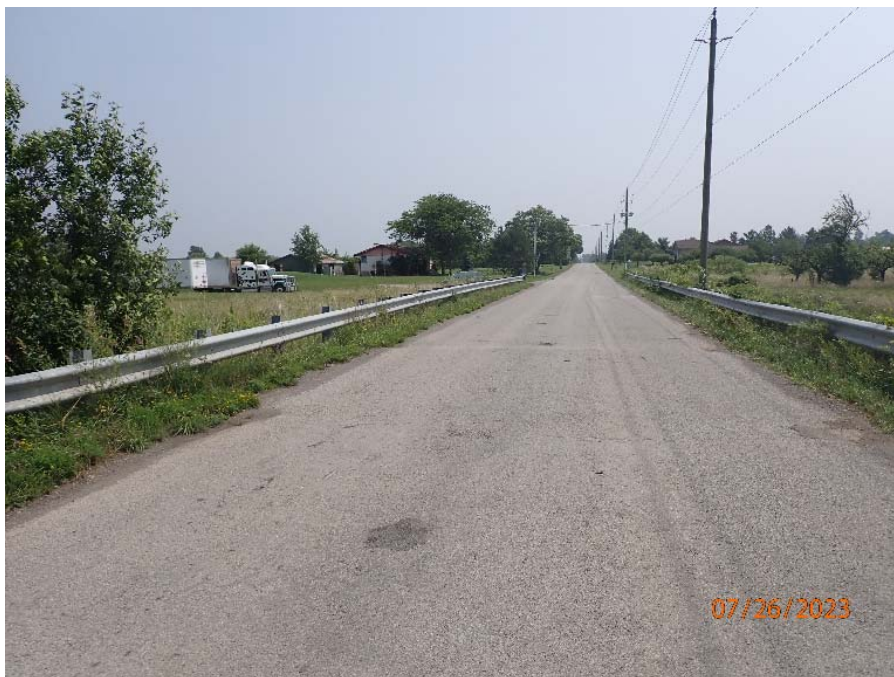
Photograph No. 1: 0379: Roadway over the structure looking east.

The surface treated roadway over the structure is generally in fair condition with light settlement at the extents of the structure and deterioration along the edges of the roadway. No traffic protection is provided over the structure or on the approaches. There are no hazard markers. The vegetated roadway embankments are generally in good condition with medium to severe erosion at all four corners of the structure. The bridge has been widened to the north and to the south at some time in the past. The exposed portions of the bridge deck top are in good condition with light scaling.

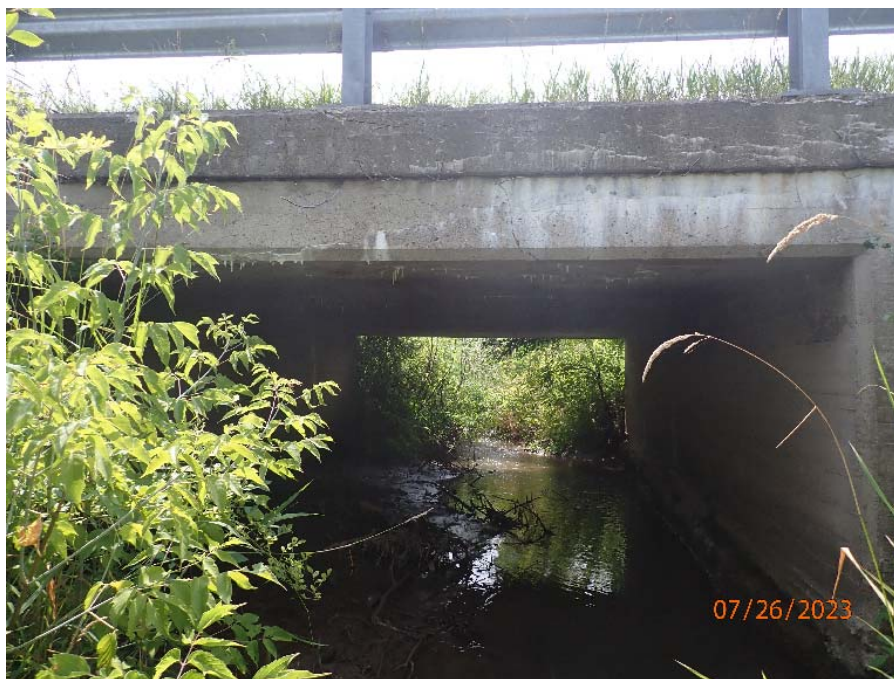
Photograph No. 2: 0390: North elevation.

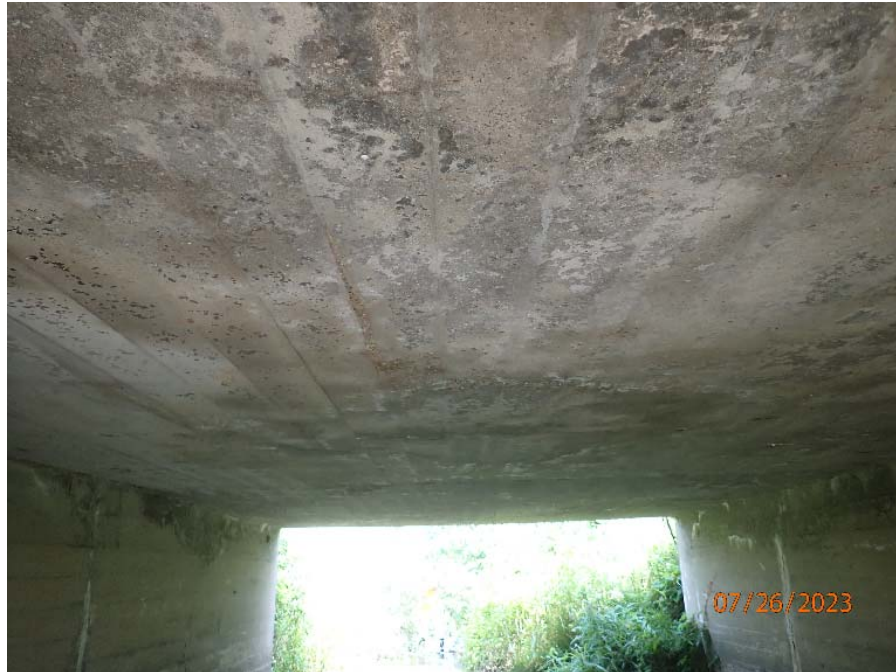
Photograph No. 3: 0421: Underside of the structure looking north.

The concrete deck soffit of the original structure is generally in fair to good condition. There is an area of severe spalling with exposed corroded reinforcing steel, and medium to severe delaminations at both the north and south ends of the original soffit (approximately 1.0m² poor (north), and 1.5m² poor (south)). The concrete abutment sidewalls of the original structure are generally in good condition. There are wide vertical cracks and spalling between the original and widened portions of the structure with evidence of leakage and efflorescent staining at these locations. There are 300mm CSP culverts draining through the newer portions of the abutment sidewalls at all four corners in fair to poor condition with perforations, efflorescent staining and active leakage onto the abutment sidewalls. The concrete deck soffit and abutment sidewalls of the widened portions of the structure are generally in good condition. The footings are exposed by approximately 0.2m to 0.6m. The watercourse is unobstructed with minor erosion within the structure.

We recommend placing riprap along the footings in 1-5 Years to prevent further erosion.

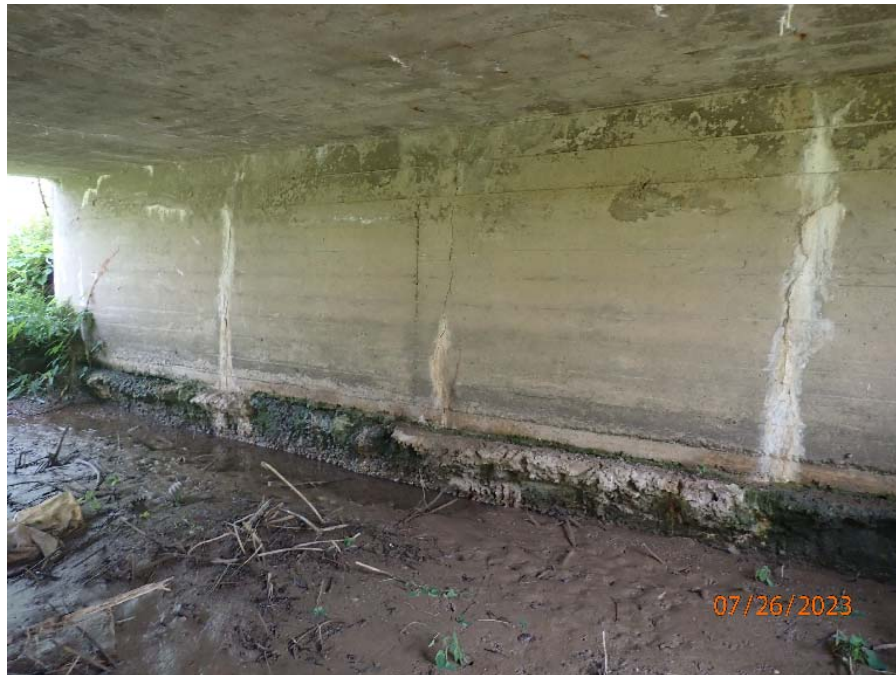
Photograph No. 4: 0416: Wide vertical cracks and efflorescent staining in abutment sidewall.

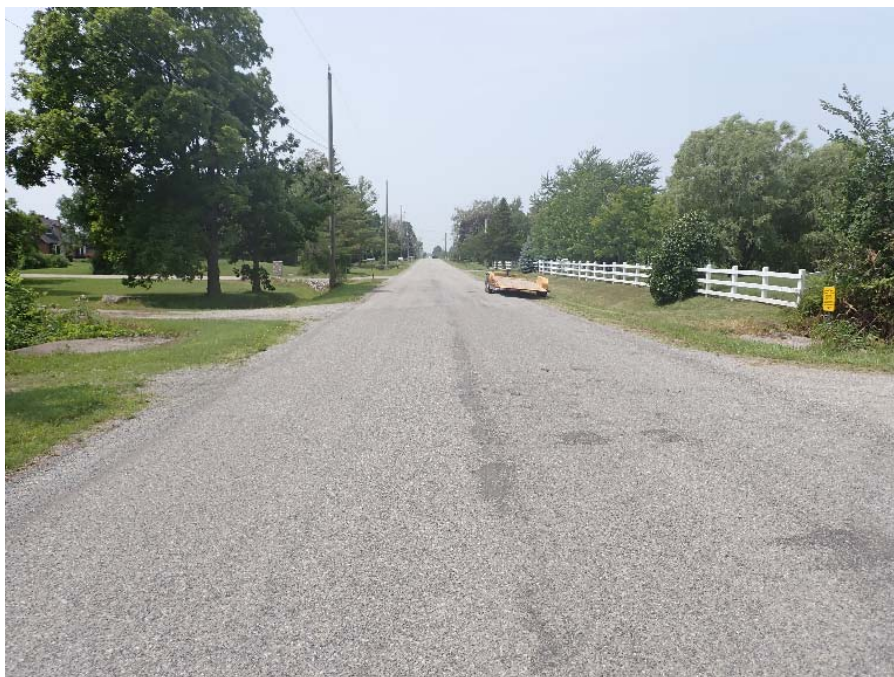
Photograph No. 1: 0433: Roadway over the structure looking west.

The surface treated roadway over the structure and the asphalt approach roadways are in good condition with approximately 50mm of settlement at the extents of the structure. There is no traffic protection provided over the structure or on the approaches. There are hazard markers at all four corners. The vegetated roadway embankments are in generally good condition with light erosion at the northwest and northeast corners. The concrete curbs and headwalls are generally in good condition with light disintegration (approximately 0.1m², poor).

We recommend placing riprap along the footings NOW to prevent further erosion. We also recommend that the Town review their Roadside Safety Policy NOW to determine if steel beam guiderails are required to provide traffic protection over the structure.

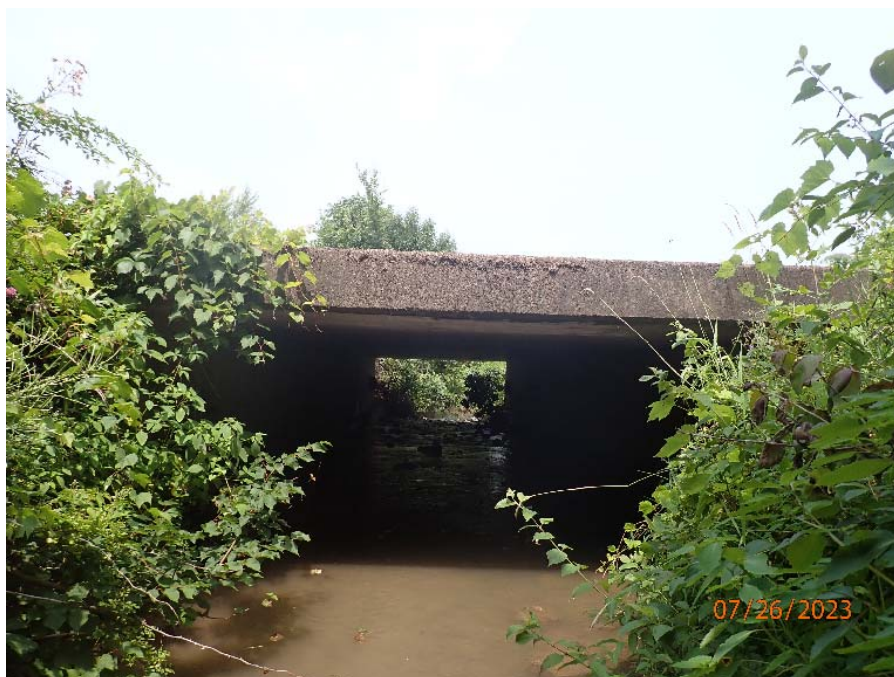
Photograph No. 2: 0523: South elevation.

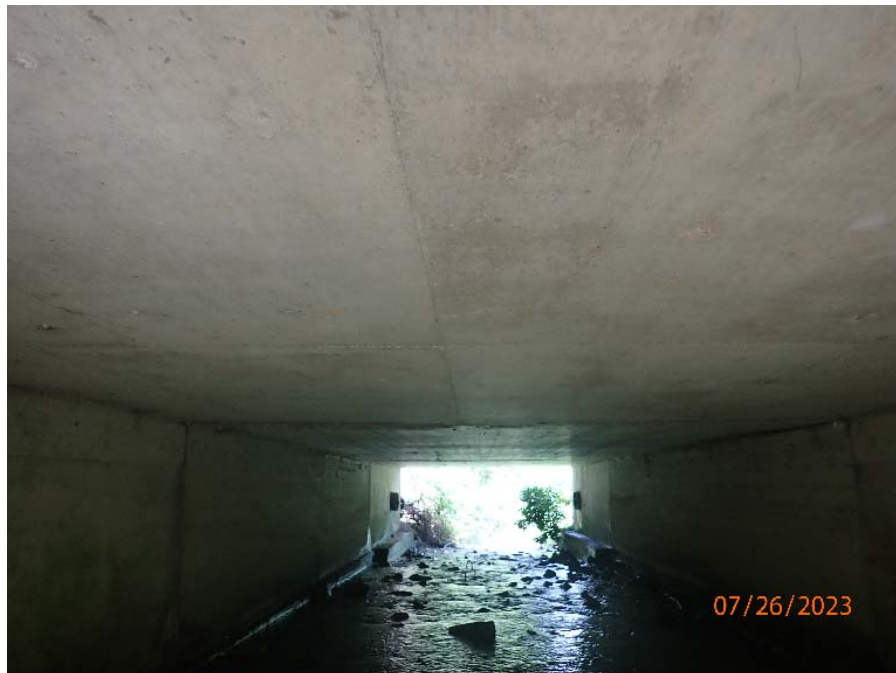
Photograph No. 3: 0518: Underside of the structure looking north.

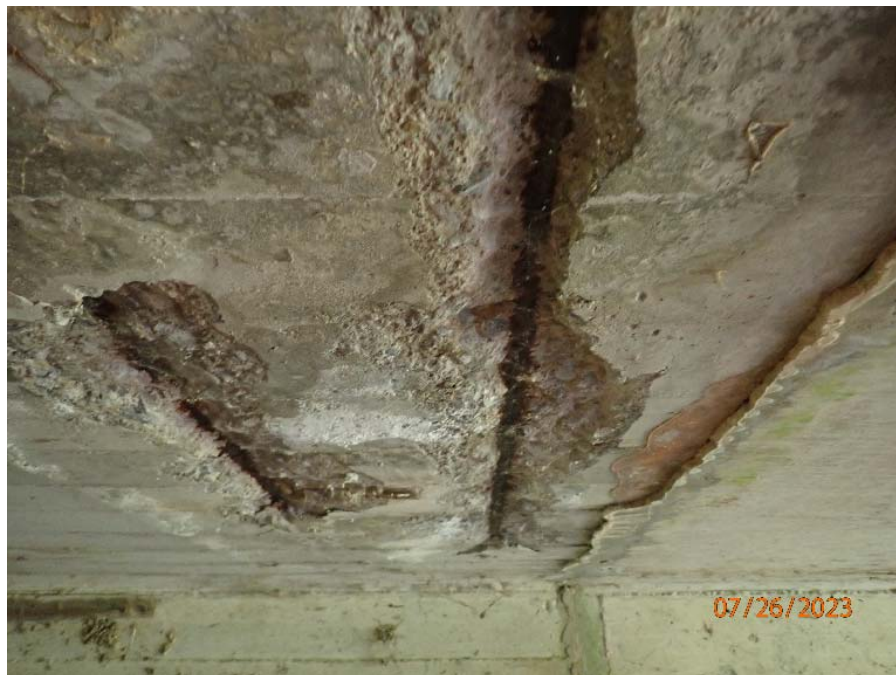
Photograph No. 4: 0487: Severe spall at south end of original portion of the soffit.

The concrete deck soffit is generally in good condition. There is an area of severe spalling, exposed corroded reinforcing steel, and light delamination and the north end of the structure (0.5m² poor). The concrete abutment sidewalls are generally in good condition with localized narrow to wide vertical cracks with efflorescent staining. There is active leakage through the crack in the west abutment sidewall. The concrete footings are severely scoured, the west footing is exposed by approximately 0.6m, and the east footing is exposed by approximately 1m. The concrete wingwalls are in good condition.

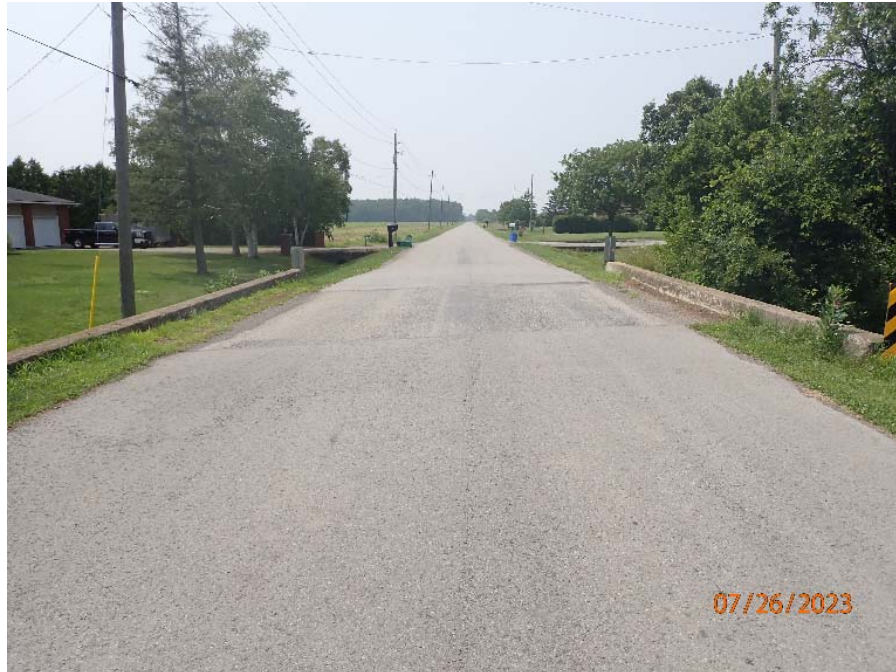
Photograph No. 1: 0530: Roadway over the structure looking west.

The surface treated roadway over the structure is in good condition with asphalt paving on the approaches. There is no traffic protection provided over the structure or on the approaches. There are hazard markers at all four corners. The vegetated roadway embankments are in good condition. The bridge was widened by approximately 1.5m to the north and to the south. The newer concrete curbs and headwalls are in good condition. The original concrete curbs and headwalls have been removed. The exposed portions of the concrete bridge deck top are in good condition.

We recommend placing riprap along the footings in 1-5 Years to prevent further erosion. We also recommend that the Town review their Roadside Safety Policy NOW to determine if steel beam guiderails are required to provide traffic protection over the structure.

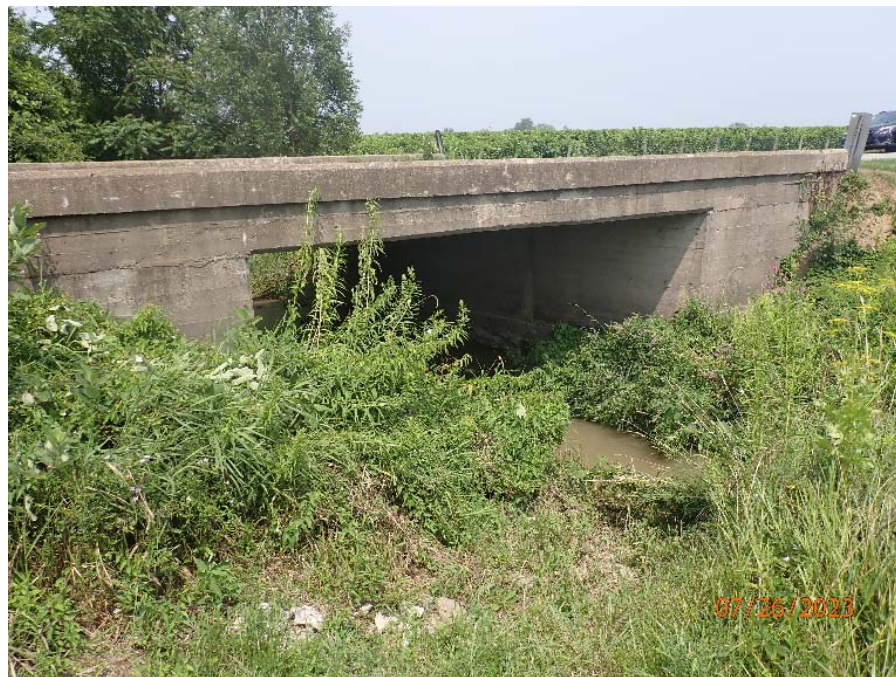
Photograph No. 2: 0538: South elevation.

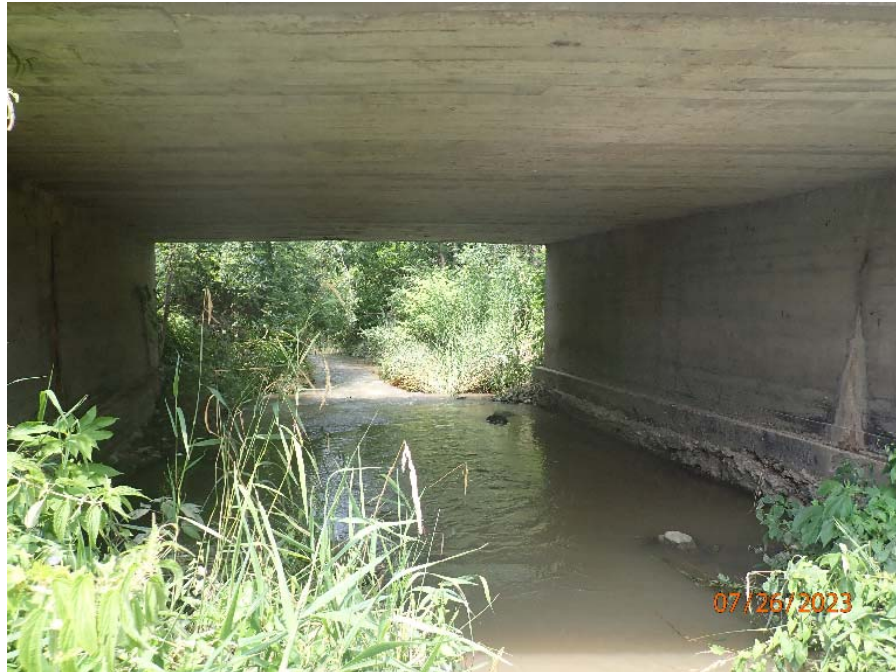
Photograph No. 3: 0541: Underside of the structure looking north.

The widened portions of the concrete deck soffit, abutments, and wingwalls are in good condition. The original portion of the concrete deck soffit is generally in good condition with medium to severe spalls, exposed corroded reinforcing steel, and light to medium delaminations, especially at the ends and centre of the original portion. The original concrete abutments are in good condition with light scaling above the waterline and narrow vertical cracks with evidence of leakage at the interface between the original and new portions of the abutment sidewalls. There is medium scour along the footings, which are exposed by approximately 0.3m.

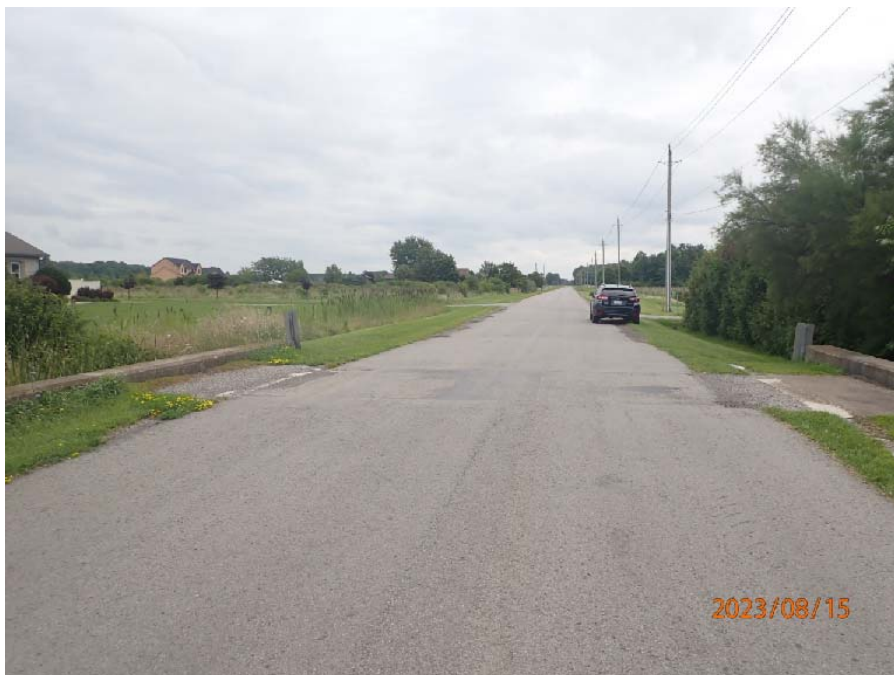
Photograph No. 1: 0425: Roadway over the structure looking east.

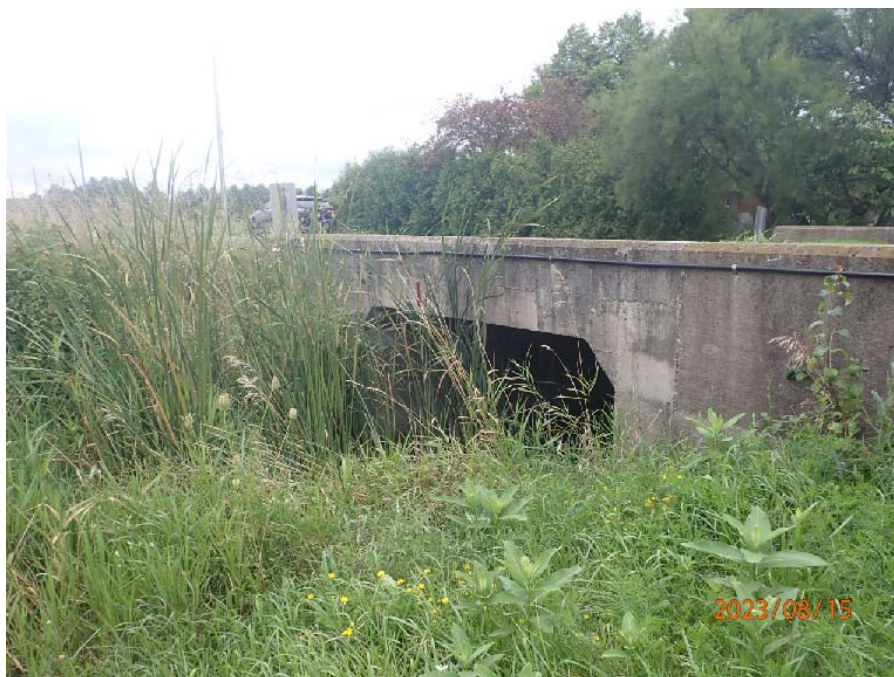
Photograph No. 2: 0430: North elevation.

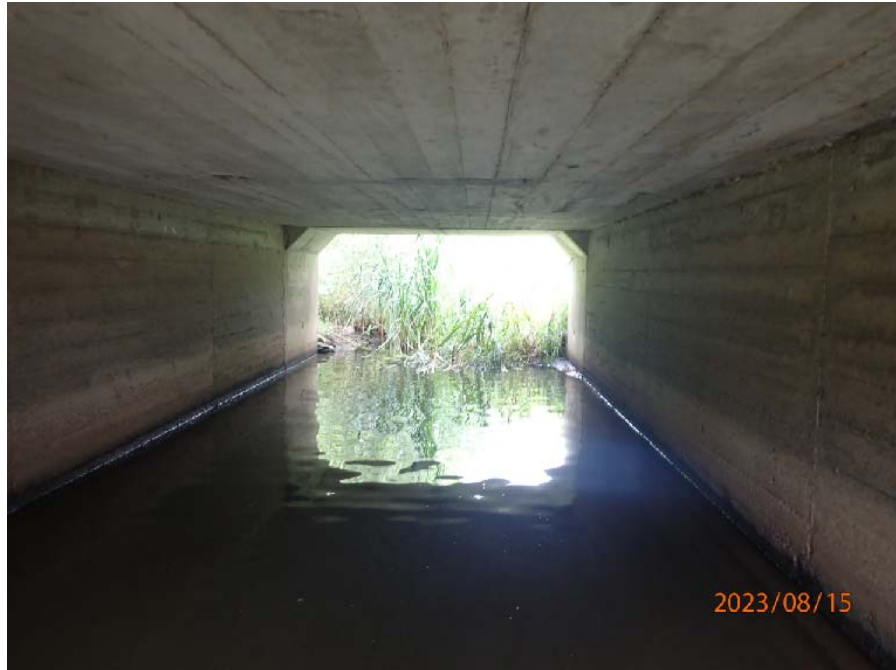
Photograph No. 3: 0442: Interior of structure looking south.

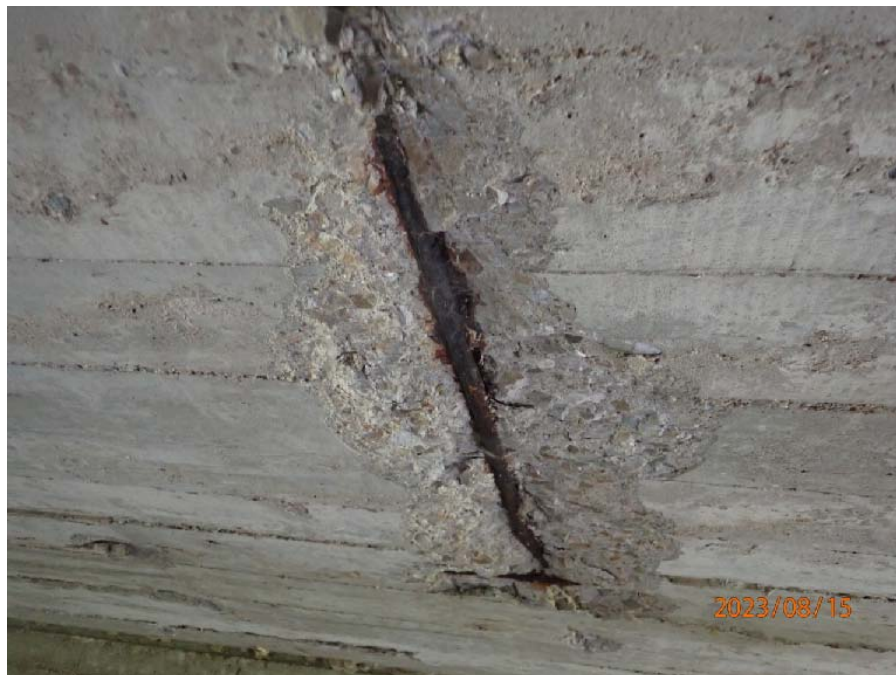
Photograph No. 4: 0449: Spall with exposed corroded reinforcing steel at the centre-span of the soffit.

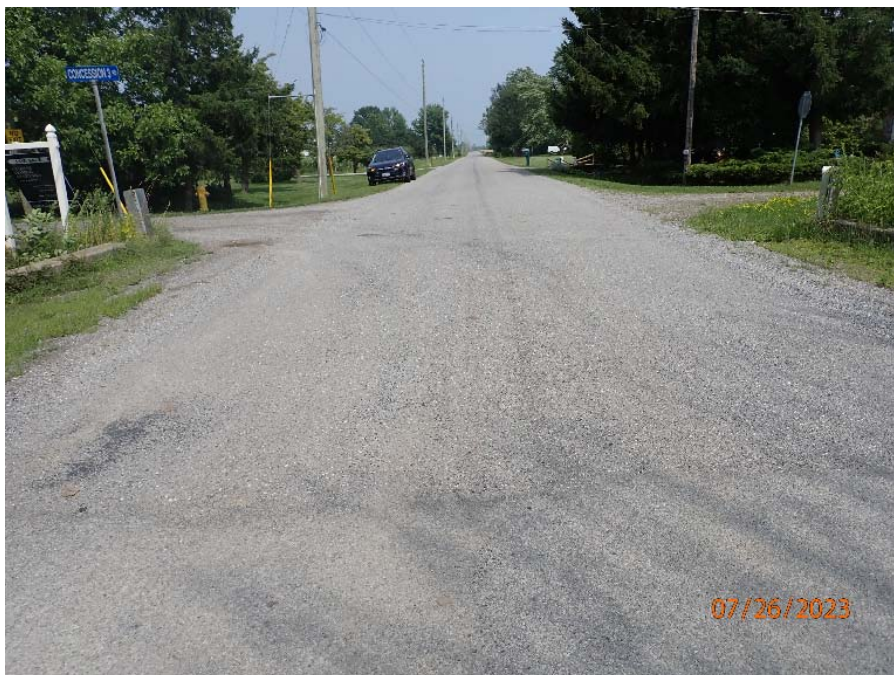
Photograph No. 1: 0708: Roadway over the structure looking east.

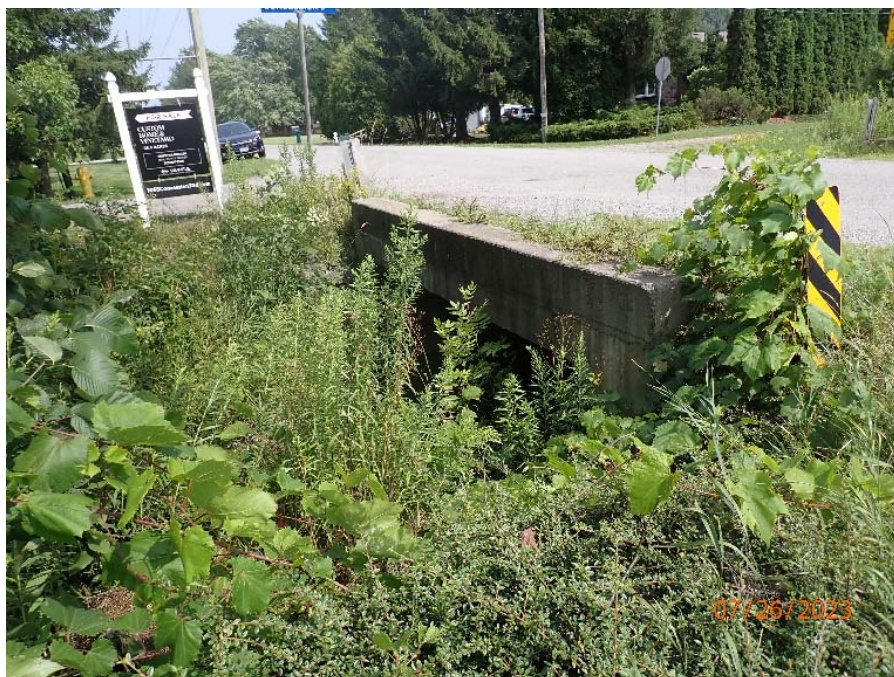
Photograph No. 2: 0754: North elevation.

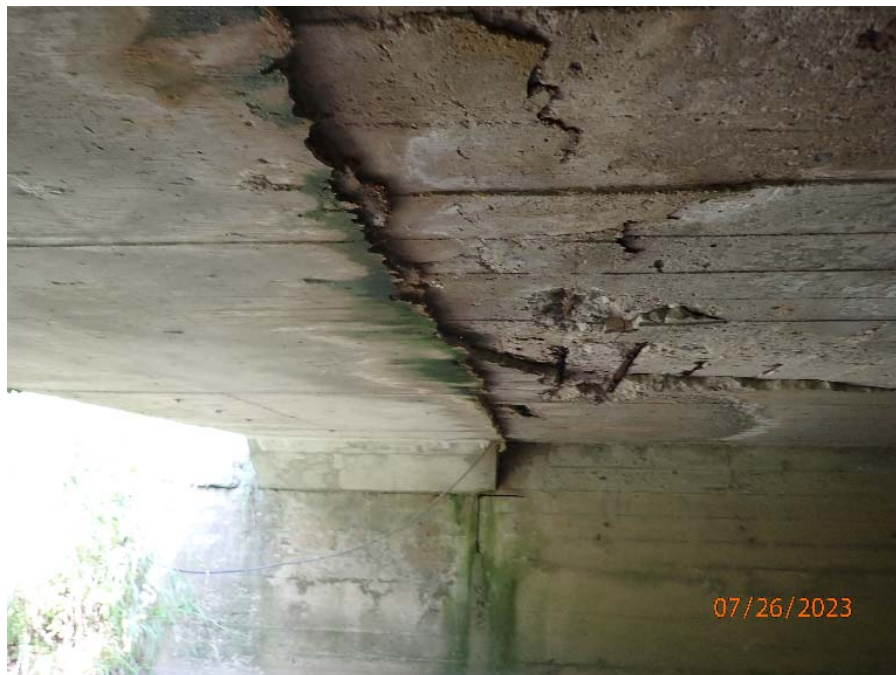
Photograph No. 4: 0723: Area of severe spalling, delamination, and exposed reinforcing steel at the north end of the original soffit.

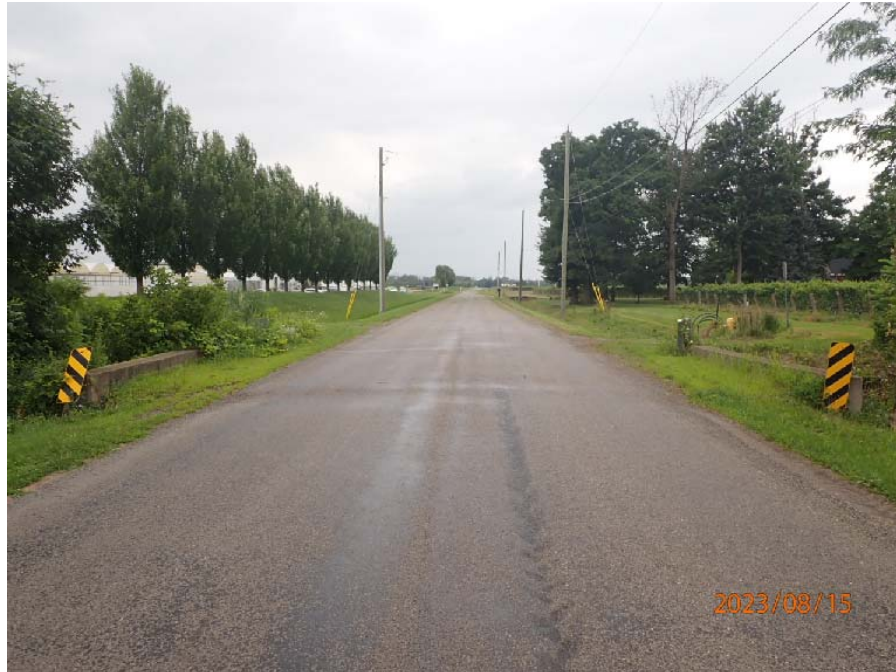
Photograph No. 1: 0658: Roadway over the structure looking west.

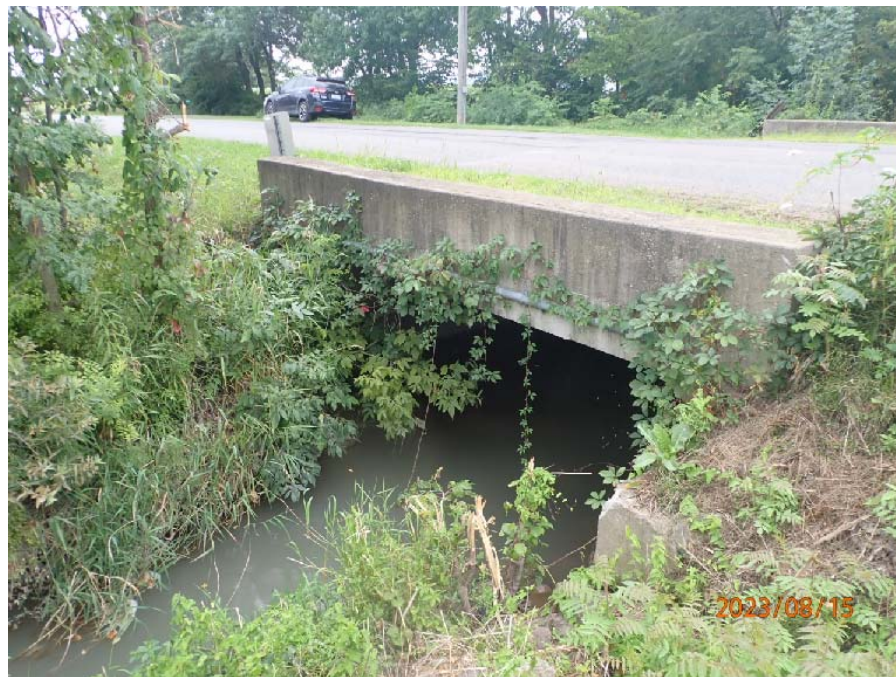
Photograph No. 2: 0603: North elevation.

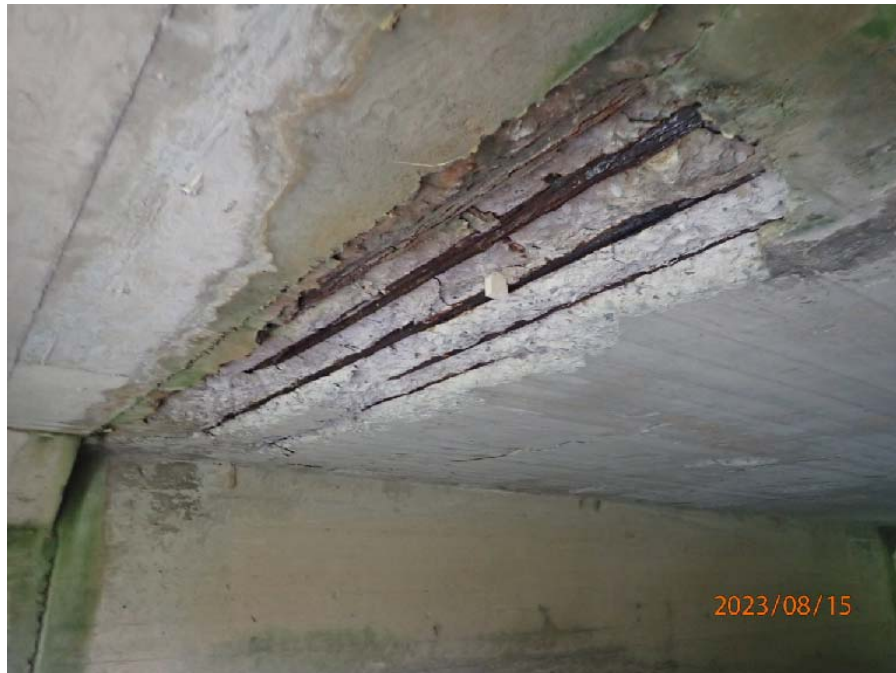
Photograph No. 4: 0618: Severe spall in the original deck soffit at the north construction joint.
