TOWN OF NIAGARA-ON-THE-LAKE

2023 MUNICIPAL BRIDGE APPRAISAL REHABILITATION/REPLACEMENT NEEDS

February 2024

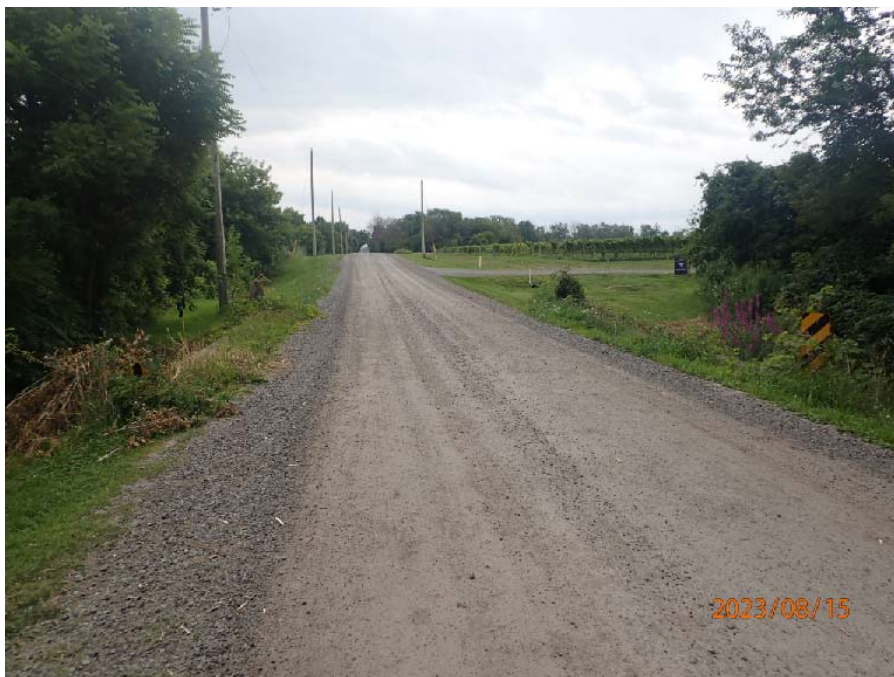
Photograph No. 1: 0722: Roadway over the structure looking east.

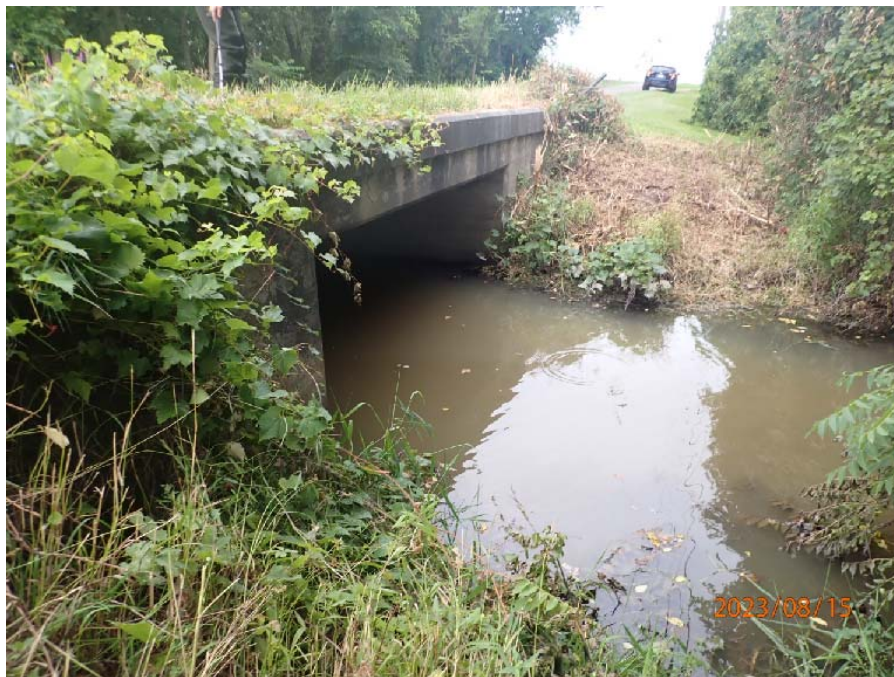
Photograph No. 2: 0748: North elevation.

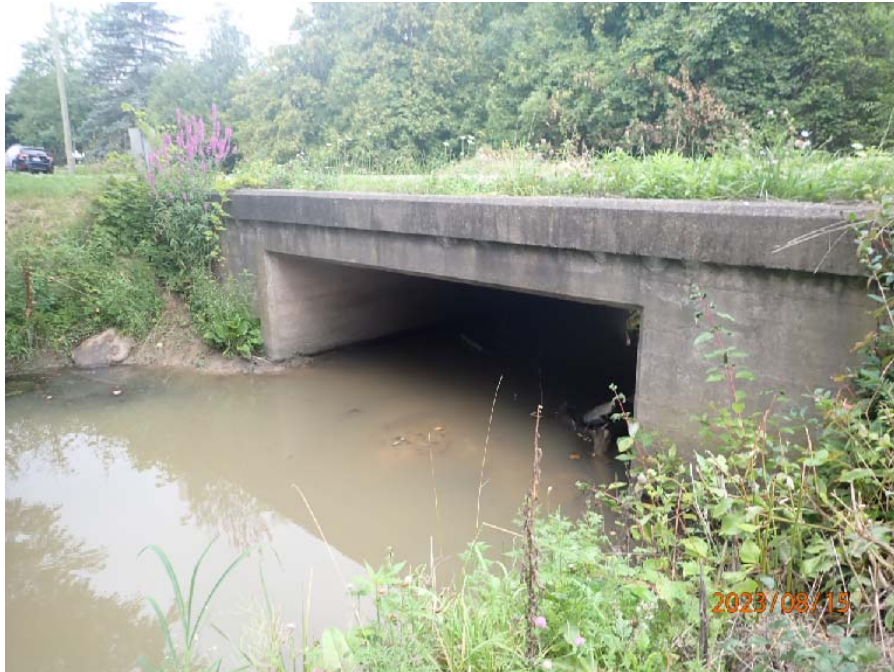
Photograph No. 3: 0725: South elevation.

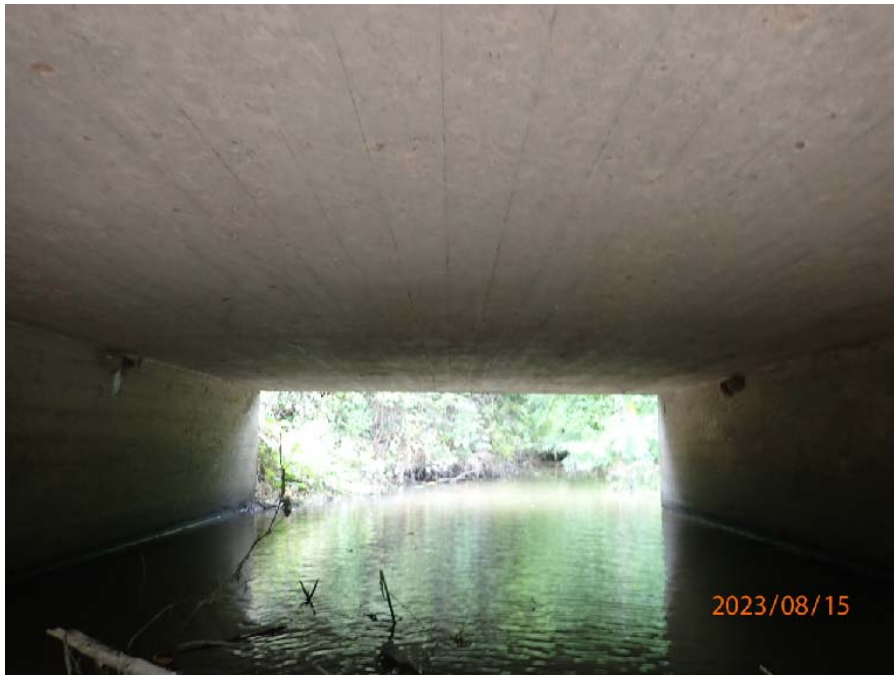
Photograph No. 4: 0742: Interior looking north.

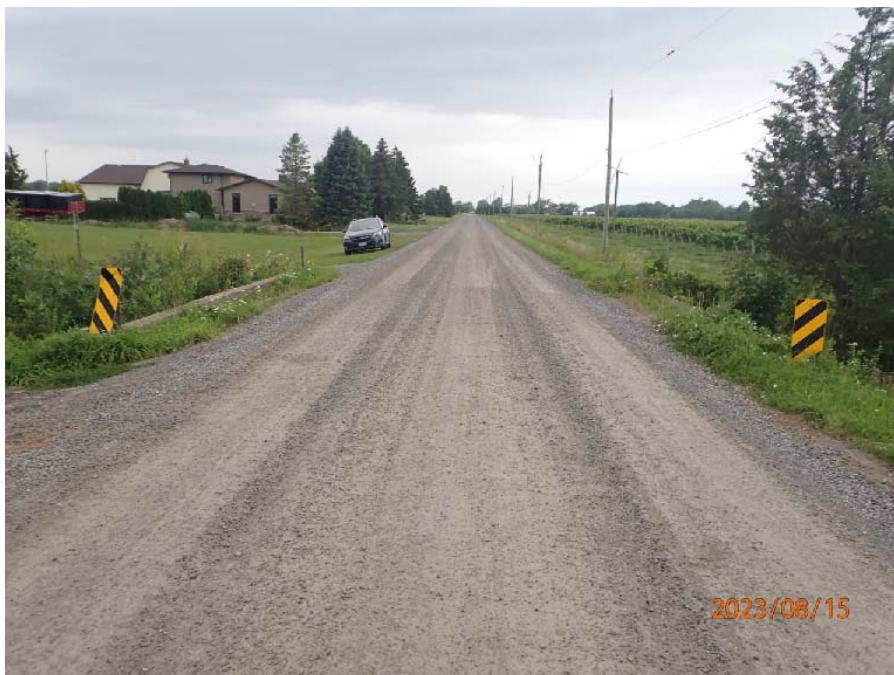
Photograph No. 1: 0811: Roadway over the structure looking west.

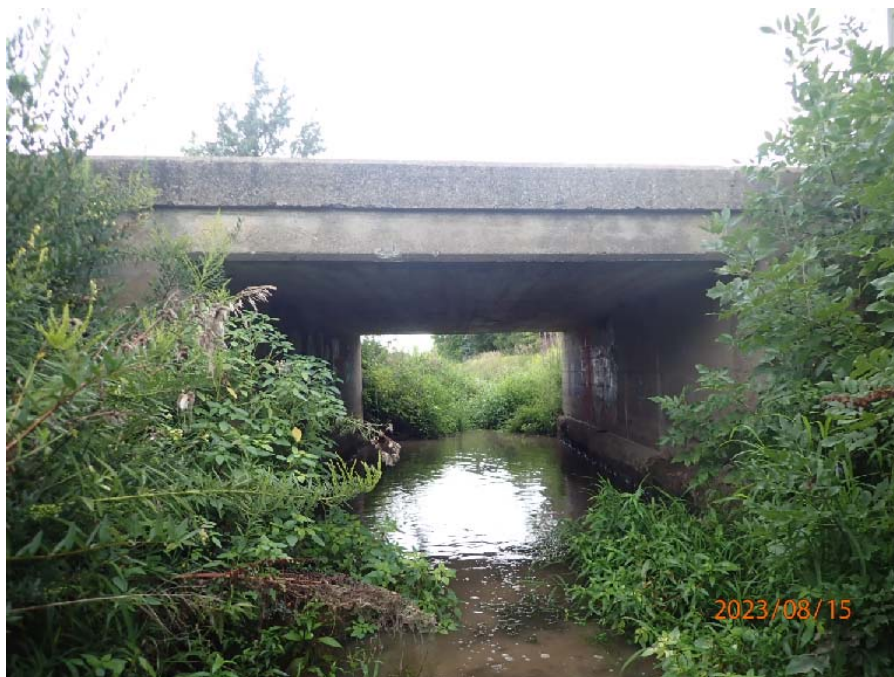
Photograph No. 2: 0862: South elevation.

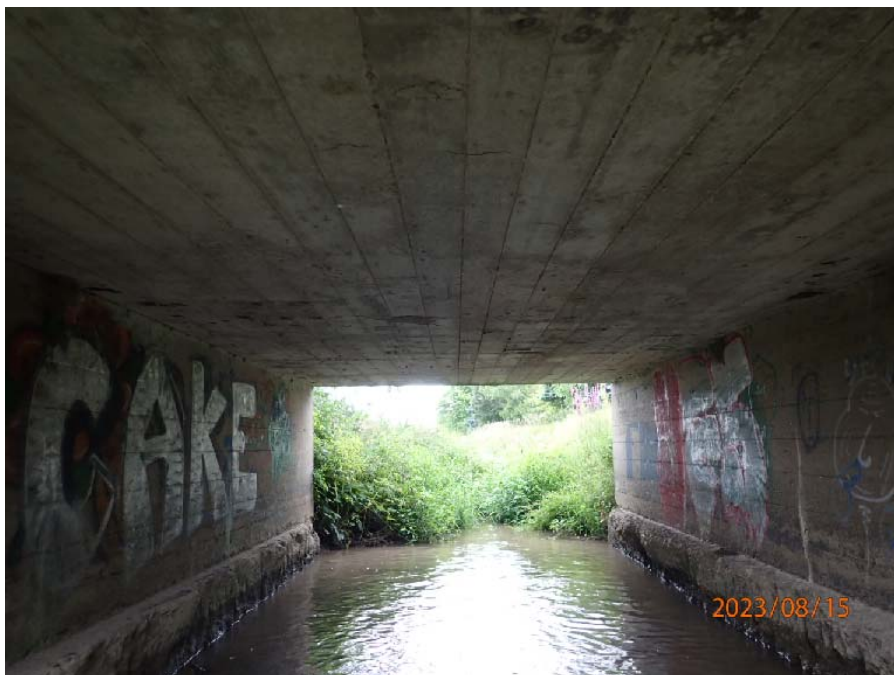
Photograph No. 3: 0858: Underside of the structure looking north.

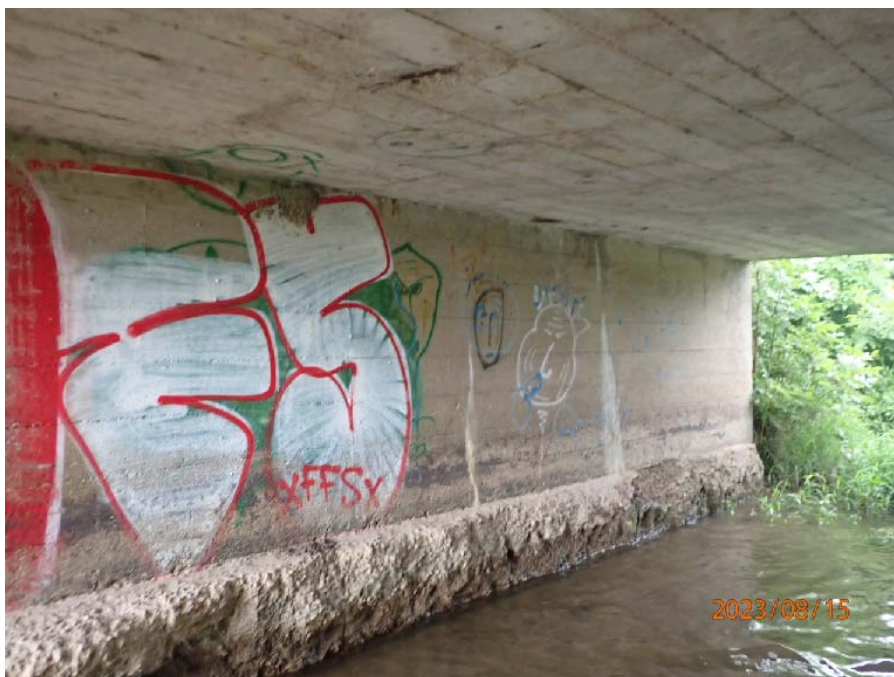
Photograph No. 4: 0839: East abutment sidewall and footing.

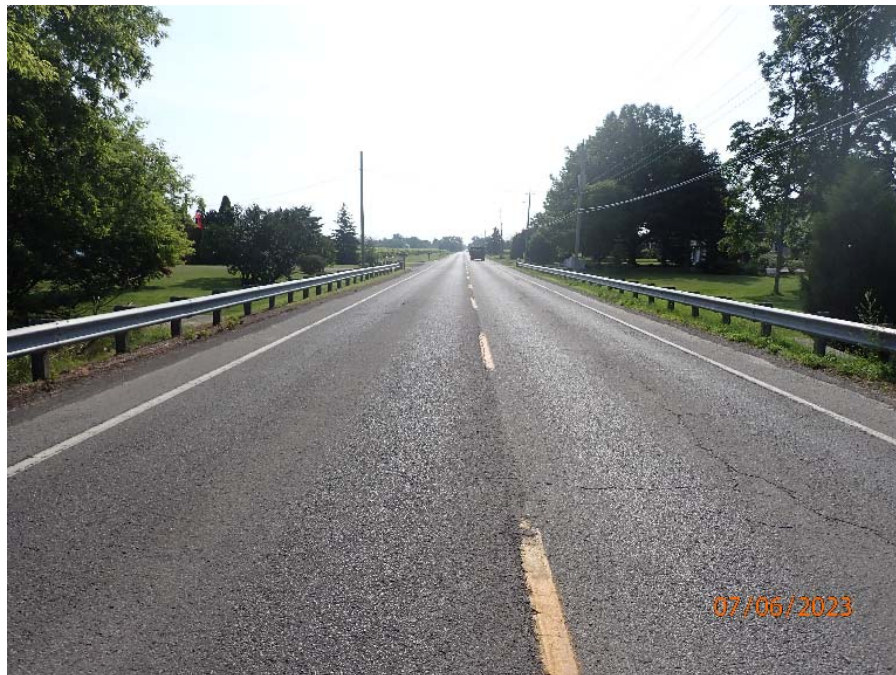
Photograph No. 1: 0096: Roadway over the structure looking east.

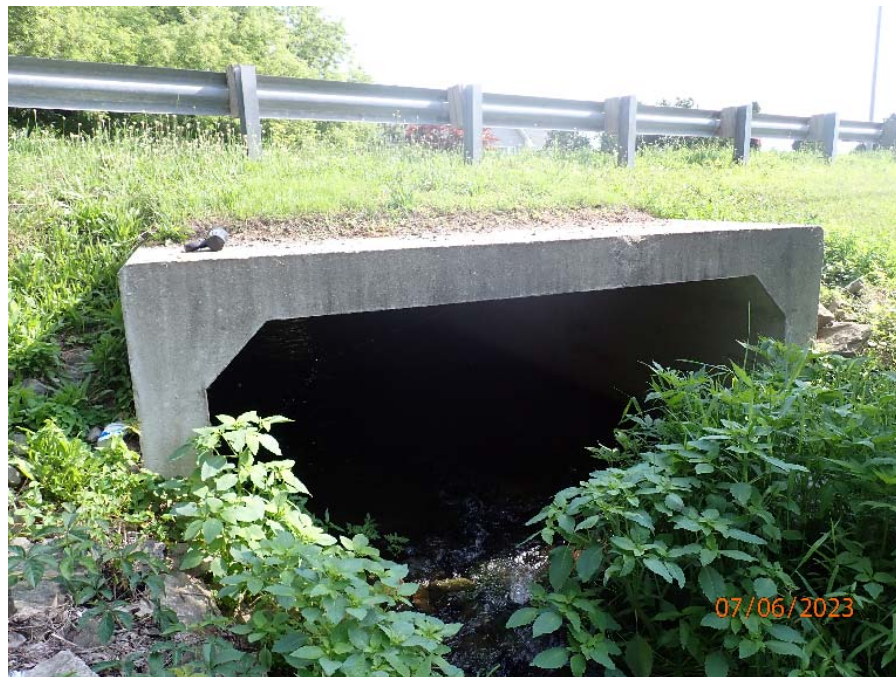
Photograph No. 2: 0170: South elevation.

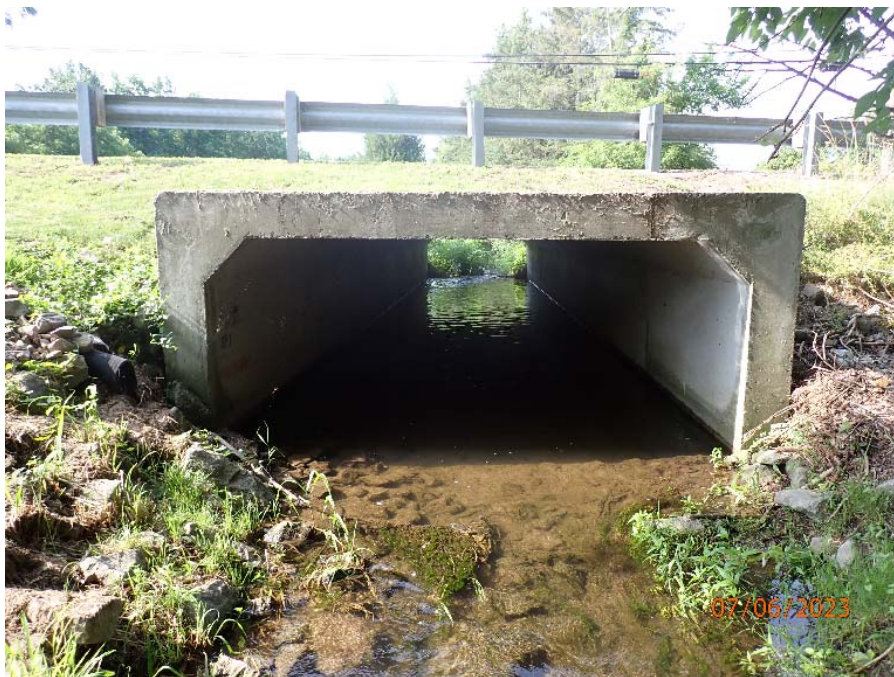
Photograph No. 3: 0140: North elevation.

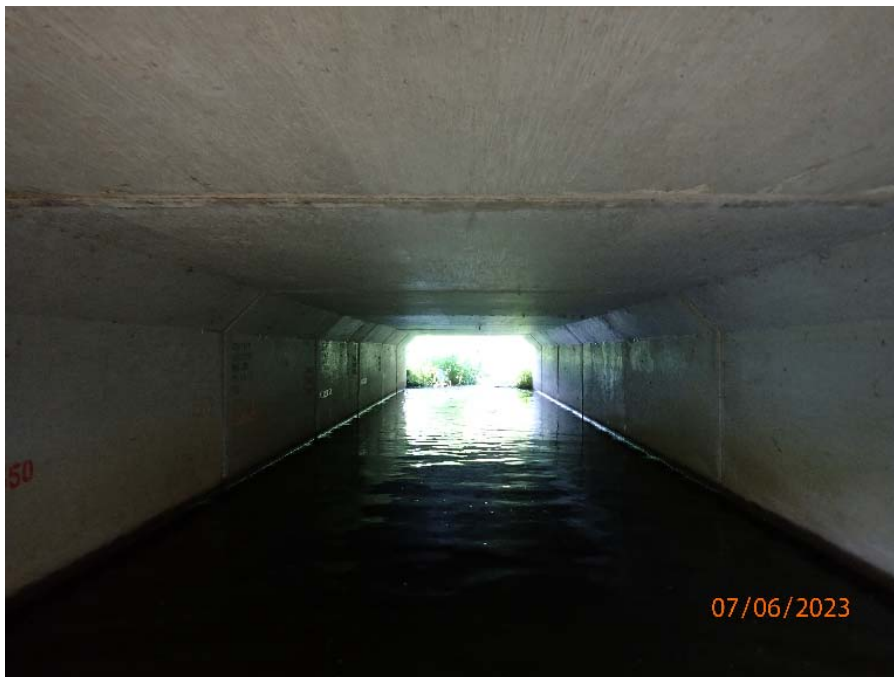
Photograph No. 4: 0143: Underside of the structure looking south.

The concrete deck soffit is in good condition with isolated areas of narrow cracking and light delamination on the original portions of the structure. The widened portions of the deck soffit and the deck overhangs are in good condition. The galvanized steel deck drains are in good condition. The concrete abutments and wingwalls are in good condition. There is evidence of leakage on the northwest and northeast wingwall. The vegetated roadway embankments are in good condition. There is a utility on the south fascia of the structure.

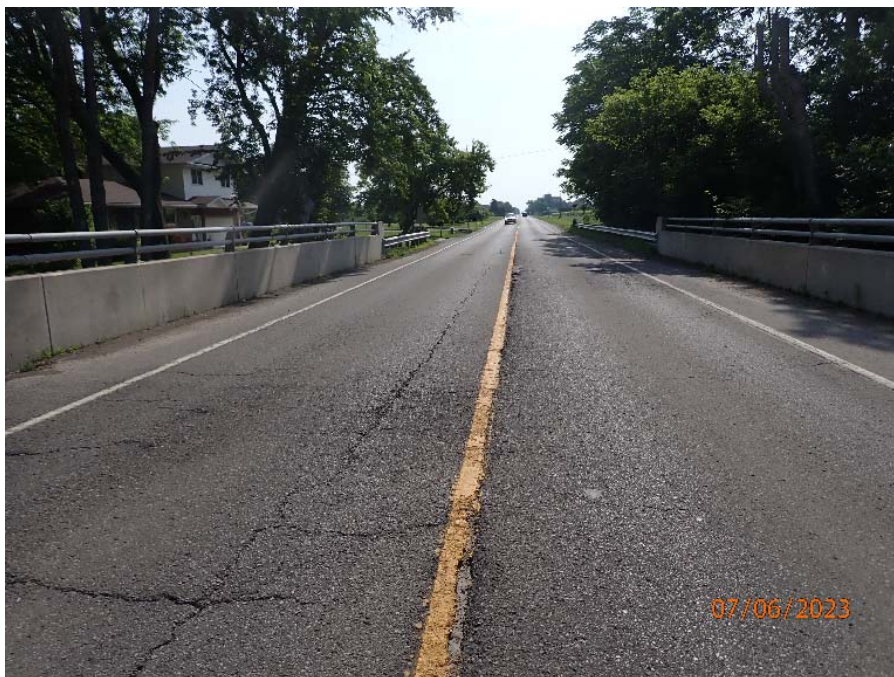
Photograph No. 1: 0197: Roadway over the structure looking east.

The surface treated roadway over the structure is in good condition. There is no traffic protection provided over the structure or on the approaches. The vegetated roadway embankments are generally in good condition.

We recommend placing riprap along the upstream and downstream ends of the culverts in 1-5 Years to mitigate the erosion at these locations. We also recommend that the Town review their Roadside Safety Policy NOW to determine if steel beam guiderails are required to provide traffic protection over the structure.

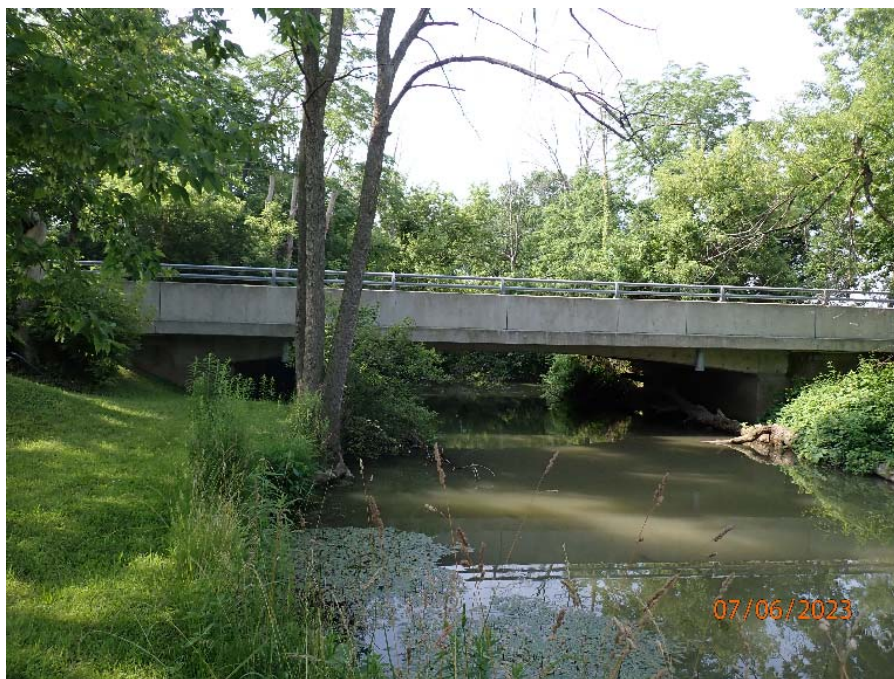
Photograph No. 2: 0248: North elevation.

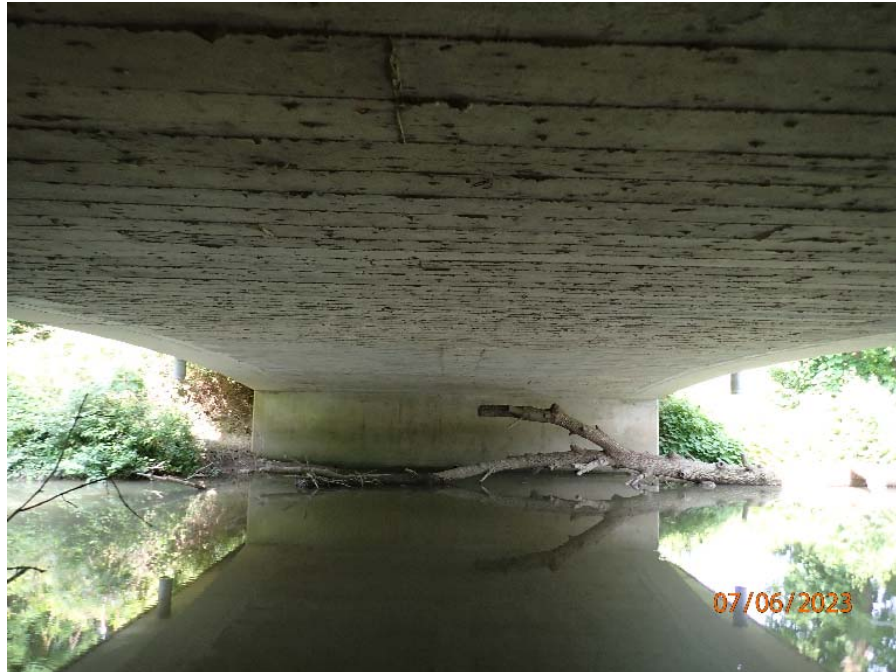
Photograph No. 3: 0238: Underside of the structure and west abutment looking west.

The steel multi-plate pipe arch culverts are generally in good condition with light to medium corrosion at the waterline. There are isolated areas of efflorescent staining on the walls and at the bolt locations inside both cells. The galvanized steel sheet wall retaining walls at both ends of the structure are generally in good condition with light rotation of the wall between the two cells at the west end of the structure. There is damage at the west end of the south cell, including several small holes. The north culvert exhibits reverse curvature of the obvert. There is a build-up of debris at the east and west ends of the south cell.

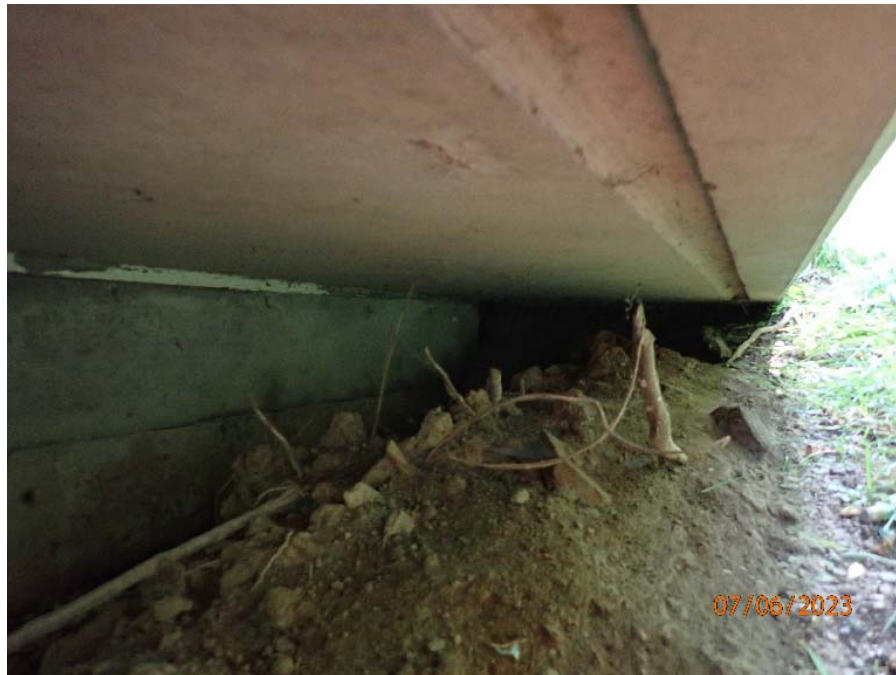
Photograph No. 4: 0232: Medium erosion and possible underpinning at southeast cantilever.

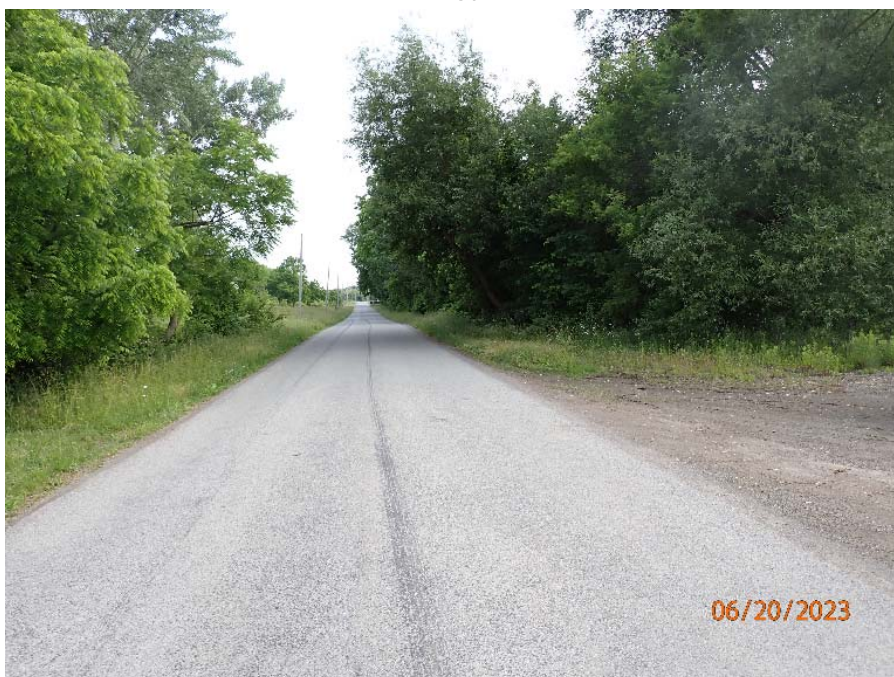
Photograph No. 1: 0166: Roadway over the structure looking north.

The surface treated roadway over the structure is in good condition. There is steel beam guiderail over the structure, which is generally in good condition. Some of the timber offset blocks exhibit minor splitting and have rotated. One of the guiderail posts is missing a timber offset block at the northeast corner. There are eccentric loader end treatments and hazard markers provided in all four corners. The vegetated roadway embankments and rock protection are in good condition.

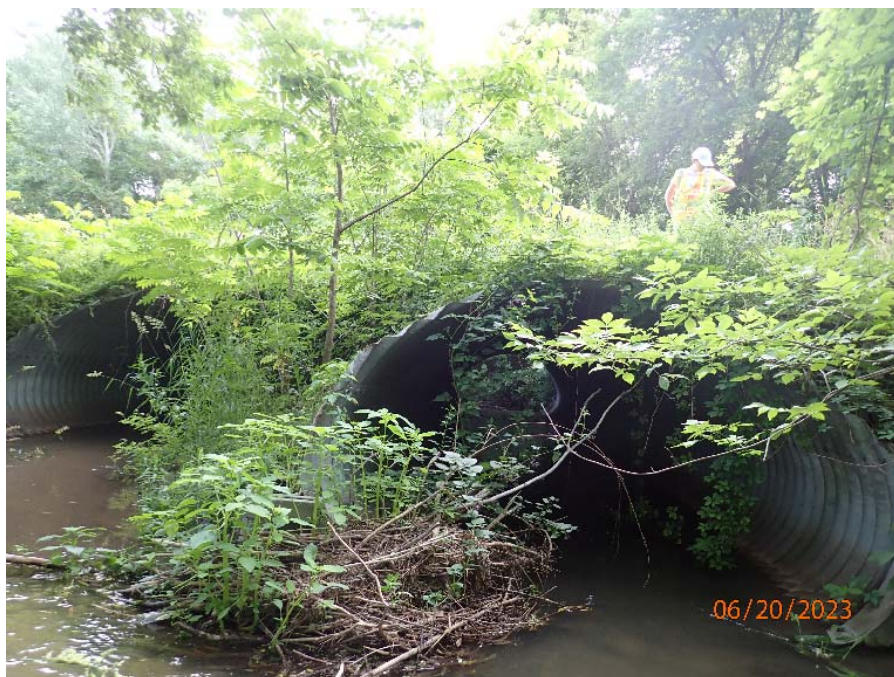
Photograph No. 2: 0188: West elevation.

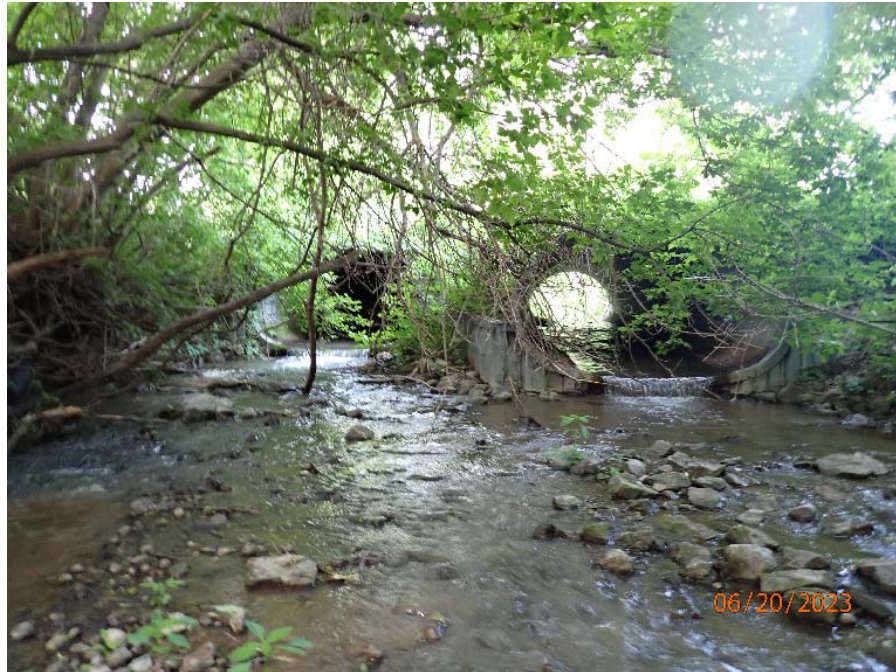
Photograph No. 3: 0209: East elevation.

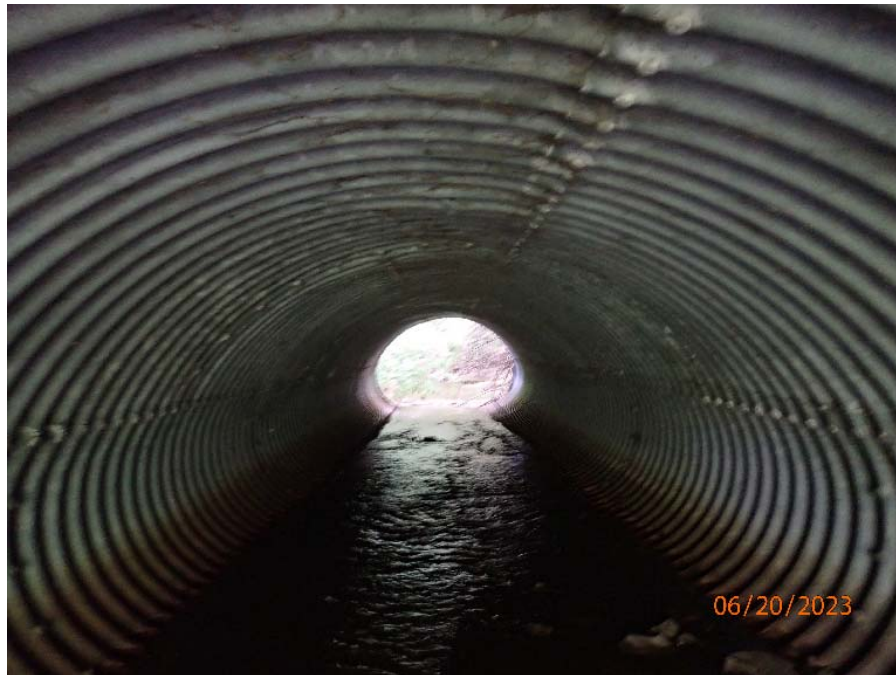
Photograph No. 4: 0200: Underside of the south cell looking east.

The multi-plate pipe arch culvert is in good condition. There is efflorescent staining around several of the bolt heads throughout the structure. The concrete footings are generally in good condition with minor scaling at the top of the east footing. The steel sheet covers of the concrete footings exhibit medium corrosion. The watercourse is unobstructed with no evidence of scour. A dam is located approximately 100m upstream of the culvert.

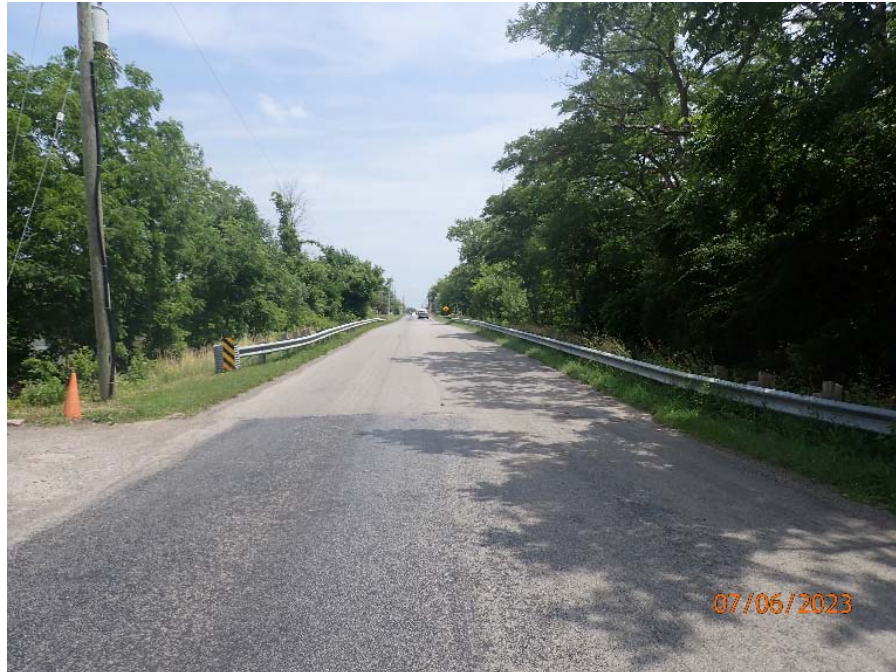
Photograph No. 1: 0623: Roadway over the structure looking east

The surface treated roadway over the structure and on the approaches is generally in good condition with light settlement along the edges of the roadway. There is steel beam guiderail over the structure, which is generally in good condition. There are terminal end treatments at all four corners. There is light vehicular damage at the northwest corner of the structure. The vegetated roadway embankments are in good condition. The stone and concrete fill on the embankments of the structure is generally in good condition with settlement on the north side.

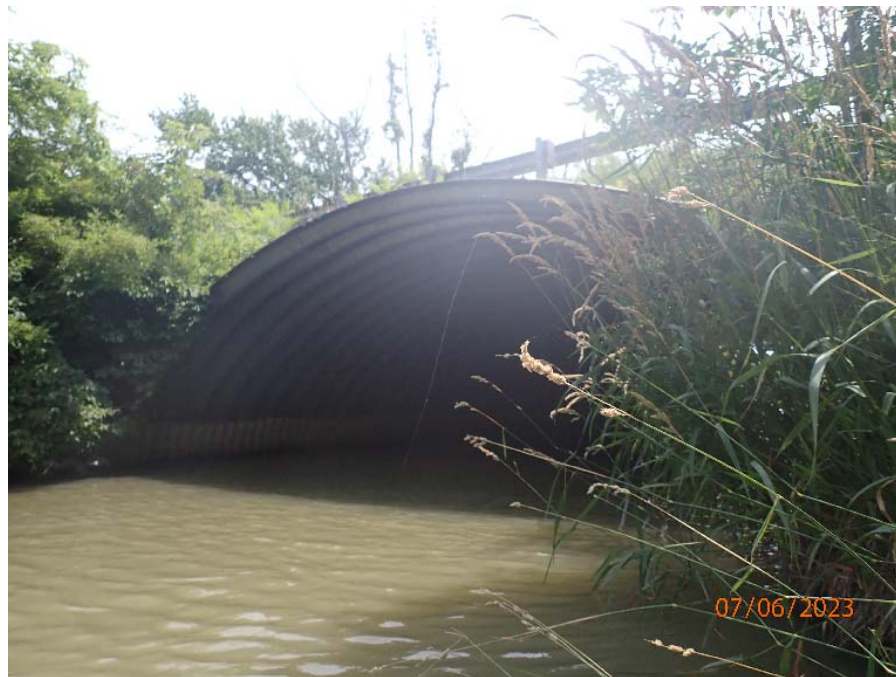
Photograph No. 2: 0631: North elevation.

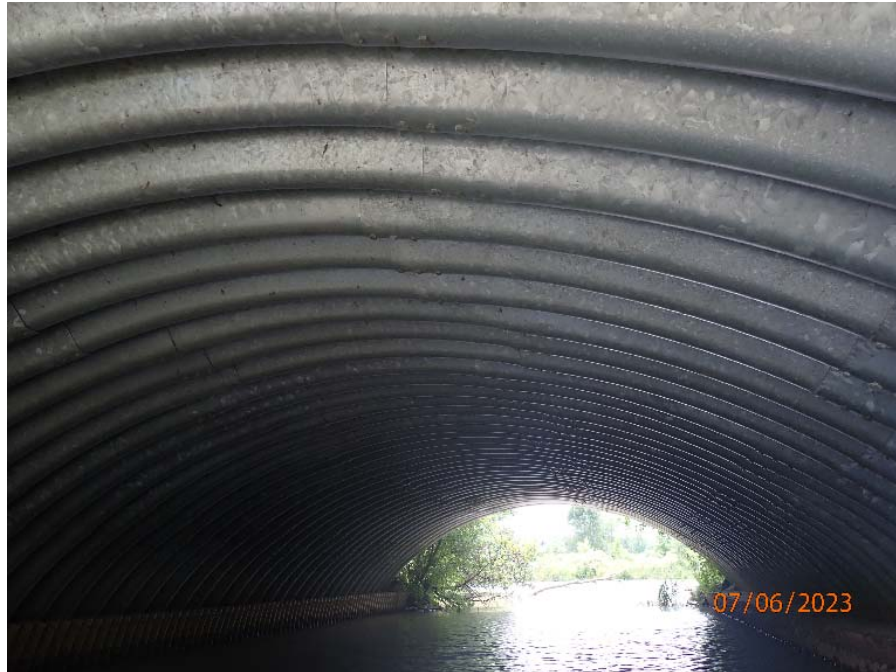
Photograph No. 3: 0646: Underside of the structure looking south.

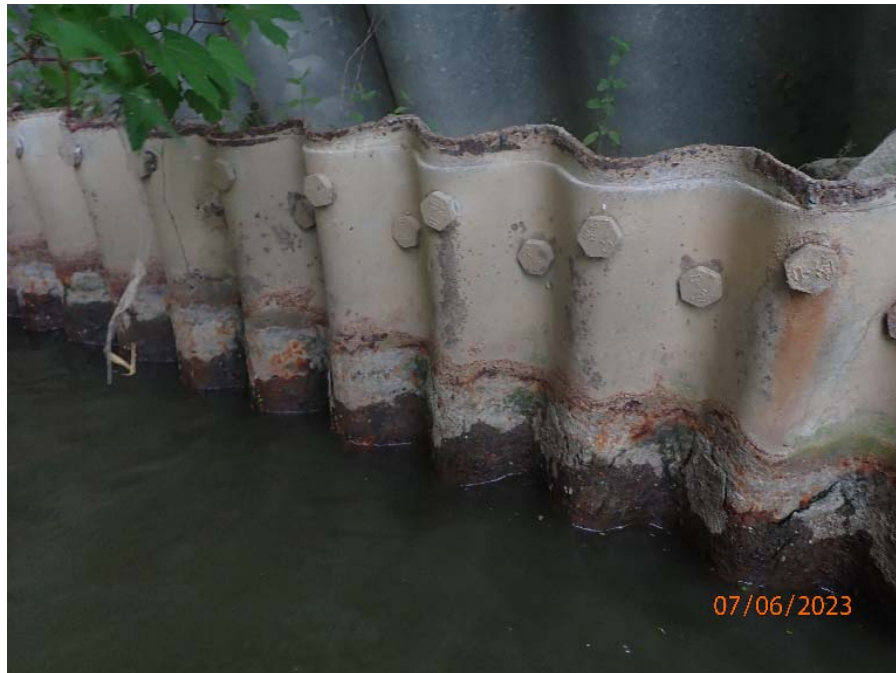
Photograph No. 4: 0649: Medium corrosion along west wall.

The steel multi-plate pipe arch culverts are in poor condition. The exposed tops of the culverts have light corrosion. There is medium to severe corrosion and section loss along the waterline in both culverts, particularly at the ends. There are perforations along the waterline throughout the west cell. There is an area of severe perforations and 100% section loss at the southwest corner of the west cell. There are also localized perforations at the south end of the east cell. Bulging and corrosion are evident in both cells. There is a deformation in the crown at the mid-span of the west cell, which is approximately 150mm deep. There are isolated areas of efflorescent staining and rust staining at the bolt locations in both cells, several of the bolts are loose in the east cell along the crown. There are light deformations at the ends of both of the culverts. There is undermining at the north end of the west cell, approximately 200mm. There is a build-up of debris at the south end of the structure, limiting access and restricting water flow through the west cell.

We recommend replacing the structure NOW. We also recommend monitoring the structure and roadway every 6 months and after large storm events for signs of failure (settlements, loss of fill, deformations, etc.).

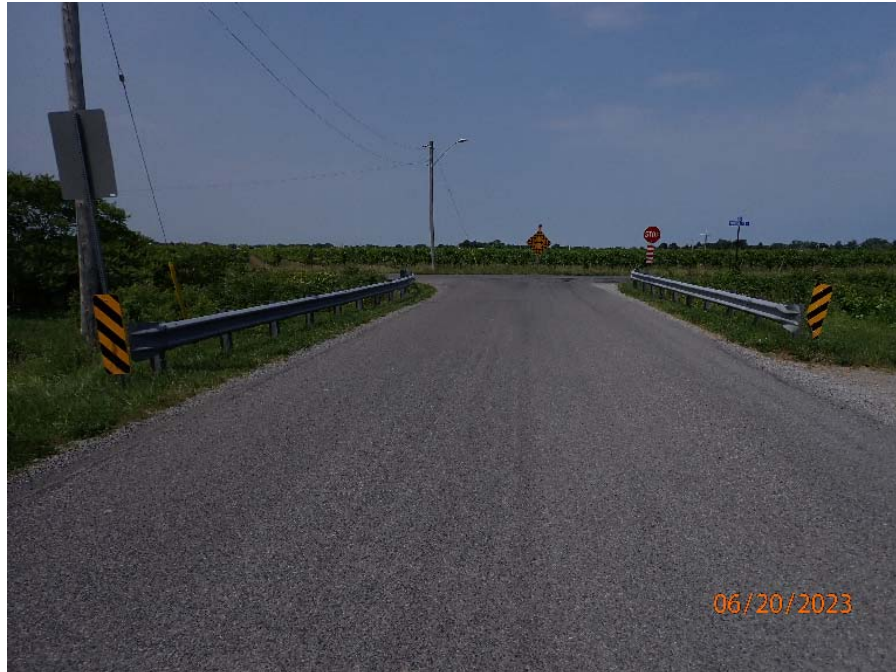
Photograph No. 1: 0470: Roadway over the structure looking west.

The asphalt paved roadway over the structure is generally in good condition with light settlement over the structure. There is steel beam guiderail over the structure, which is in fair to poor condition with eccentric loader end treatments at all four corners. Several of the posts and offset blocks are split, rotated, detached, and beginning to rot at the east end of the north guiderail. The vegetated roadway embankments are in good condition. The rock and concrete fill on the embankments of the structure are generally in good condition.

We recommend replacing the steel beam guiderail timber posts NOW.

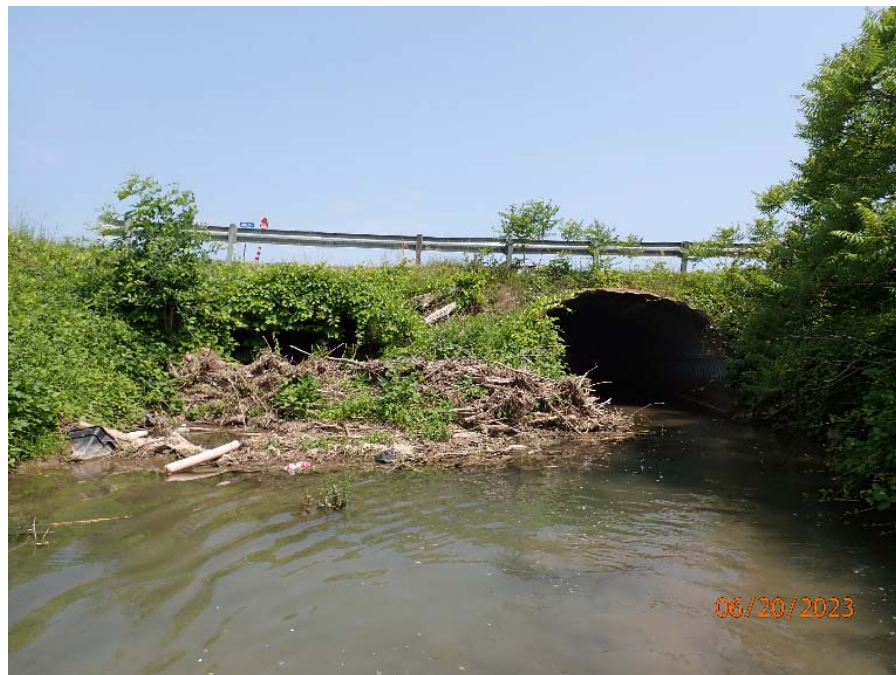
Photograph No. 2: 0538: South elevation.

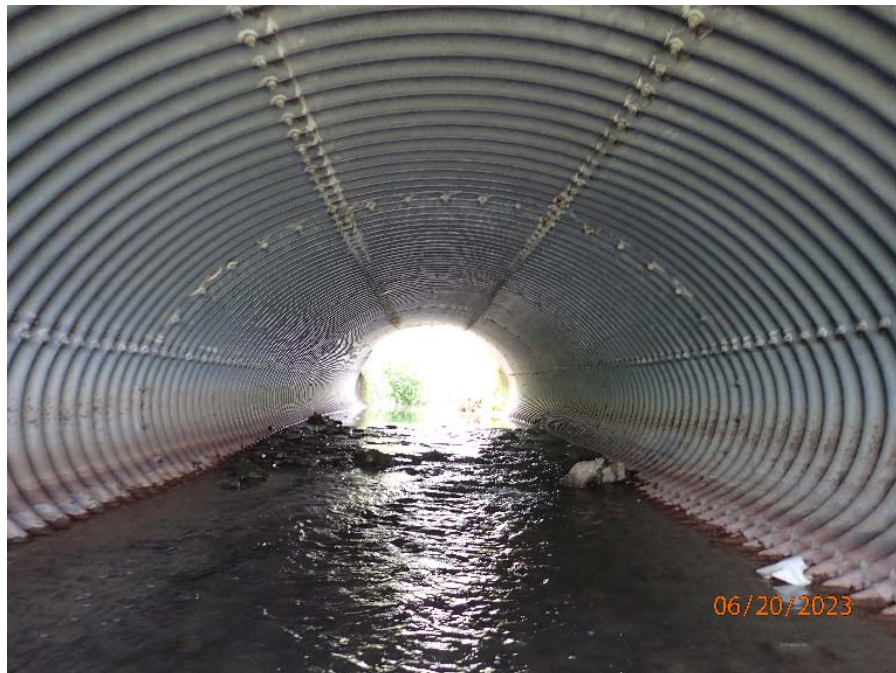
Photograph No. 3: 0499: Interior of the east cell looking south.

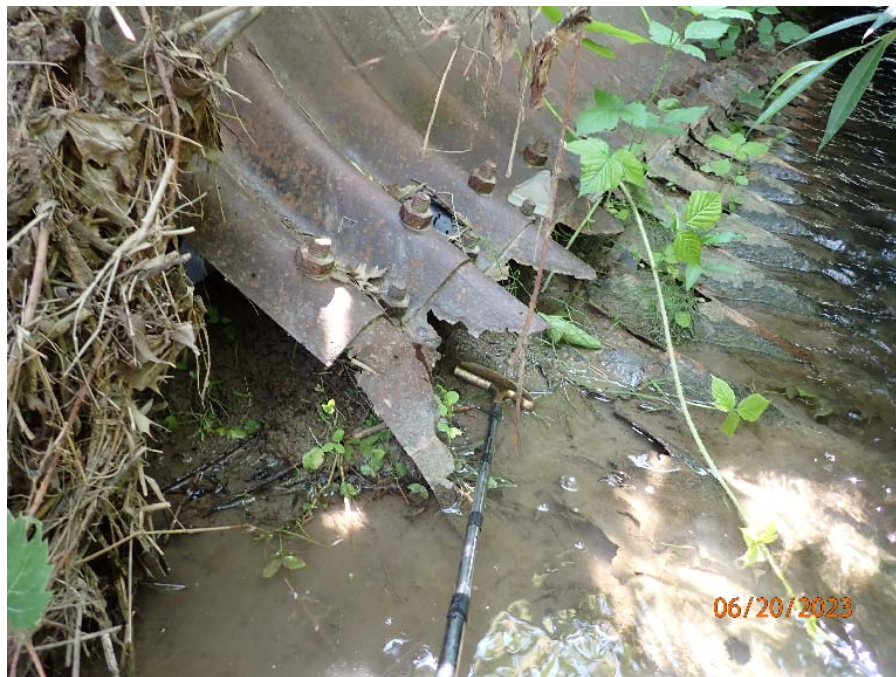
Photograph No. 4: 0545: Perforations in the north end of the west cell.

The steel multi-plate pipe arch culverts are in fair to good condition. There is medium corrosion at the waterline throughout the length of the west cell. There are localized areas of severe corrosion and perforations along the waterline at both ends of the west cell. The east cell is approximately 50% silted up and it appears that the waterway does not flow through the east cell. The east cell was not accessible at the time of inspection due to vegetation and silt buildup. It was noted in a previous inspection that the east culvert exhibits hairline cracks of the steel multi-plates along the bolt holes at the top of the sharp radius at one location in the west wall of the east cell for approximately 3m; however, this area is now covered with silt. Both culverts have light deformations at each end. There are medium deformations at the south end of the west cell. The watercourse is unobstructed in the west cell.

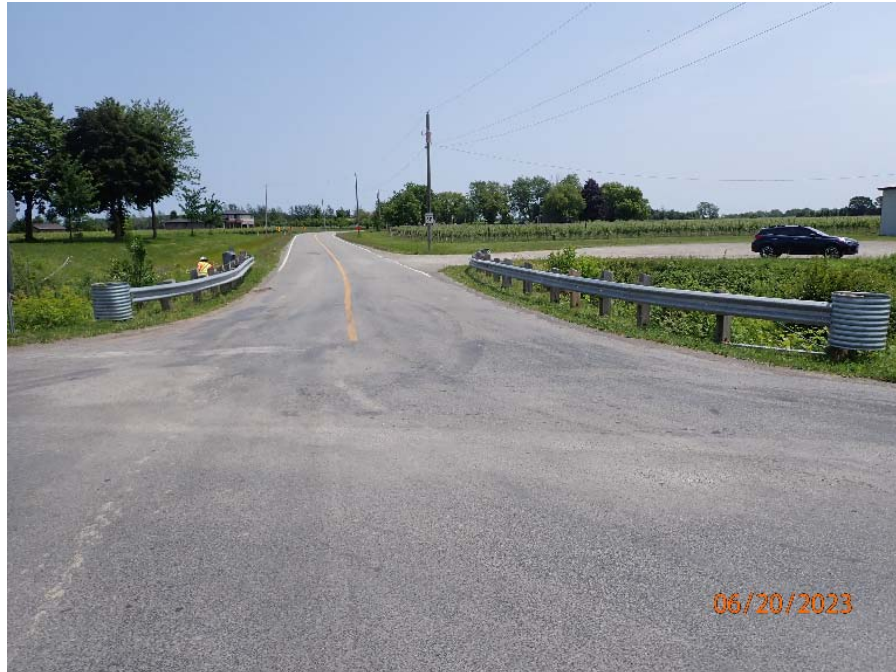
Photograph No. 1: 0597: Roadway over the structure looking east.

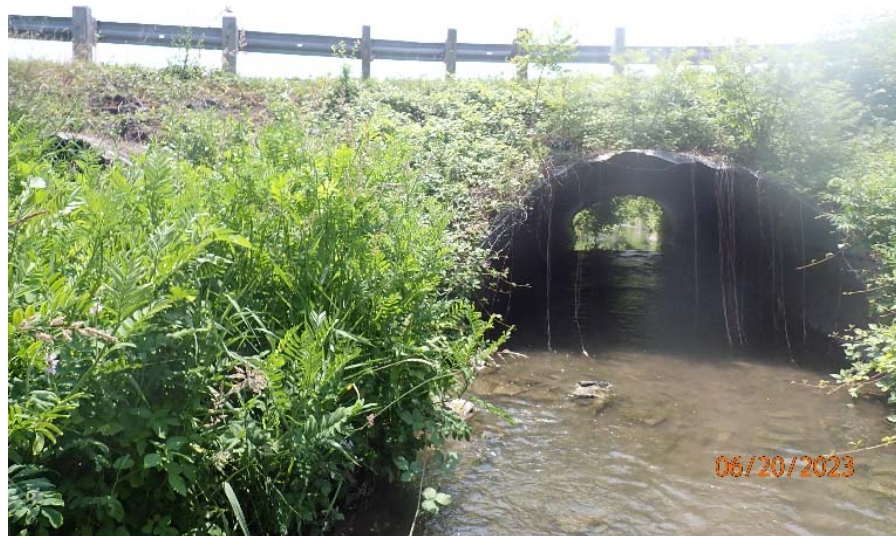
Photograph No. 2: 0648: North elevation.

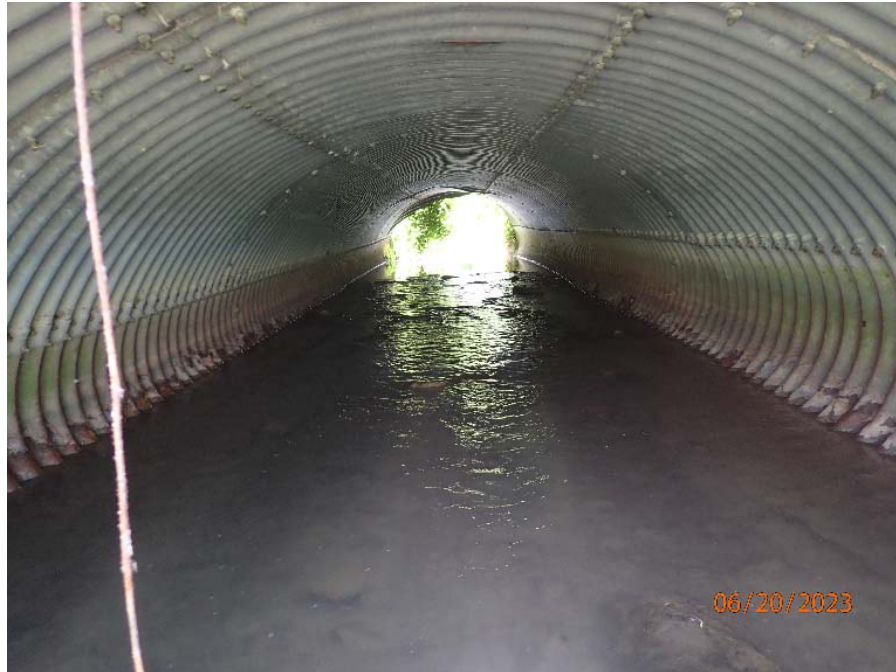
Photograph No. 3: 0653: Interior of the west cell looking north.

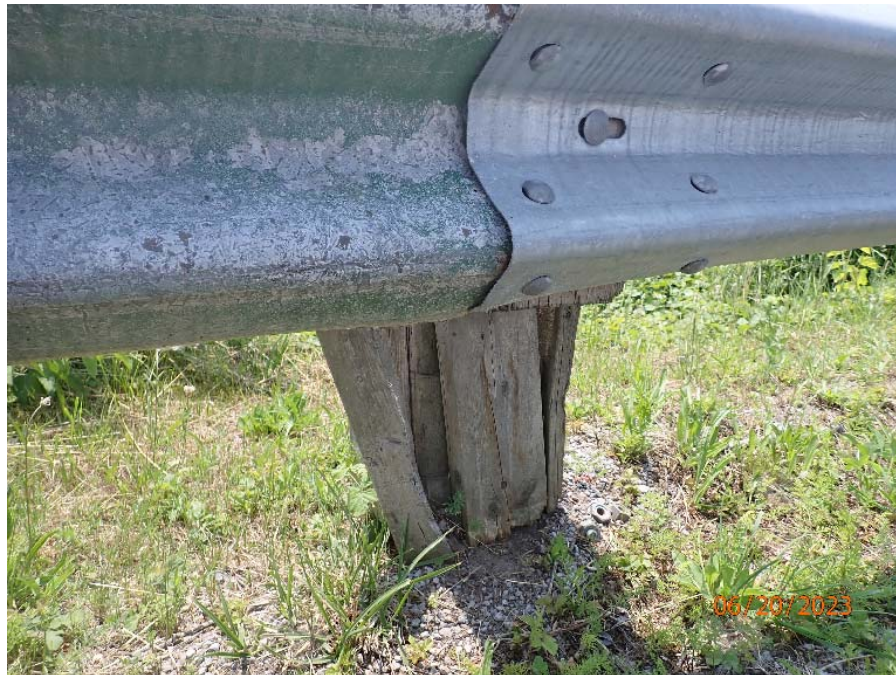
Photograph No. 4: 0588: Split timber post (typical).

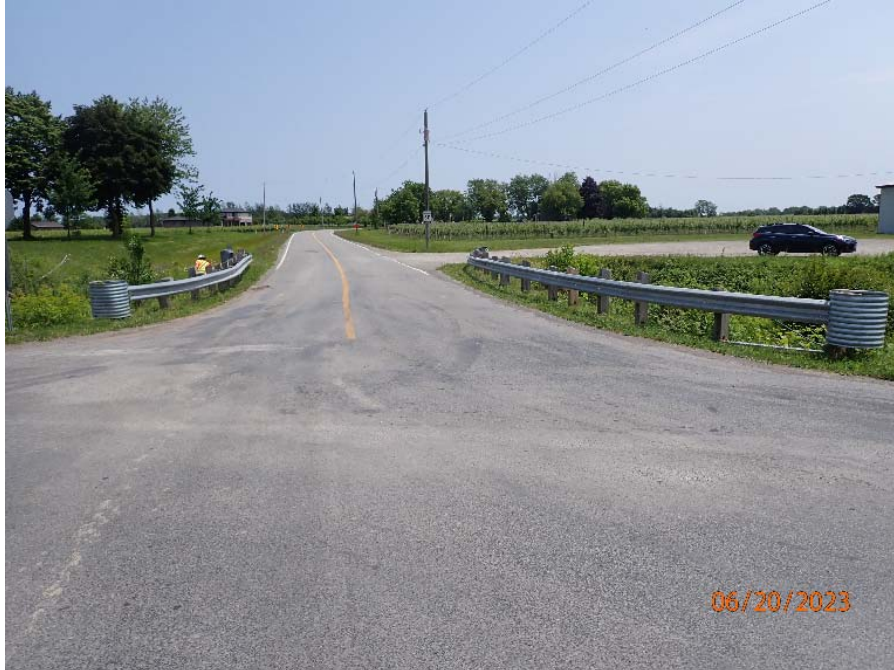
Photograph No. 1: 0597: Roadway over the structure looking east.

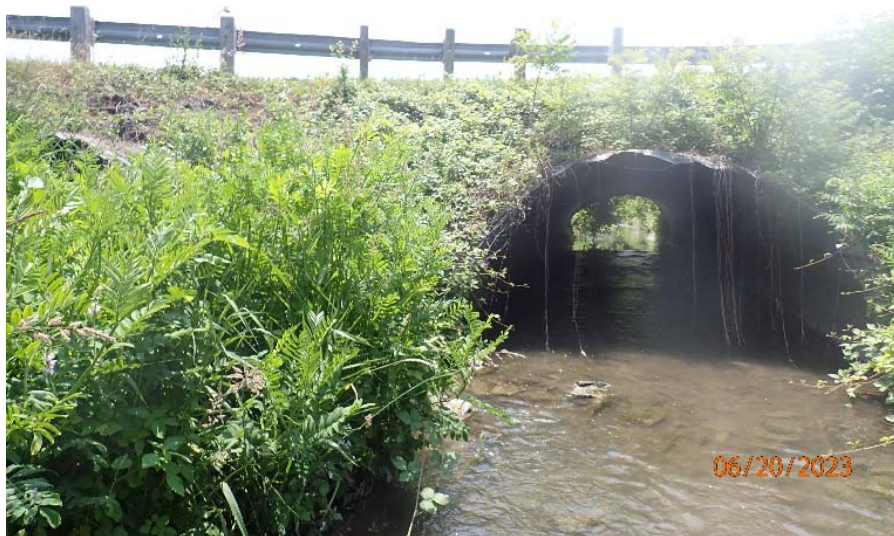
Photograph No. 2: 0648: North elevation.

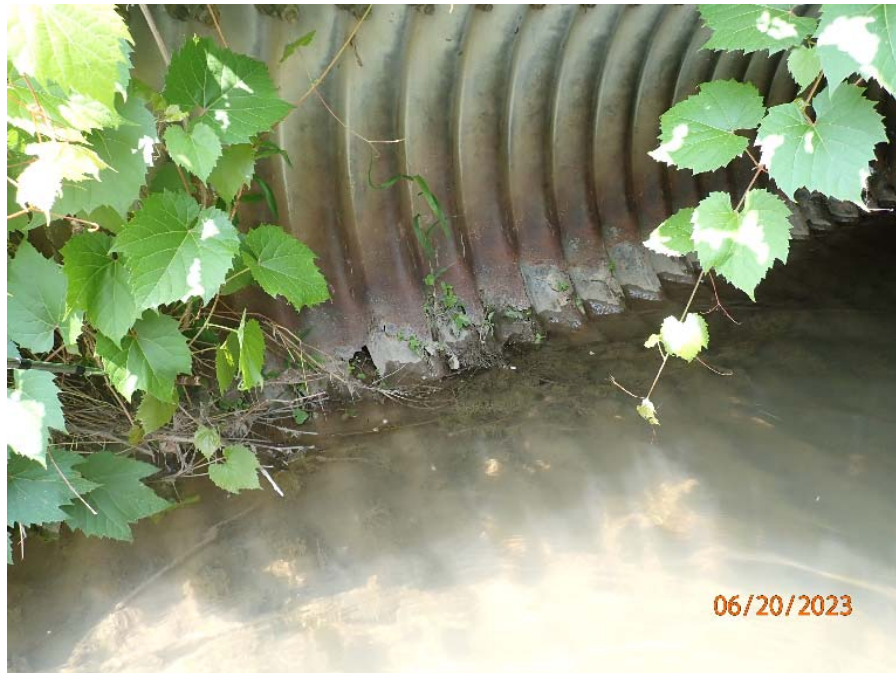
Photograph No. 4: 0619: Severe corrosion and perforations at southeast corner in the west cell.

We recommend scheduling the structure for replacement in 1-5 Years.
