TOWN OF NIAGARA-ON-THE-LAKE

2023 MUNICIPAL BRIDGE APPRAISAL REHABILITATION/REPLACEMENT NEEDS

February 2024

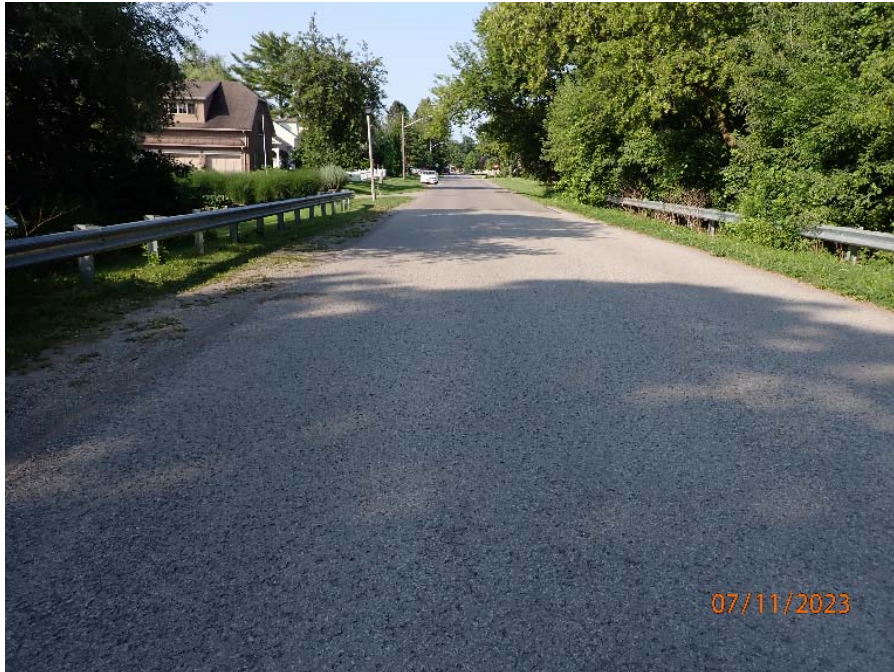
Photograph No. 1: 0012: Roadway over the structure looking south.

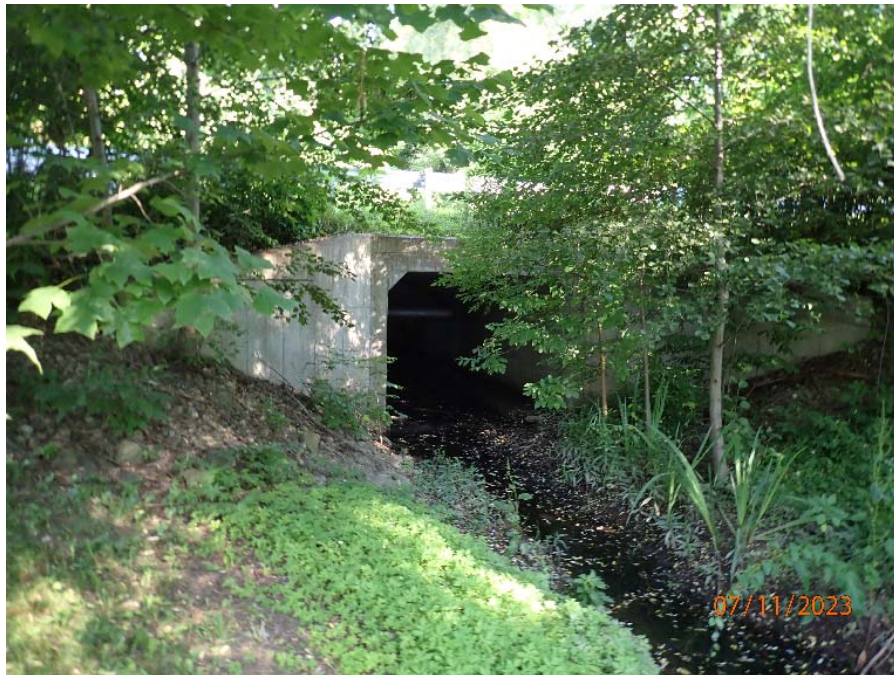
Photograph No. 2: 0039: East elevation.

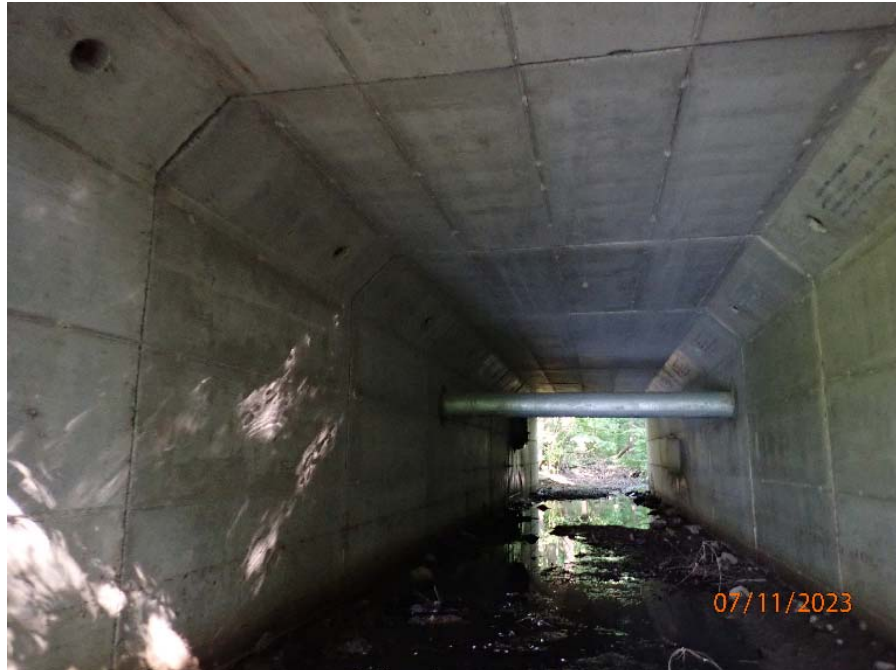
Photograph No. 3: 0050: Underside of the structure looking west.

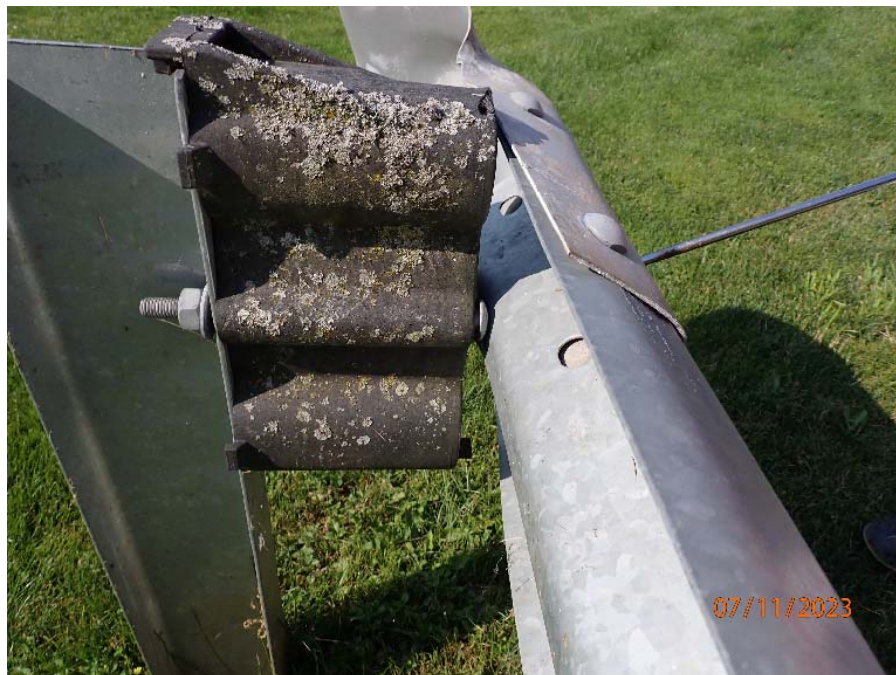
Photograph No. 4: 0020: Detached post at southeast corner.

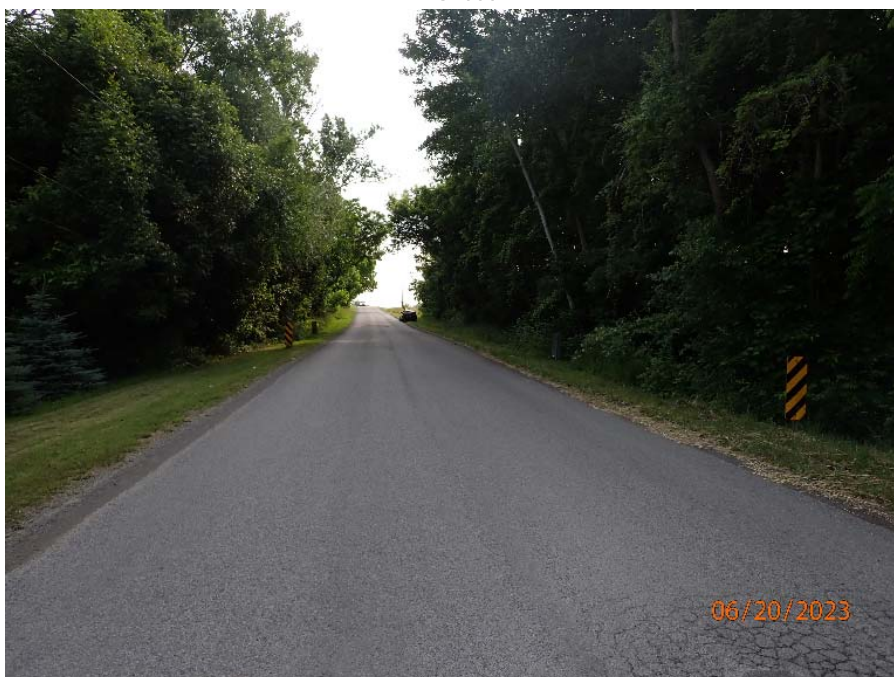
Photograph No. 1: 0111: Roadway over the structure looking east.

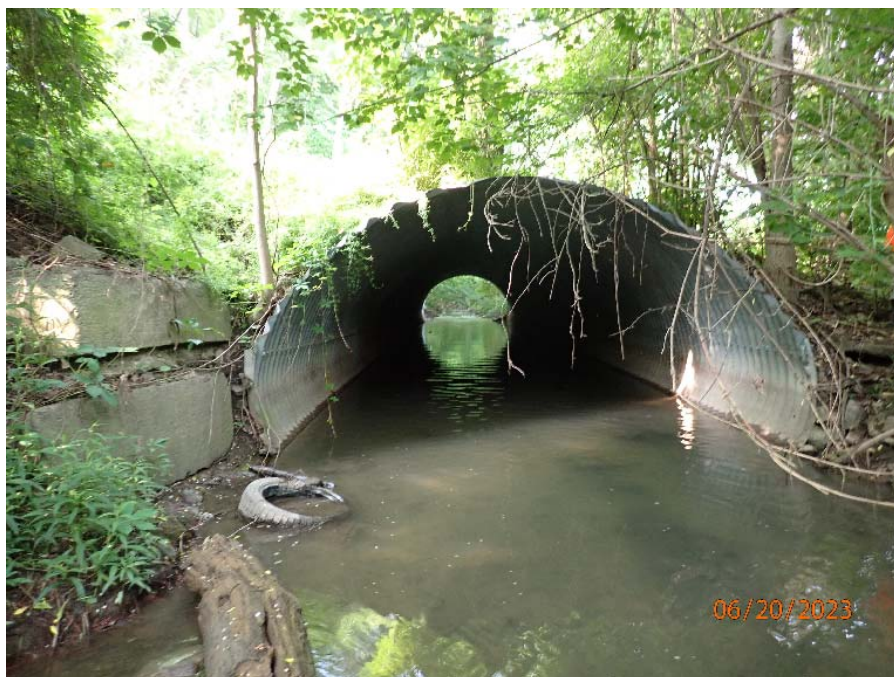
Photograph No. 2: 0120: North elevation.

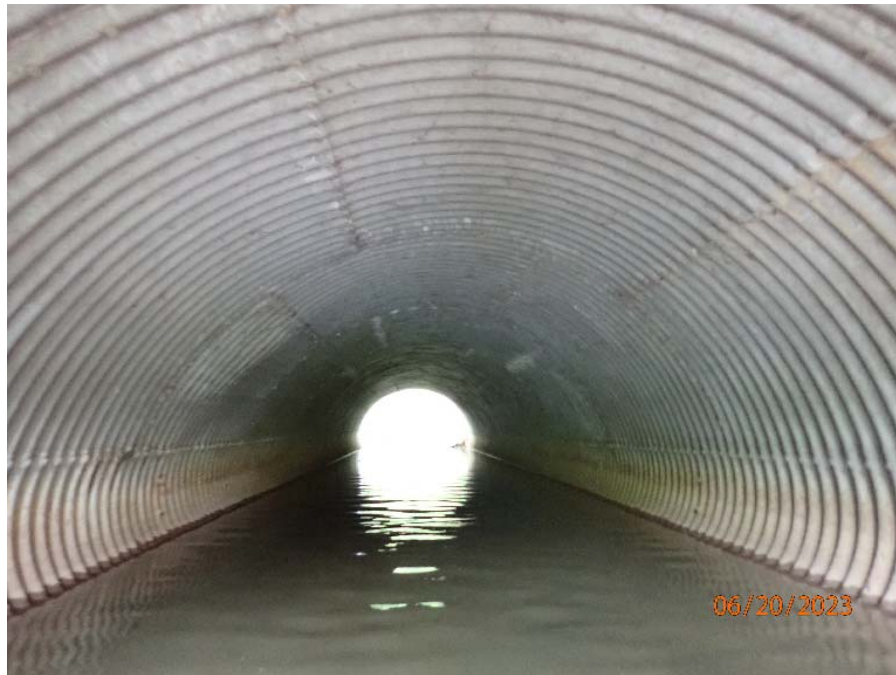
Photograph No. 4: 0126: Underside of the structure looking south.

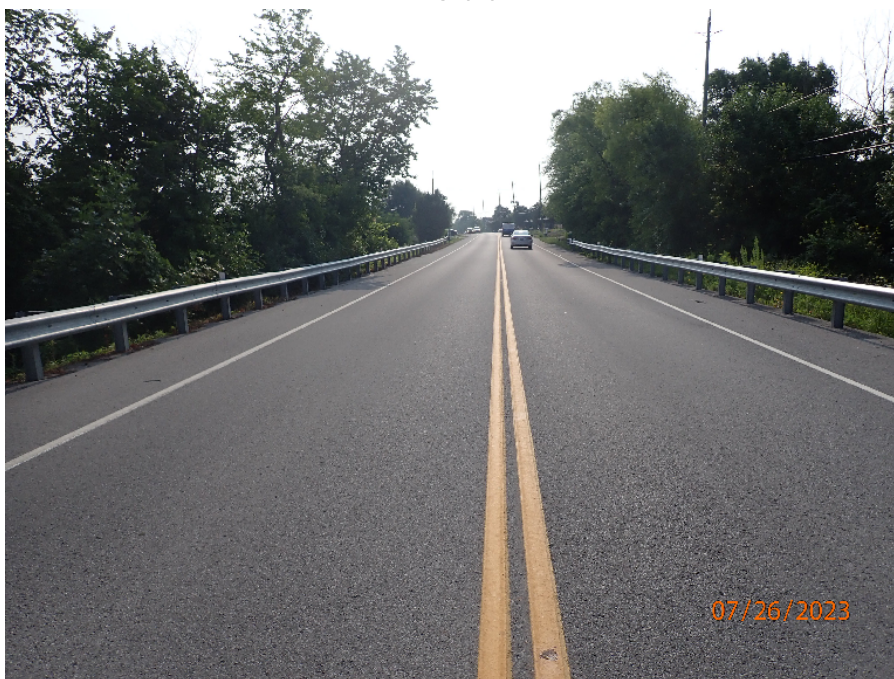
Photograph No. 1: 0014: Roadway over the structure looking east.

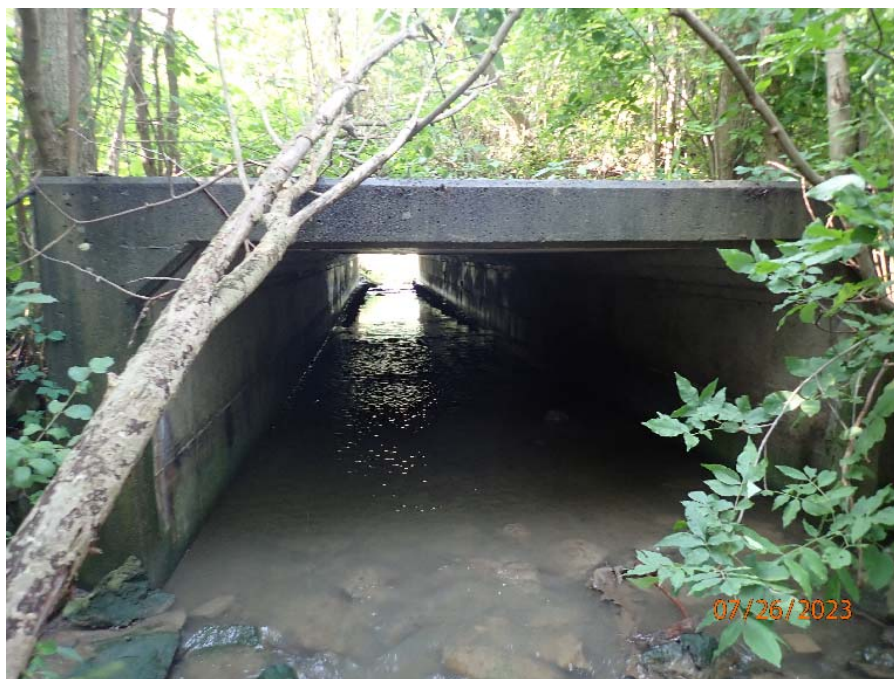
Photograph No. 2: 0112: North elevation.

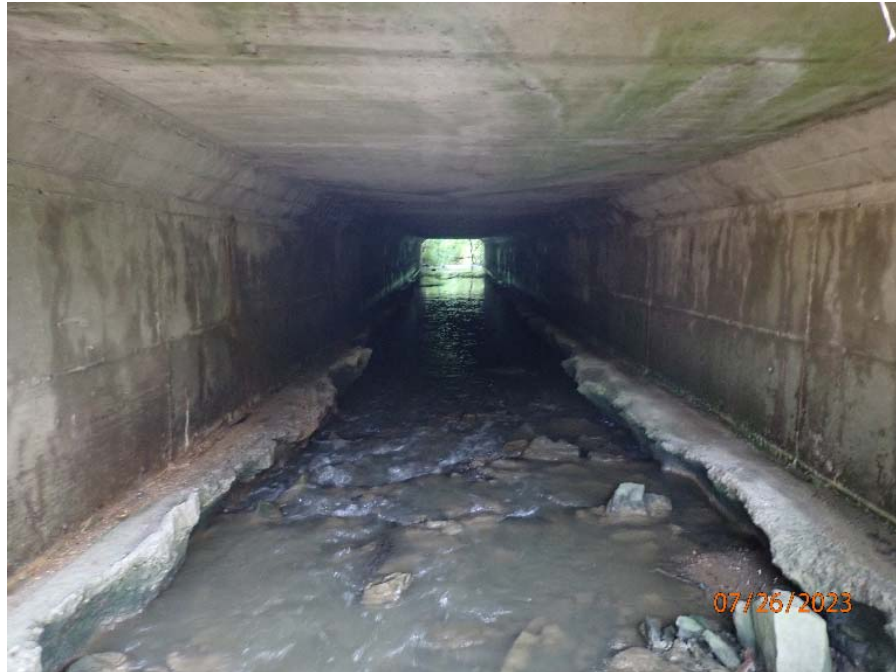
Photograph No. 3: 0055: Interior of structure looking north.

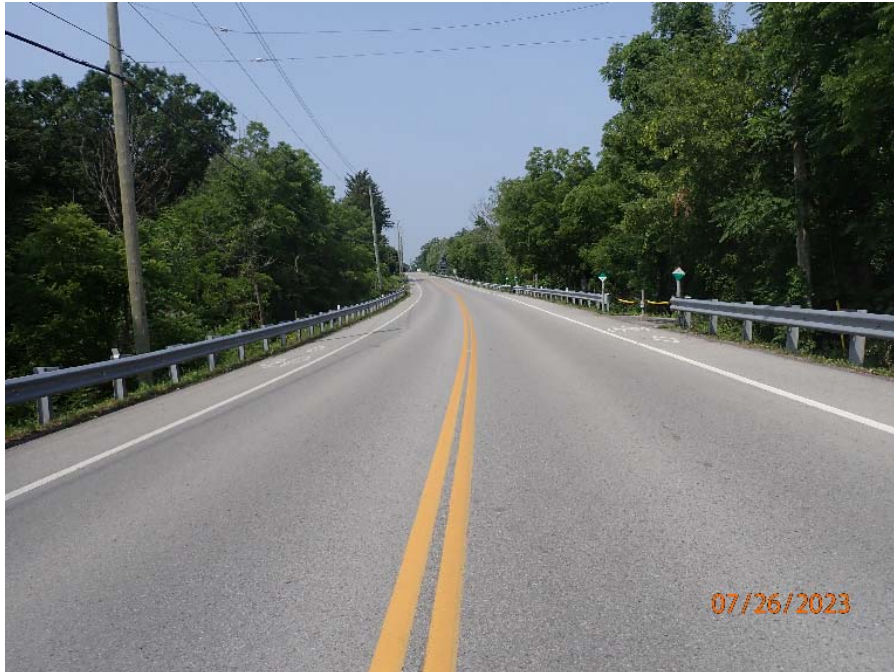
Photograph No. 1: 0307: Roadway over the structure looking west.

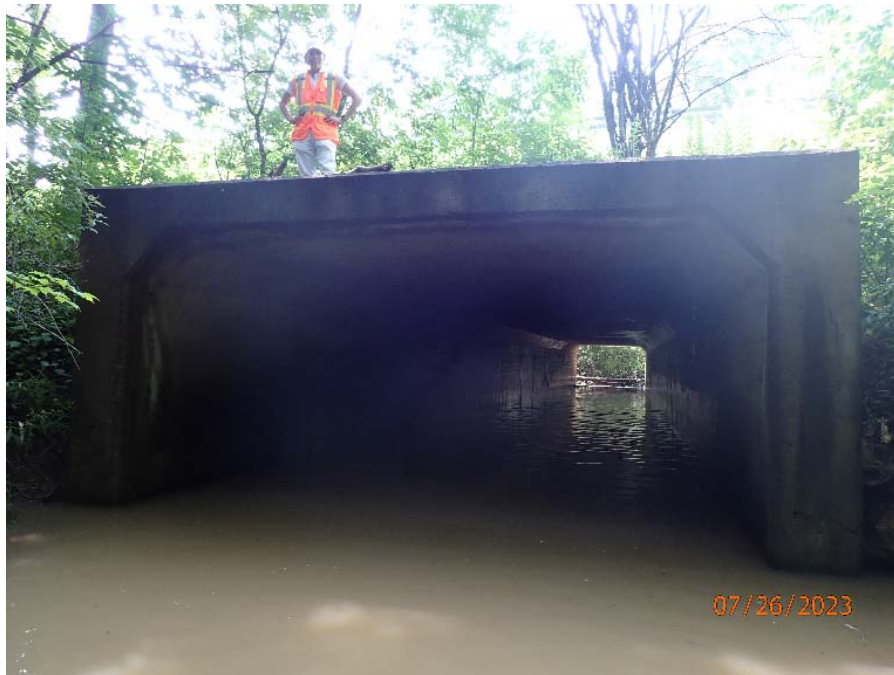
Photograph No. 2: 0327: North elevation.

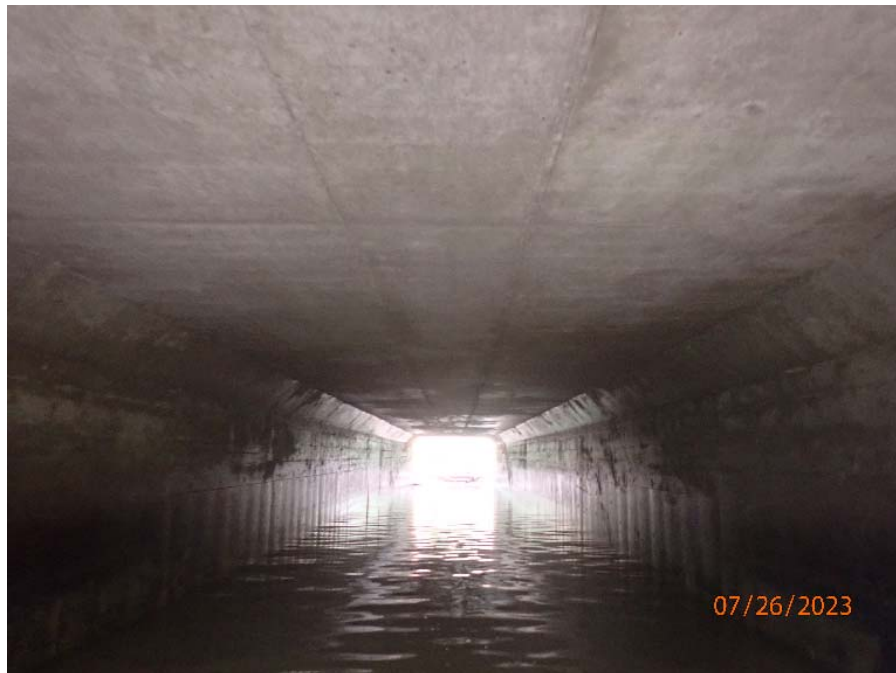
Photograph No. 3: 0337: Underside of the structure looking south.

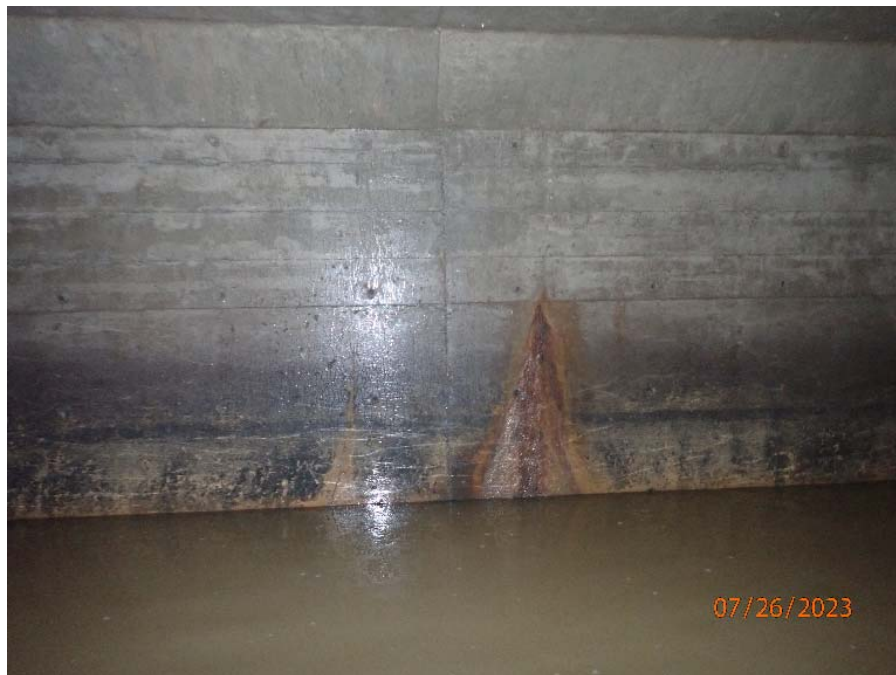
Photograph No. 4: 0356: Area of cracking, efflorescent staining, and active leakage in abutment sidewall.

The concrete culvert is generally in good condition with localized stained and unstained transverse cracks in the deck soffit. There are isolated narrow vertical cracks with leakage in the abutment sidewalls. The watercourse is unobstructed. There is an irrigation pipe running along the east side behind the guiderail. There is a 1.5m span concrete storm drain with a steel grate adjacent to the existing structure on the east that is skewed under the roadway.

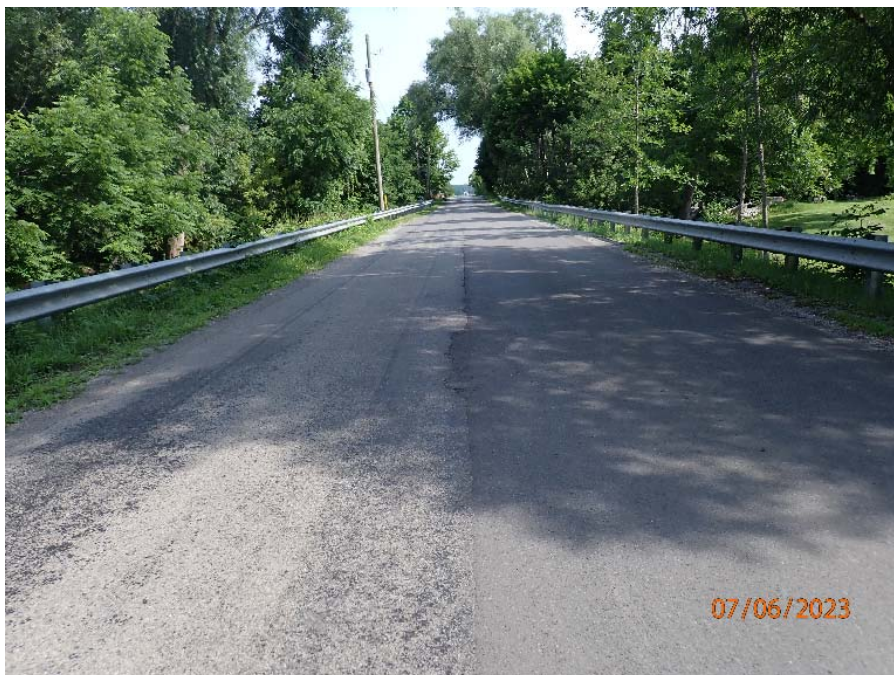
Photograph No. 1: 0271: Roadway over the structure looking north.

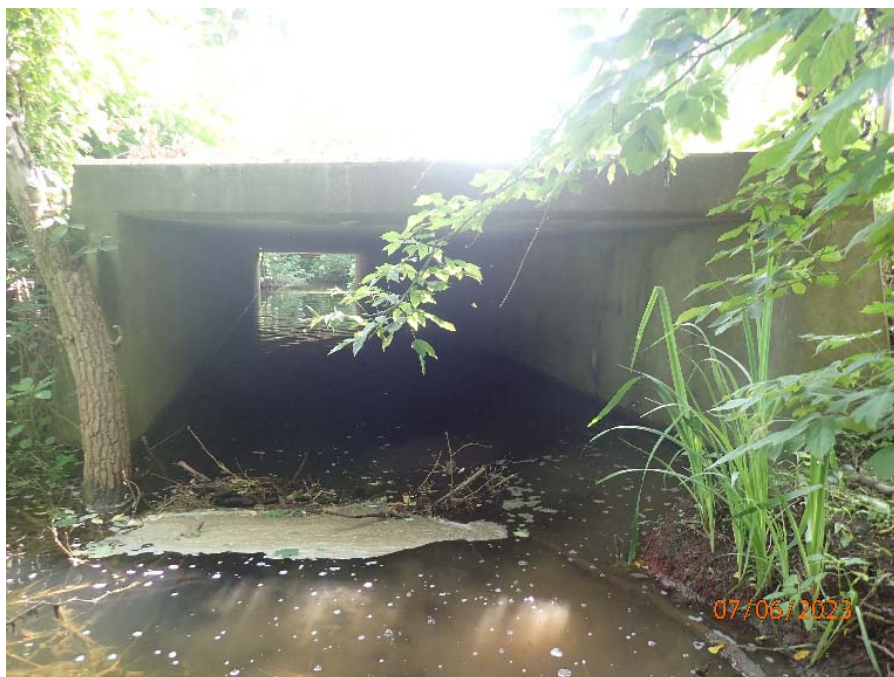
Photograph No. 2: 0343: West elevation.

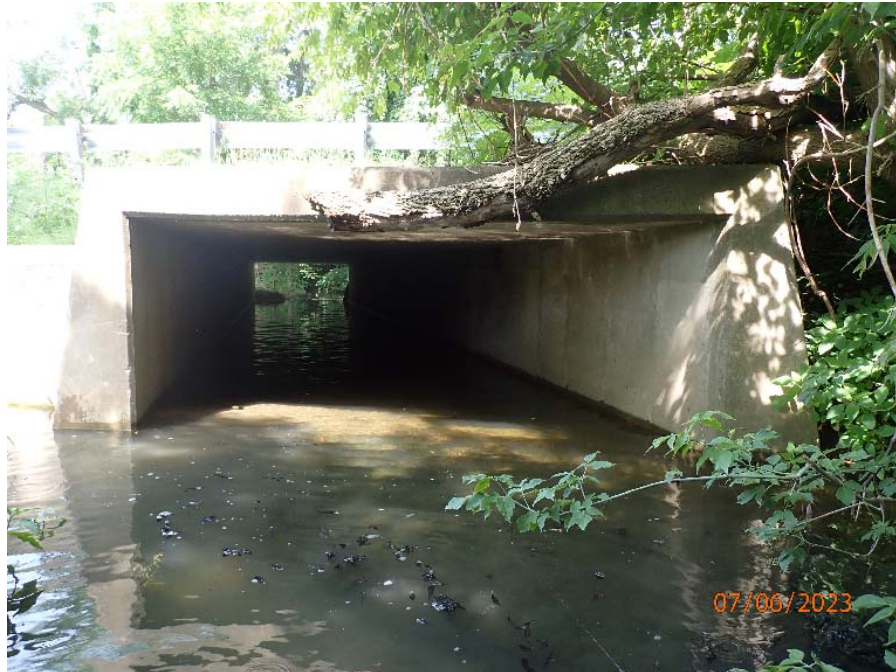
Photograph No. 3: 0317: East elevation.

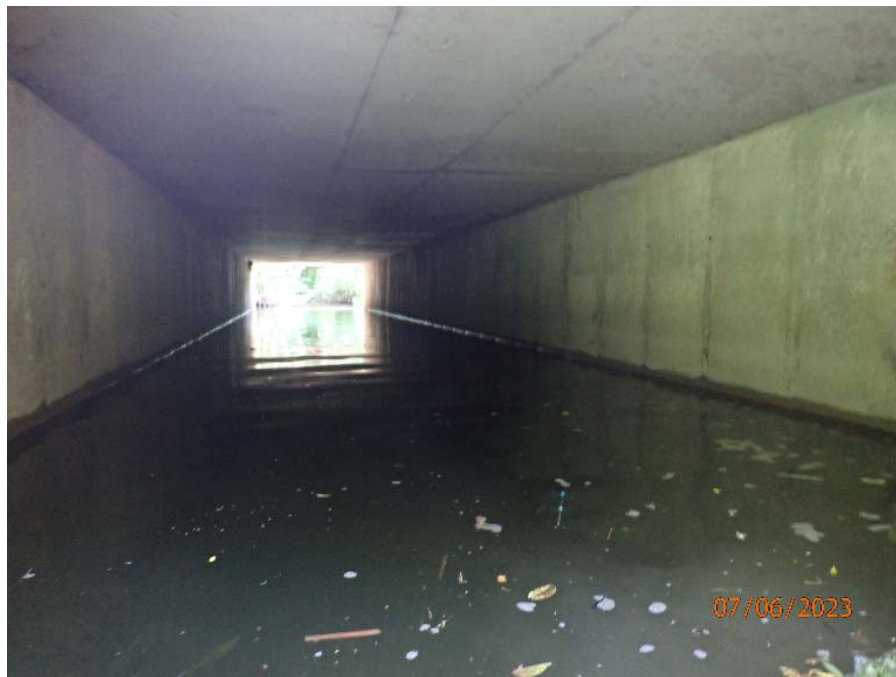
Photograph No. 4: 0345: Interior of the structure looking east.

The precast concrete box culvert units are in very good condition. There is evidence of leakage between the second and third construction joints from the west end. There is an isolated light spall between the second and third precast units from the west end. There is a 300mm diameter PVC storm water drain that outlets through the centre of the south abutment sidewall. The exposed ends of the concrete distribution slab are in very good condition. The concrete headwalls are in very good condition. There is riprap erosion protection at all four corners of the structure and along the abutment sidewalls through the structure. There is a rock check dam in the waterway at both ends of the structure.

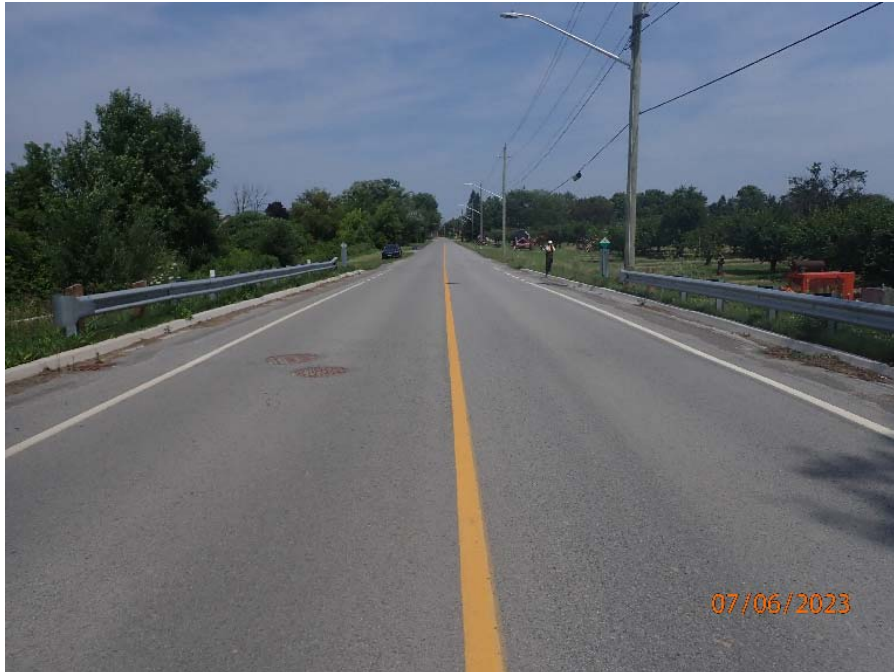
Photograph No. 1: 0500: Roadway over the structure looking south.

The asphalt paved roadway over the structure has been repaved since the previous inspection and is in very good condition. There is no traffic protection provided over the structure or on the approaches. There are no hazard markers. The vegetated roadway embankments are in generally good condition with light erosion at all four corners of the structure. The exposed portions of the bridge deck top are in generally in good condition with light to medium scaling. The concrete fascias are generally in good condition with two areas of medium scaling on the east fascia.

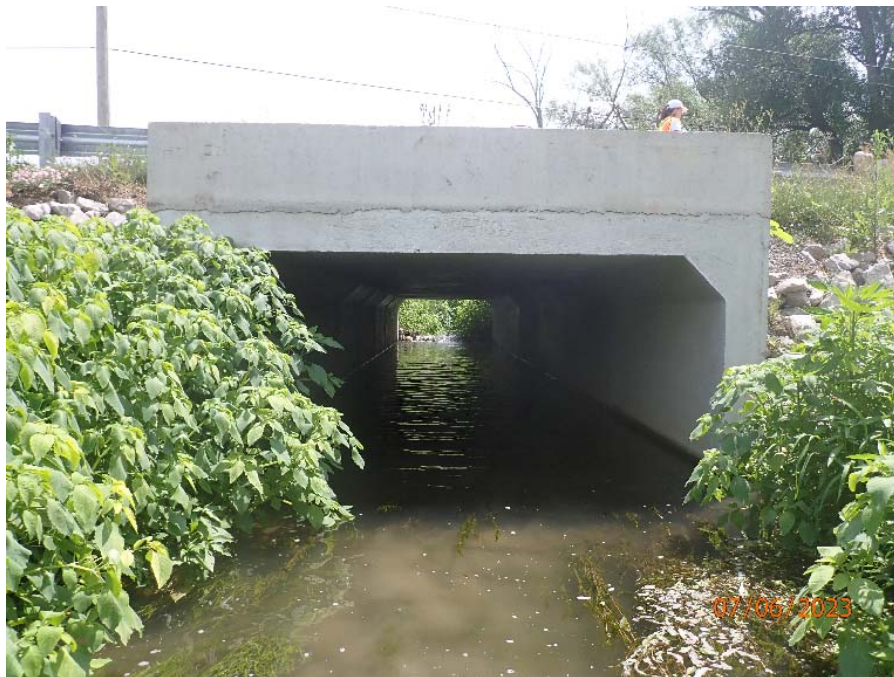
Photograph No. 2: 0517: West elevation.

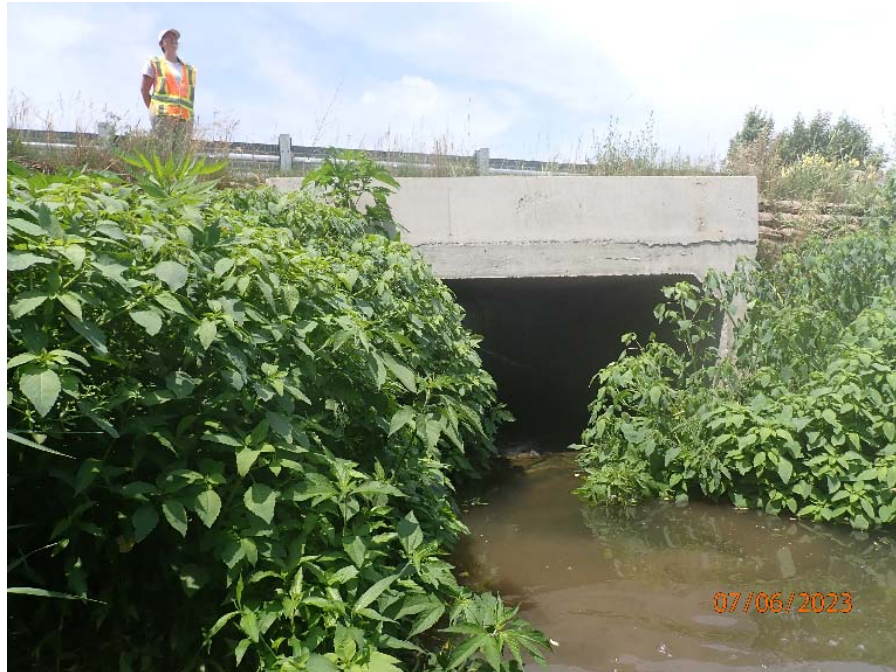
Photograph No. 3: 0541: East elevation.

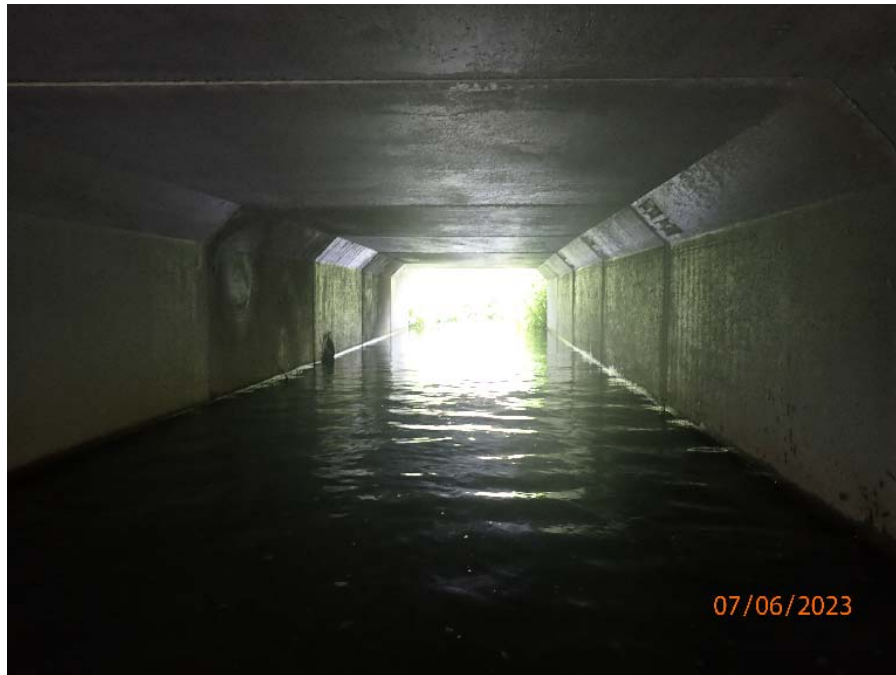
Photograph No. 4: 0544: Interior of structure looking west.

The bridge deck soffit is generally in good condition. There are two narrow transverse cracks with efflorescent staining at the centre of the soffit and an area of medium delamination at this location (approximately 0.1m² poor). There is an isolated light spall with exposed corroded reinforcing steel on the north side of the soffit. There is water staining at both ends of the soffit. The concrete abutment sidewalls are in good condition with isolated narrow to wide vertical cracks. There is an area of medium honeycombing at the east end of the south abutment sidewall (approximately 0.1m², poor). There are narrow to wide horizontal cracks at all four corners of the structure between the deck soffit and the abutment wall. The separation appears to continue along the entire north abutment wall. The streambed within the structure is scoured, exposing the top 450mm of the footings. There is a check dam at the west end of the structure.

We recommend placing riprap along the footings NOW to prevent further erosion.

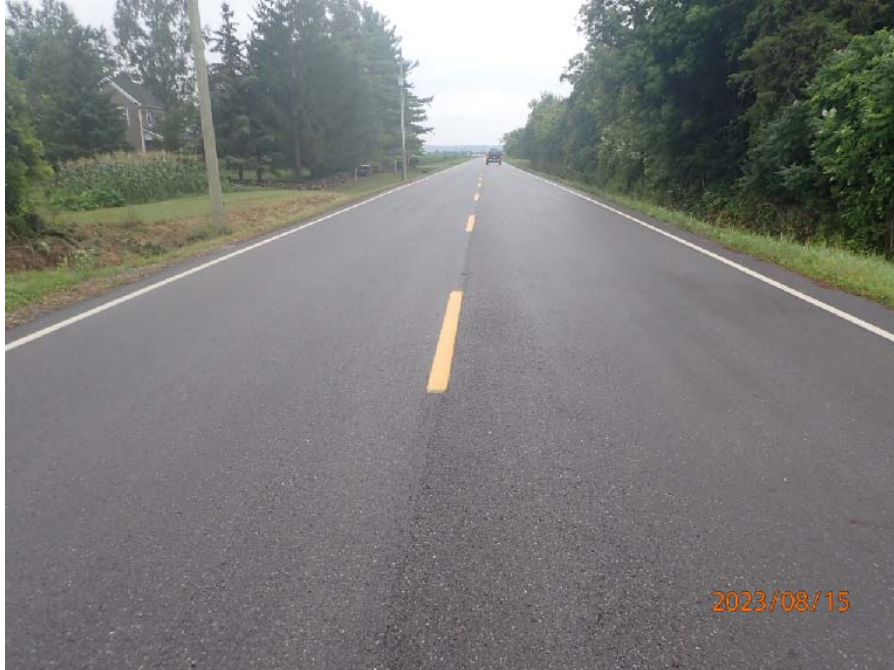
Photograph No. 1: 0761: Roadway over the structure looking south.

The surface treated roadway over the structure is generally in good condition with light settlement at the ends of the structure and light deterioration and patched and unpatched potholes along the edges of the roadway. There is no traffic protection provided over the structure or on the approaches. There are hazard markers at all four corners. The vegetated roadway embankments are generally in good condition. Concrete rubble has been placed on the embankments adjacent to the structure to minimize erosion. The exposed portions of the bridge deck top are in good condition with light scaling.

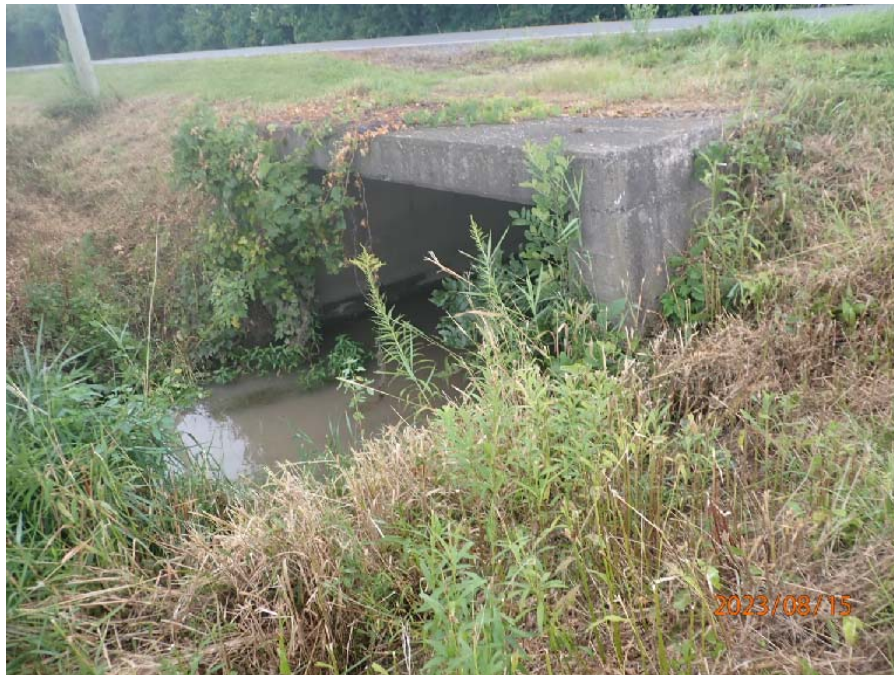
Photograph No. 2: 0806: East elevation.

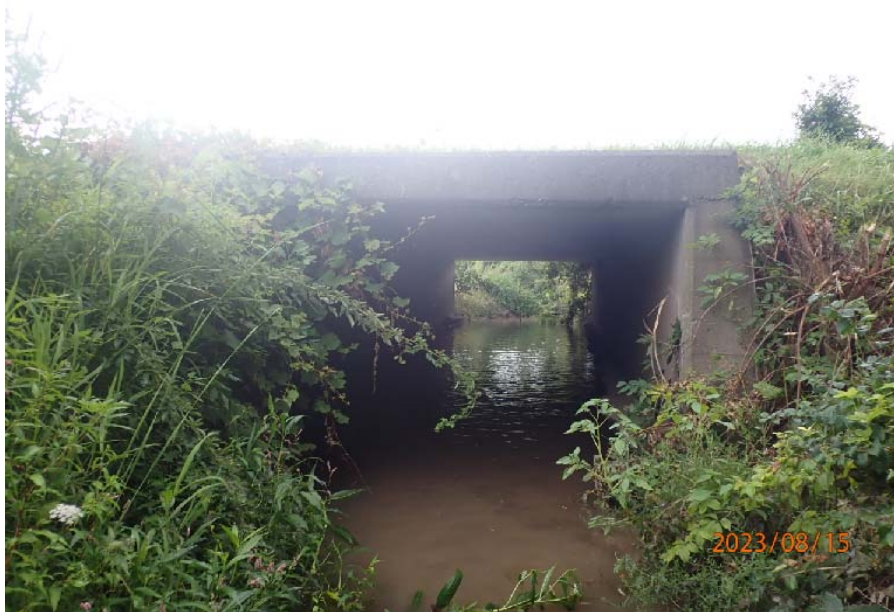
Photograph No. 3: 0798: West elevation.

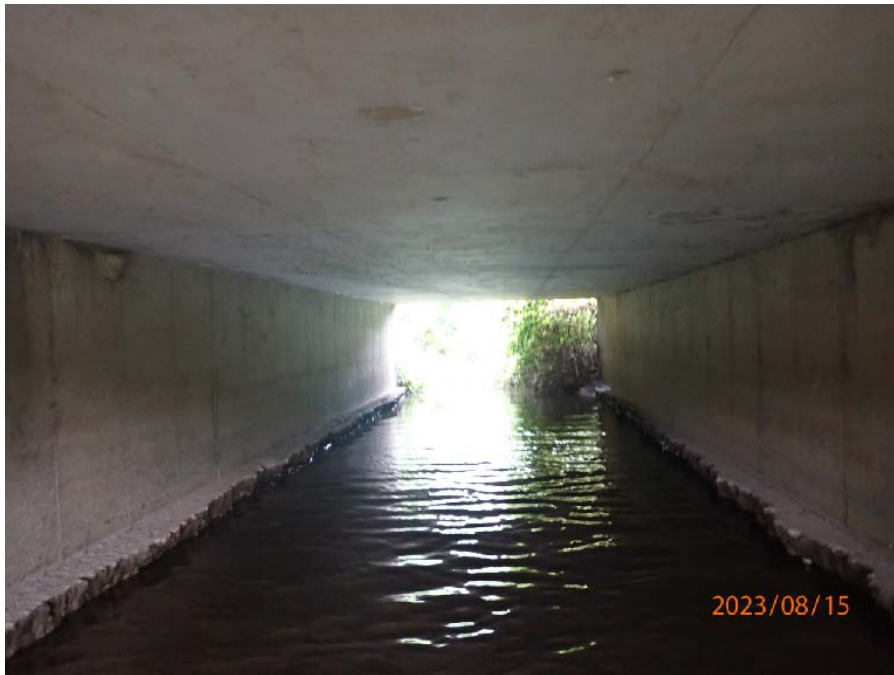
Photograph No. 4: 0775: Underside of the structure looking west.

The bridge deck soffit is in good condition. There are several light spalls with exposed corroded reinforcing steel along the east side of the soffit at the centre of the structure (0.1m² poor). There is water staining at both ends of the soffit. The concrete abutment sidewalls are generally in good condition with isolated areas of medium to severe honeycombing at the bottom of the west abutment sidewall (approximately 0.2m², poor). There is a narrow vertical crack in the east abutment sidewall with evidence of leakage and efflorescent staining. There is a steel drain through the south end of the east abutment sidewall that is in poor condition with severe corrosion and section loss. The streambed has eroded through the structure, exposing approximately 0.3m of both footings. The watercourse is unobstructed.

We recommend placing riprap along the footings in 1-5 Years to prevent further erosion.

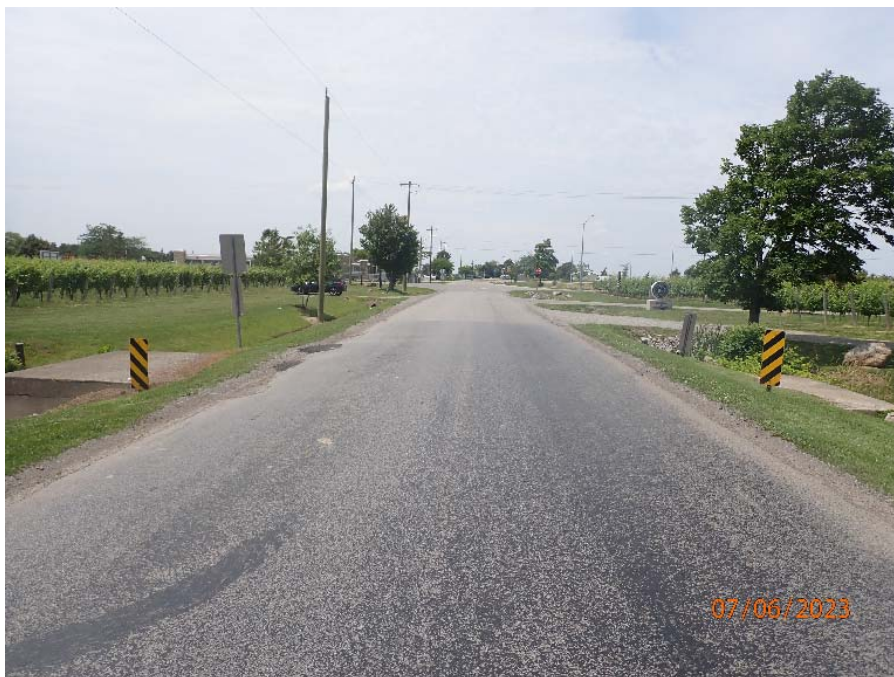
Photograph No. 1: 0560: Roadway over the structure looking west.

The surface treated roadway over the structure is generally in good condition with light deterioration of the roadway edges. There is no guiderail protection over the structure or on the approaches. There are hazard markers at all four corners. The vegetated and rock roadway embankments are generally in good condition. There is medium erosion at the southwest corner and light erosion at the northeast corner. The concrete headwalls are generally in good condition with one spall (approximately 0.2m², poor, to a 75mm depth) on each headwall. The structure was widened by 2.3m to the north and 2.1m to the south.

We recommend that the Town review their Roadside Safety Policy NOW to determine if steel beam guiderails are required to provide traffic protection over the structure.

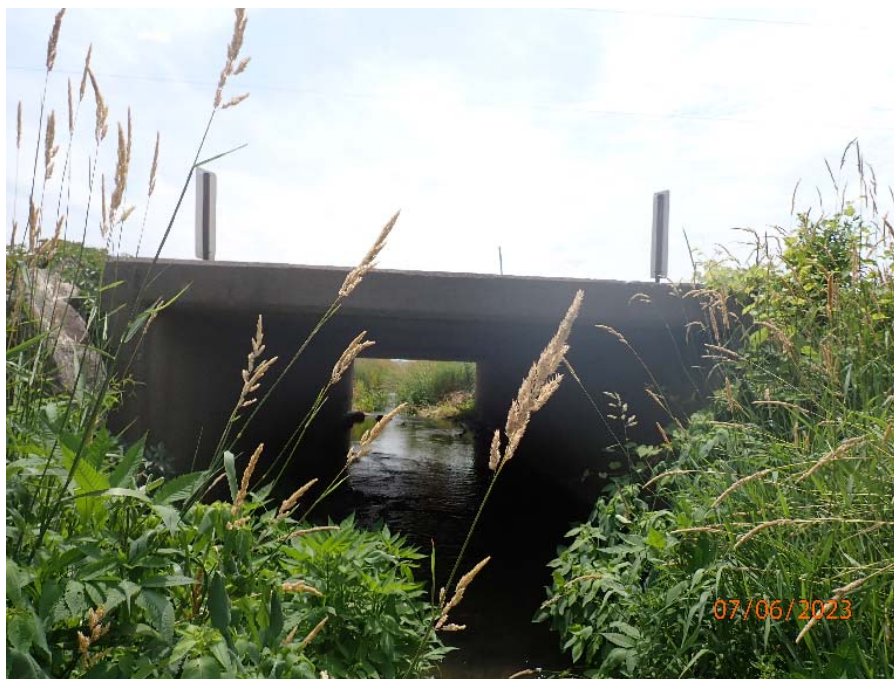
Photograph No. 2: 0618: North elevation.

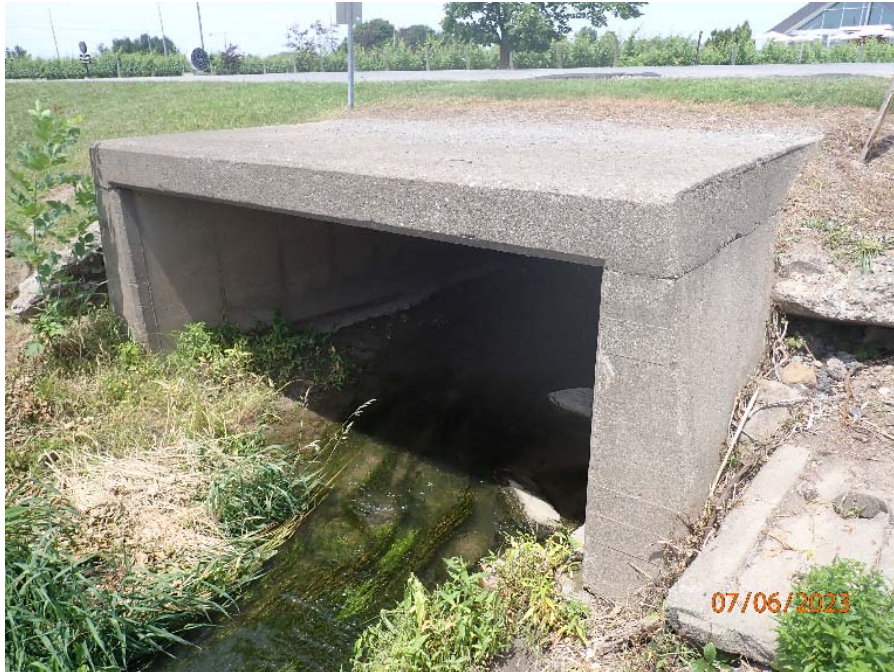
Photograph No. 3: 0574: South elevation.

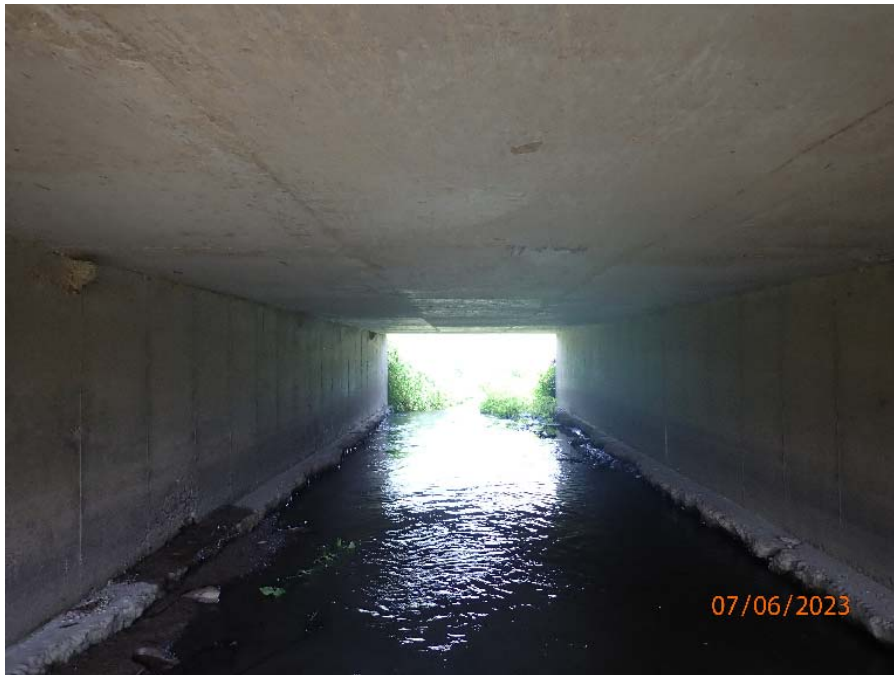
Photograph No. 4: 0580: Underside of the structure looking north.

The concrete deck soffit of the original structure is generally in good condition with localized areas of severe delamination (approximately 4m², poor) and severe spalling with exposed corroded reinforcing steel (approximately 0.5m², poor) adjacent to construction joints in the soffit at both ends. The concrete abutments of the original structure are in good condition with localized honeycombing (approximately 0.5m² in total). There is a medium pop-out on the east abutment sidewall at the south end. There are drains in the abutment sidewalls at all four corners of the structure with staining and light concrete deterioration around the drains. The concrete deck soffit, abutments, headwalls, and retaining walls of the widened portions of the structure are in good condition. There is a light delamination on the soffit of the north widened portion of the structure. The structure is on a 45 degree skew.

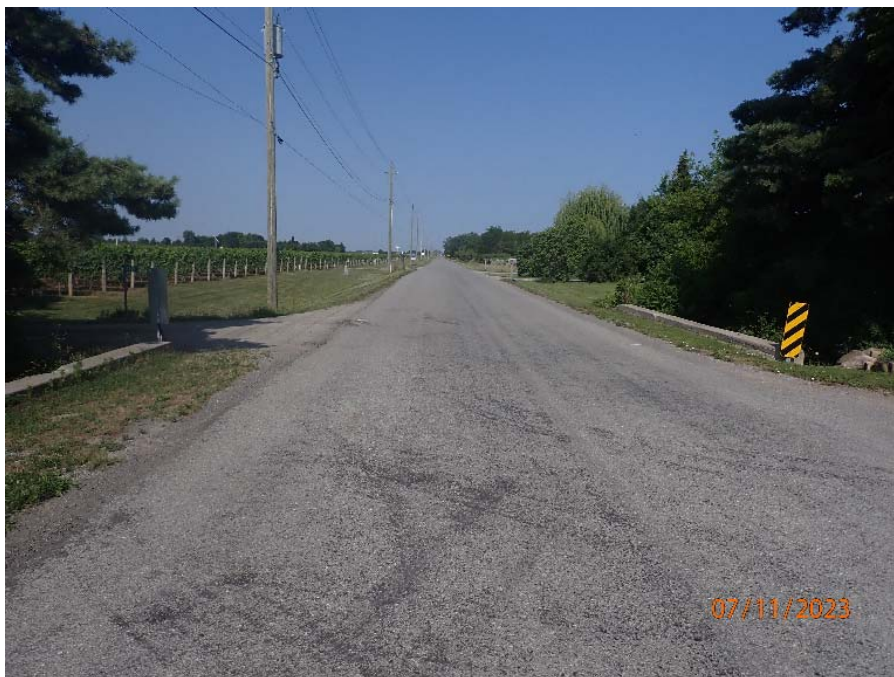
Photograph No. 1: 0112: Roadway over the structure looking west.

The surface treated roadway over the structure is in good condition. There are steel beam guiderails over the structure, which are in good condition. There are extruders at the northwest, northeast, and southeast corners and a driveway rounding at the southwest corner of the structure. There are hazard markers at all corners except for the southwest corner. The vegetated roadway embankments are generally in good condition with light erosion at all four corners.

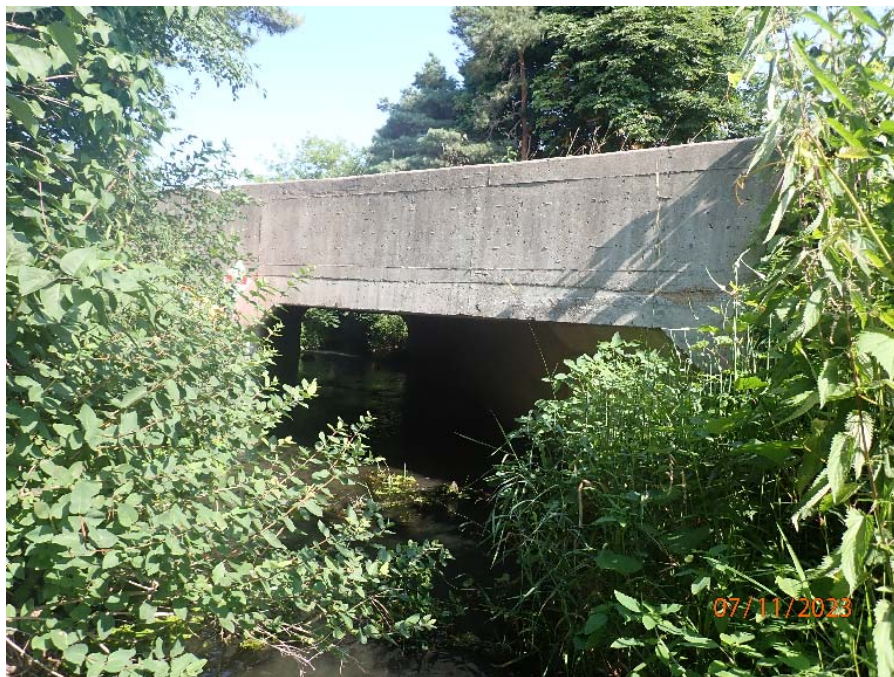
Photograph No. 2: 0140: South elevation.

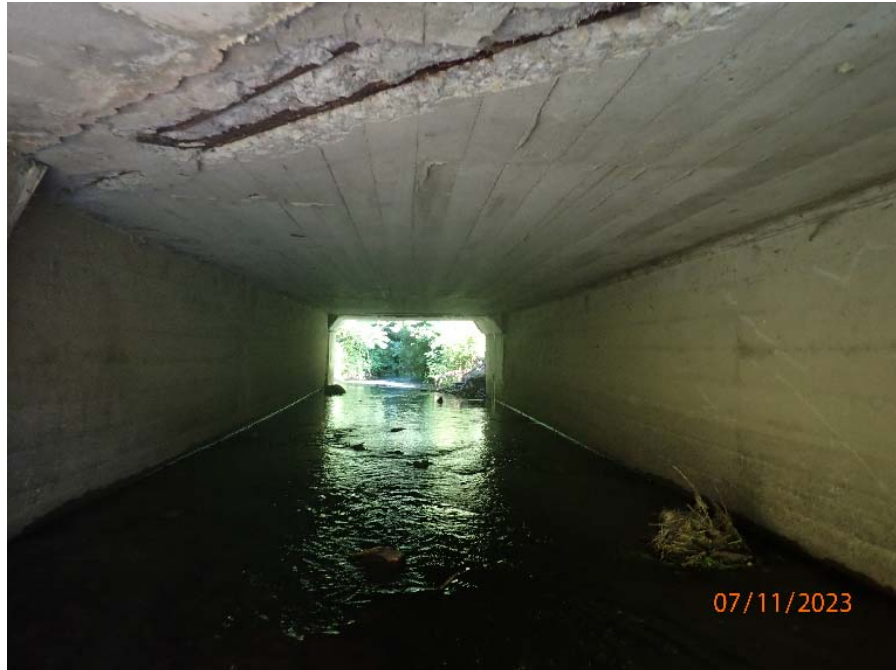
Photograph No. 3: 0150: Underside of the structure looking north.

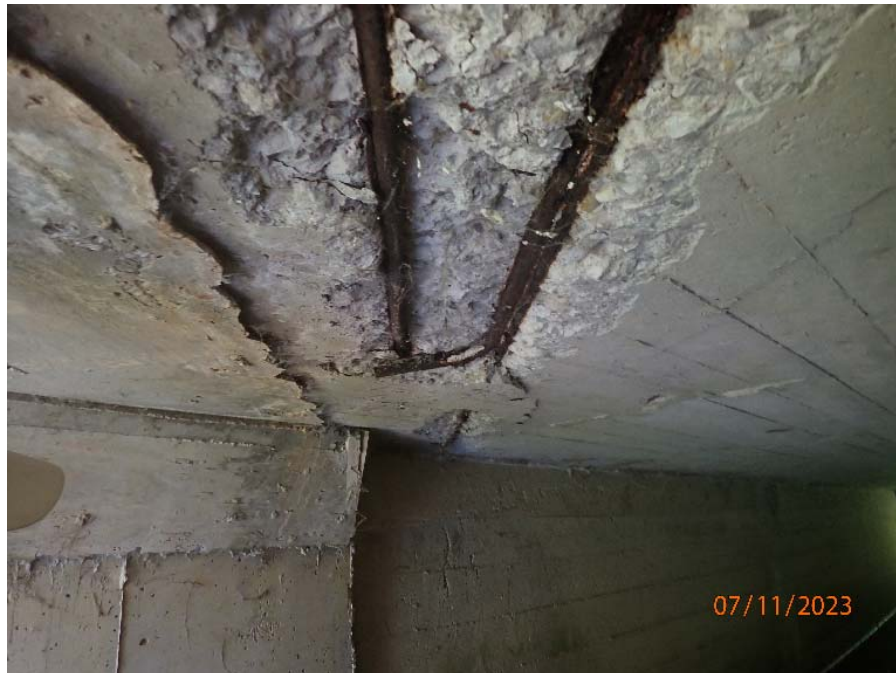
Photograph No. 4: 0162: Spall with exposed corroded reinforcing steel at the south construction joint.
