TOWN OF NIAGARA-ON-THE-LAKE

2023 MUNICIPAL BRIDGE APPRAISAL REHABILITATION/REPLACEMENT NEEDS

February 2024

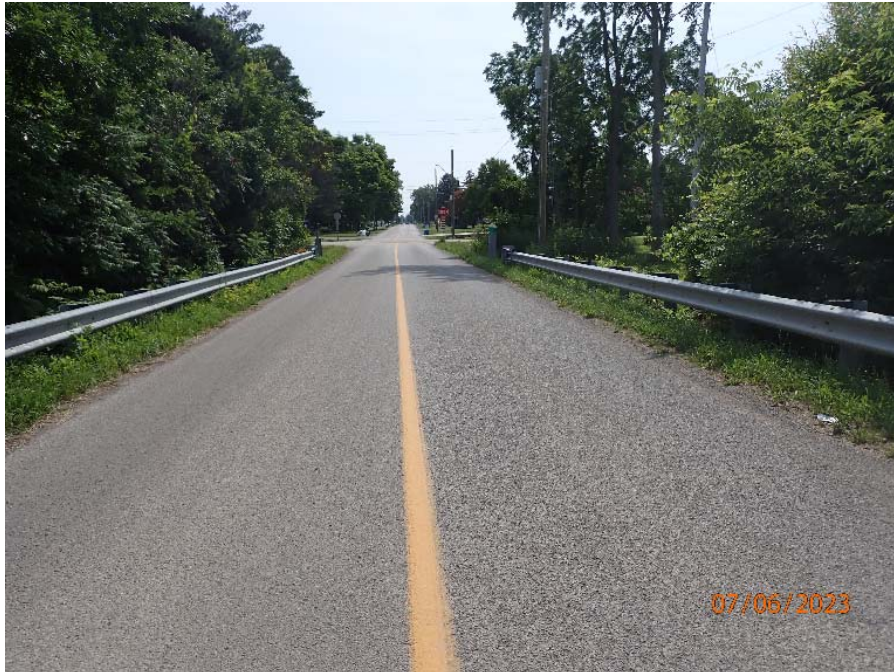
Photograph No. 1: 0365: Roadway over the structure looking east.

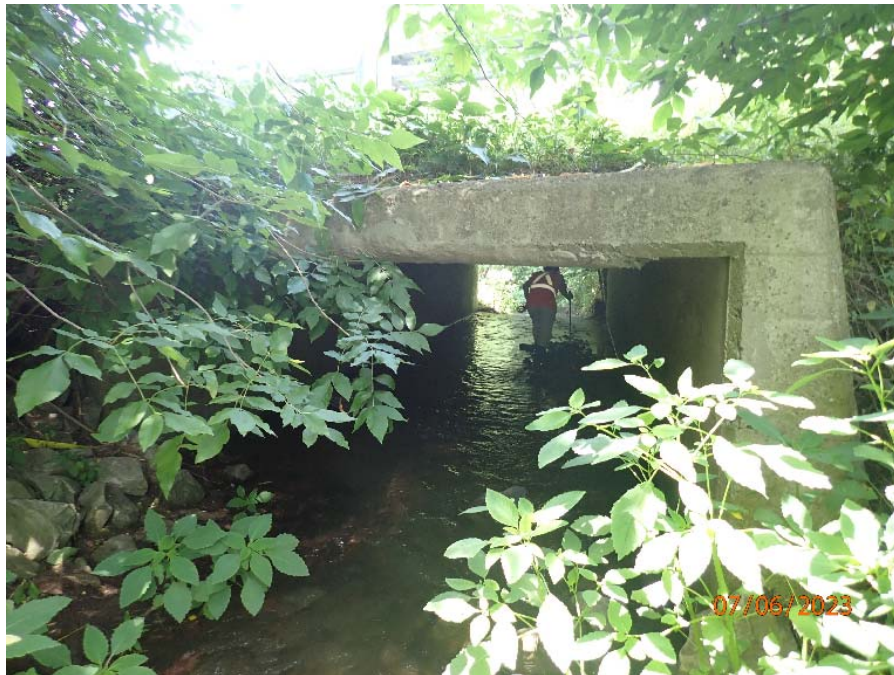
Photograph No. 2: 0411: South elevation.

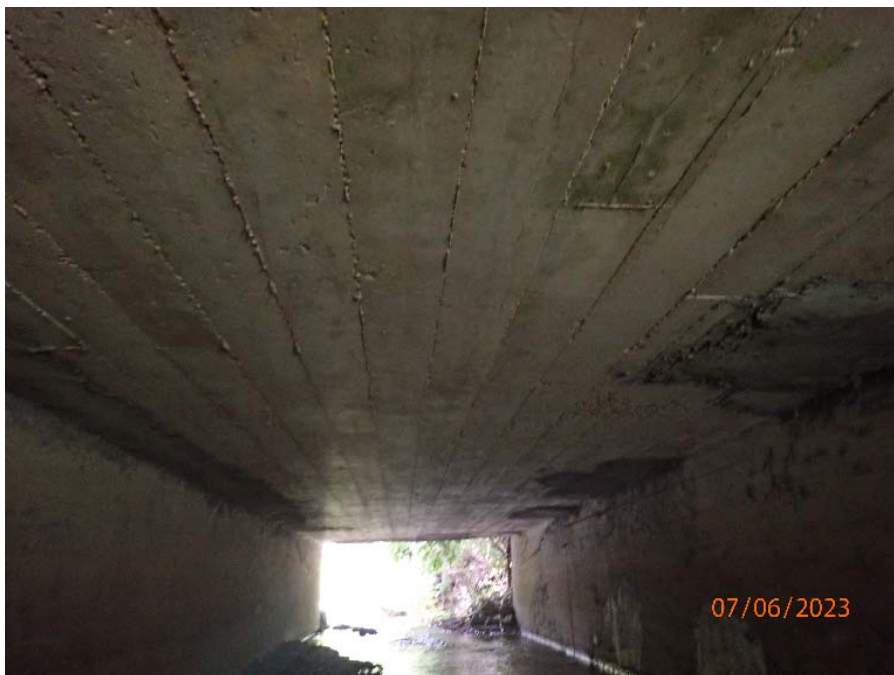
Photograph No. 3: 0383: Interior looking south.

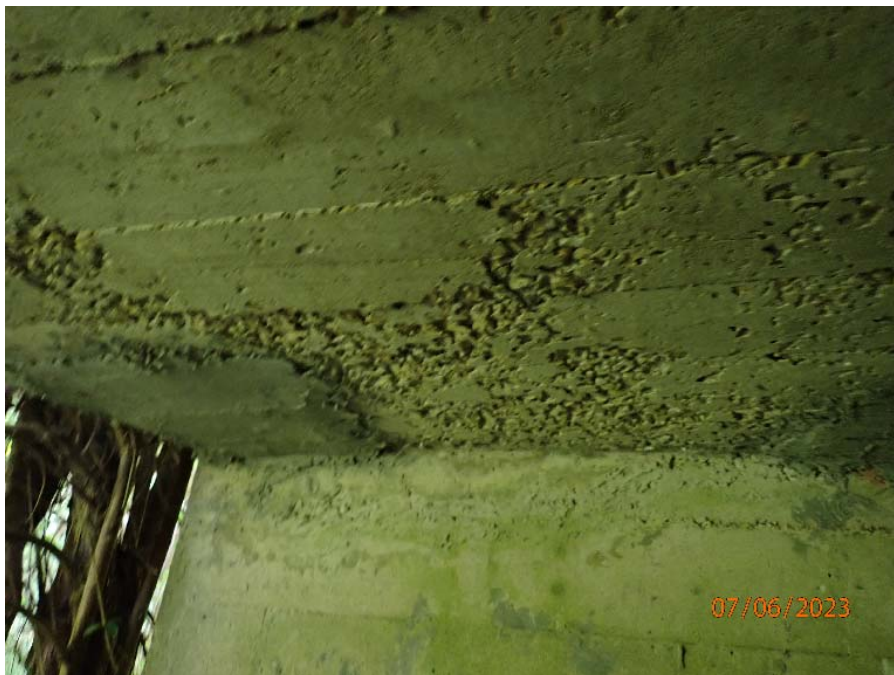
Photograph No. 4: 0387: Area of honeycombing in soffit at north end.

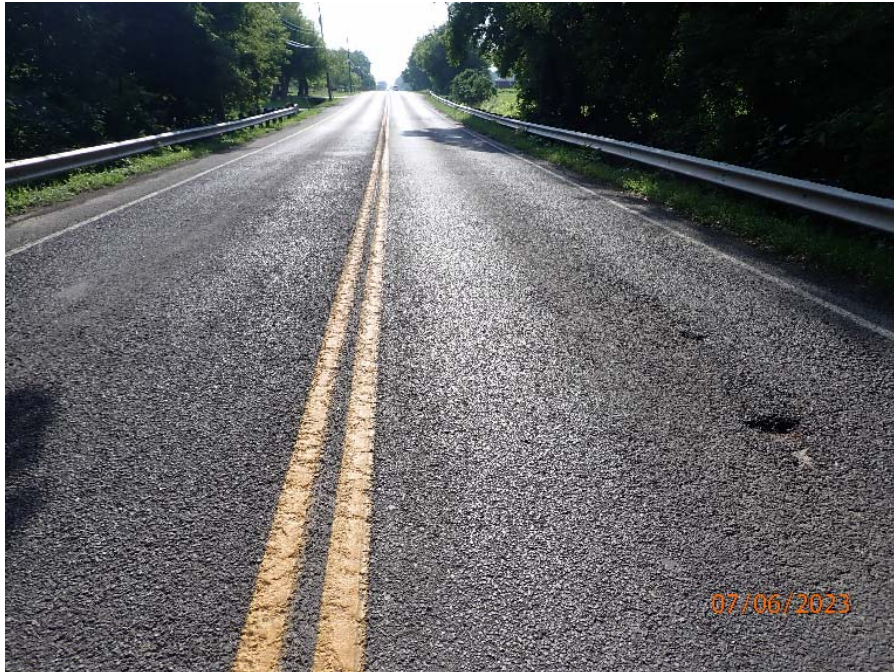
Photograph No. 1: 0013: Roadway over the structure looking east.

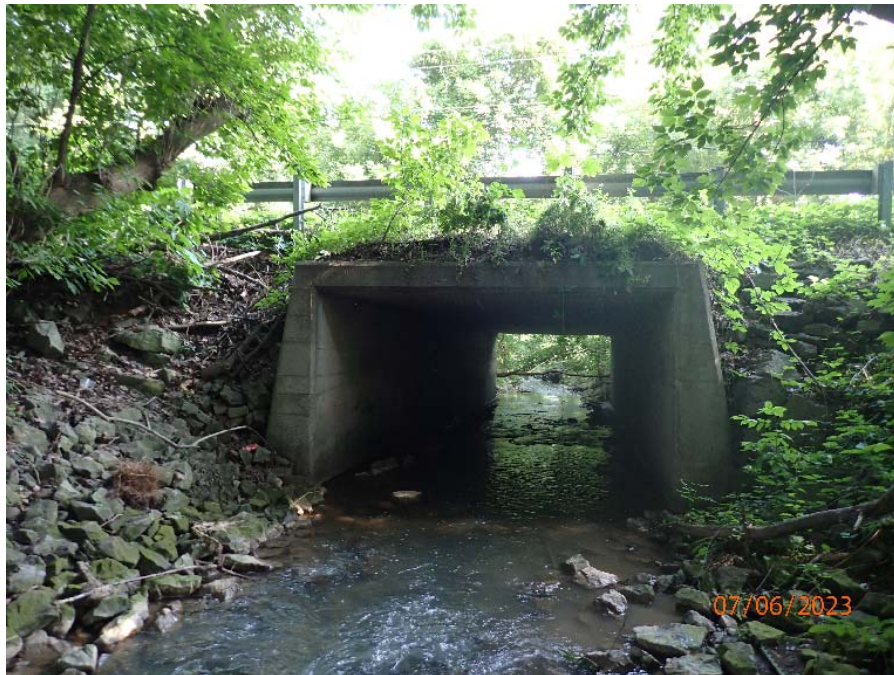
Photograph No. 2: 0070: South elevation.

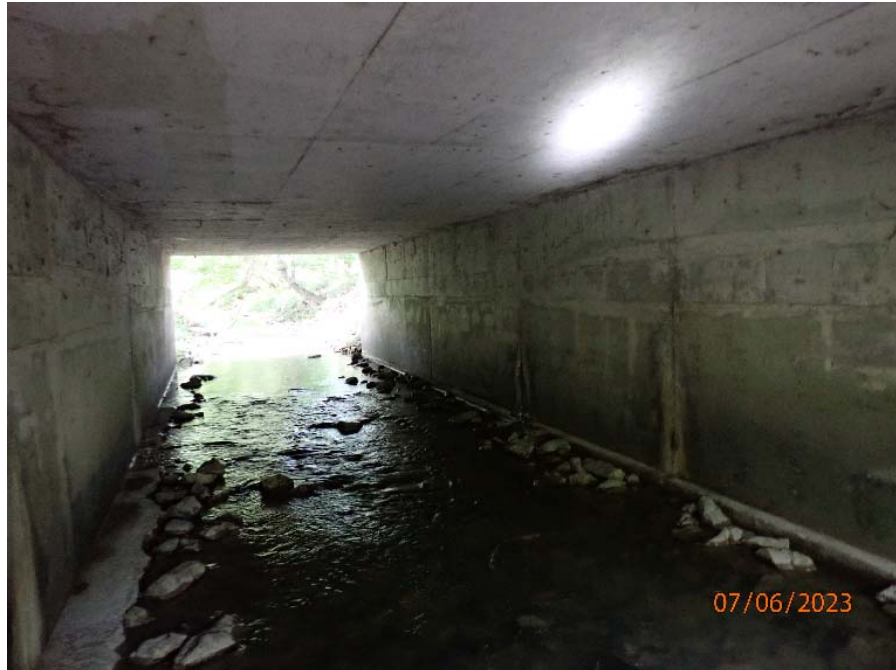
Photograph No. 3: 0042: Underside of the structure looking south.

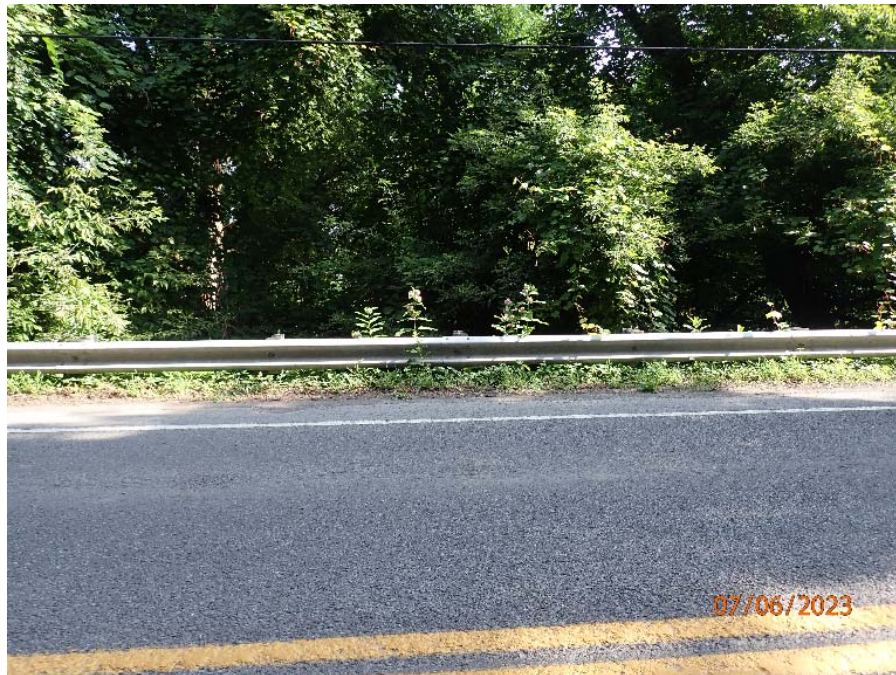
Photograph No. 4: 0089: Low guiderail at north side of roadway.

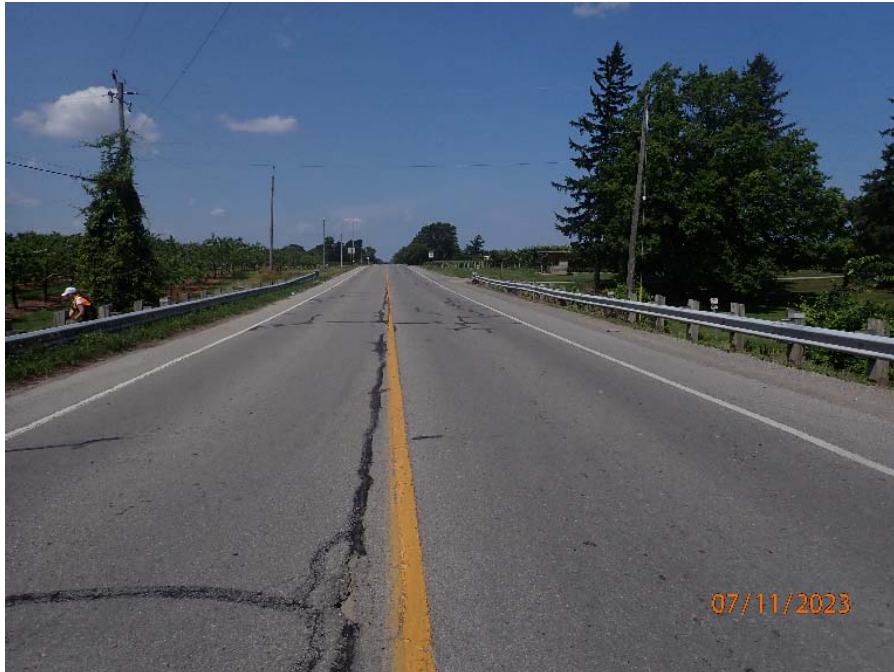
Photograph No. 1: 0386: Roadway over the structure looking west.

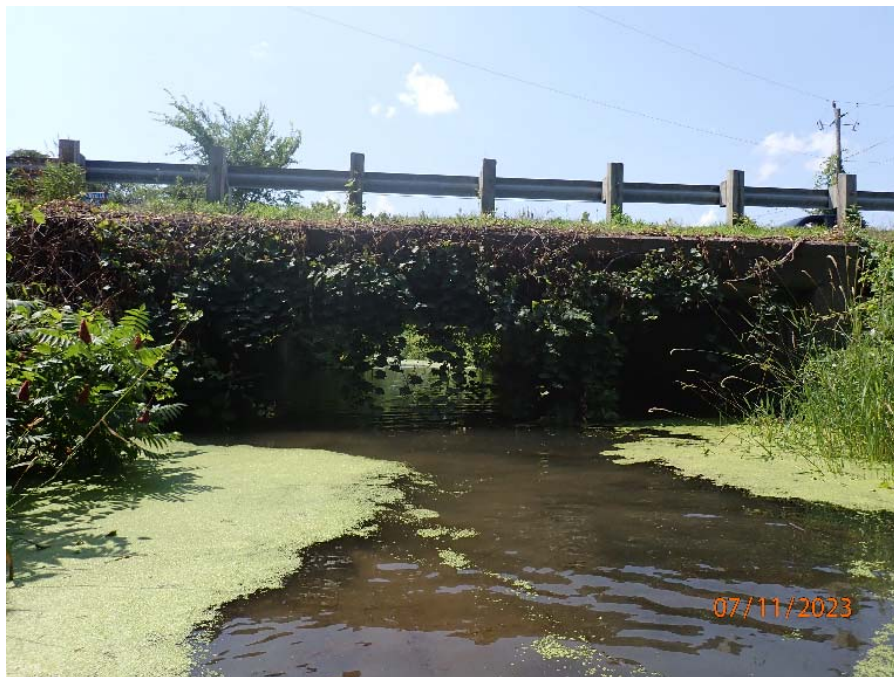
Photograph No. 2: 0407: North elevation.

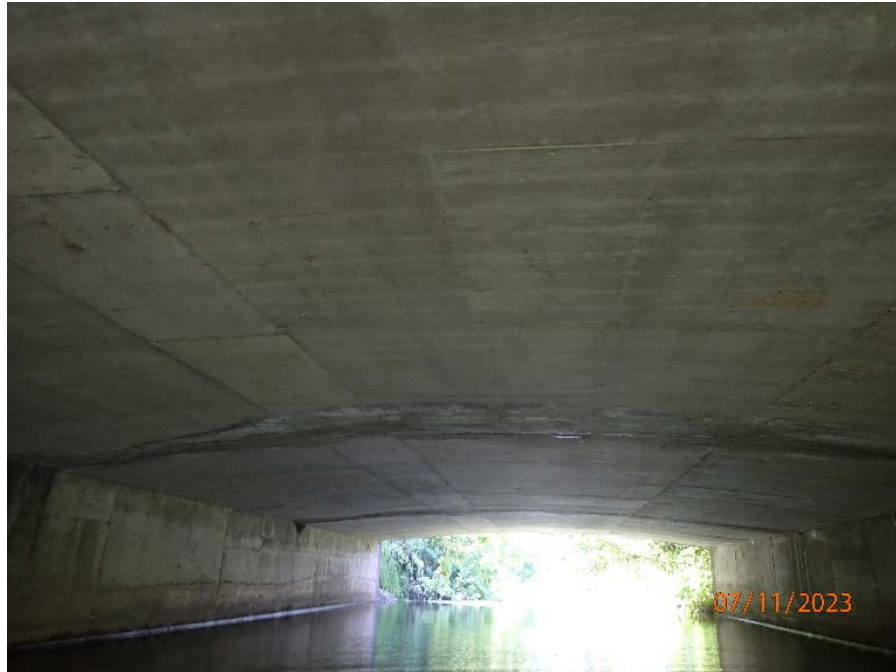
Photograph No. 3: 0399: Underside of the structure looking south.

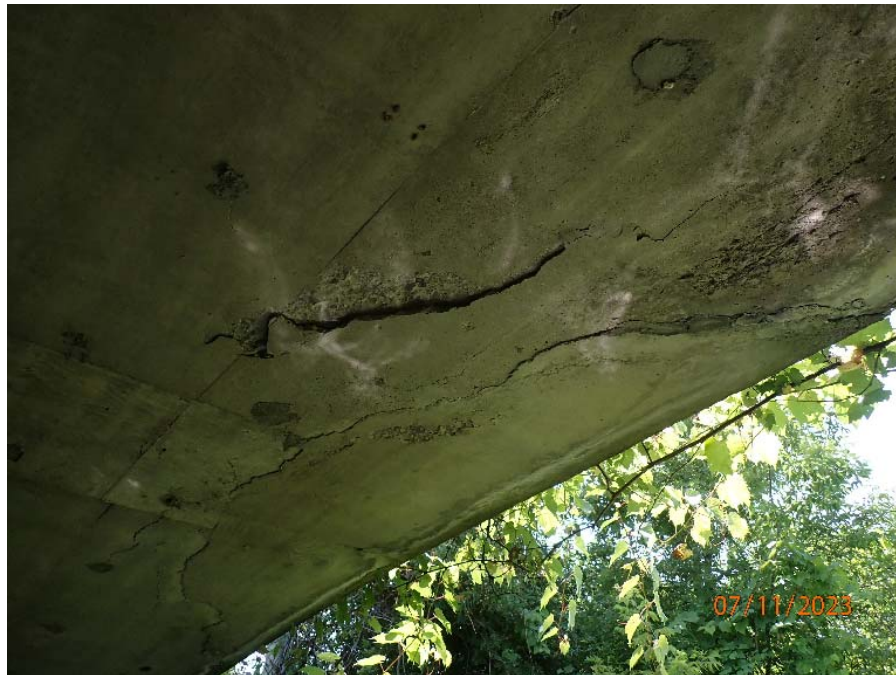
Photograph No. 4: 0437: Delamination at the south end of soffit.

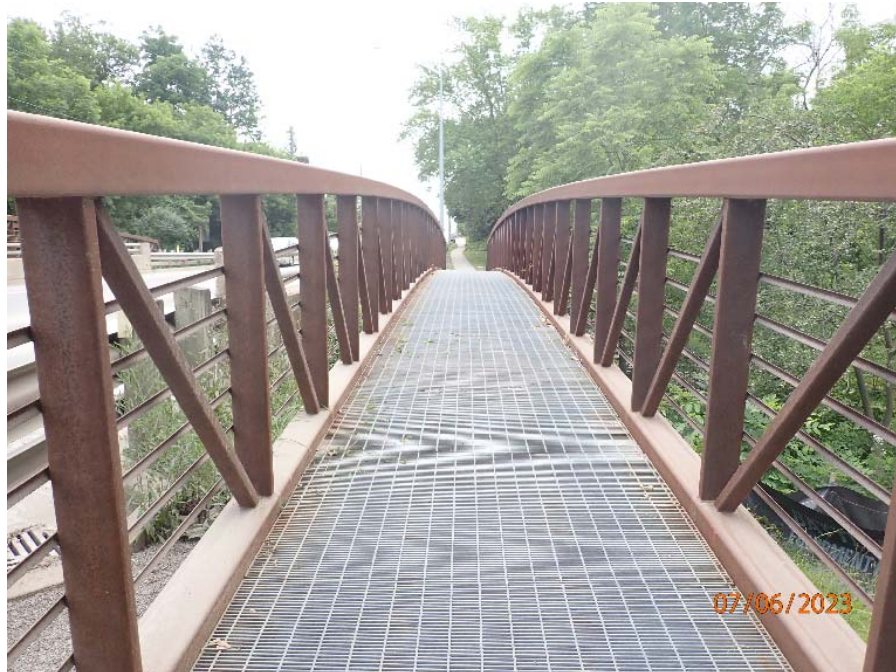
Photograph No. 1: 0786: Walkway over the structure looking south.

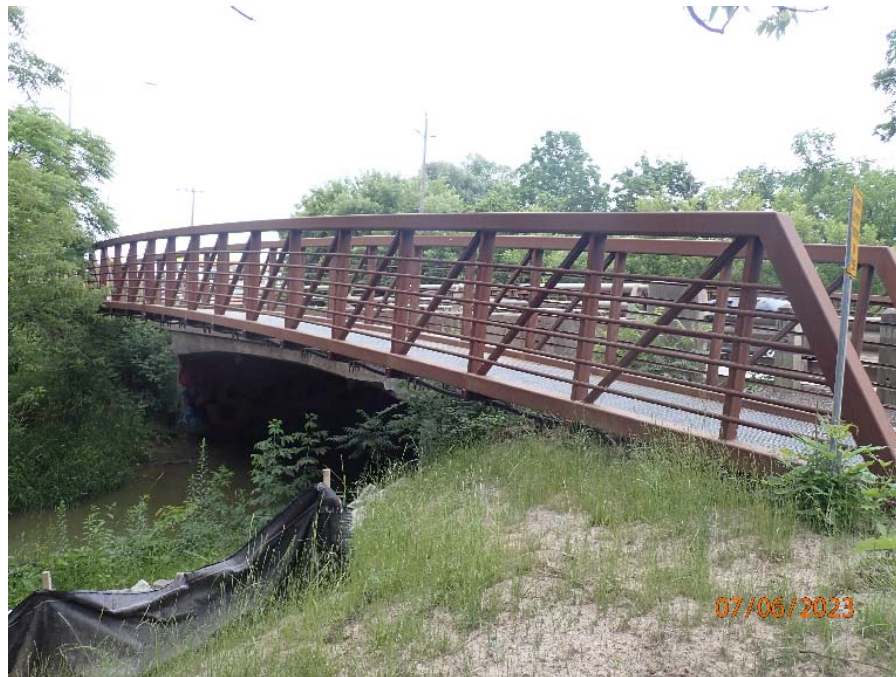
Photograph No. 2: 0802: West elevation.

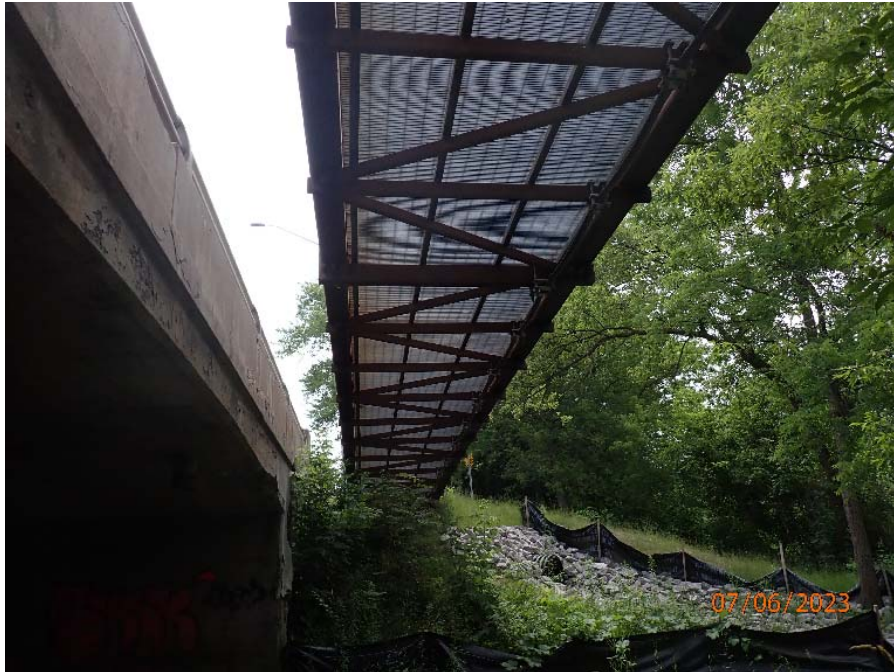
Photograph No. 3: 0760: Underside of the structure looking south.

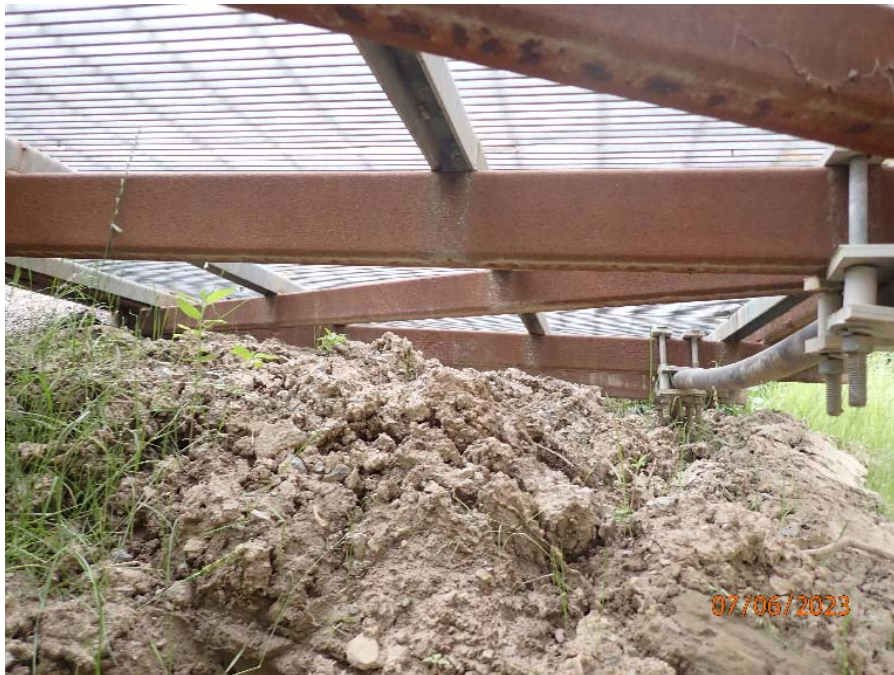
Photograph No. 4: 0809: Filled sinkhole under south end of structure, looking south.

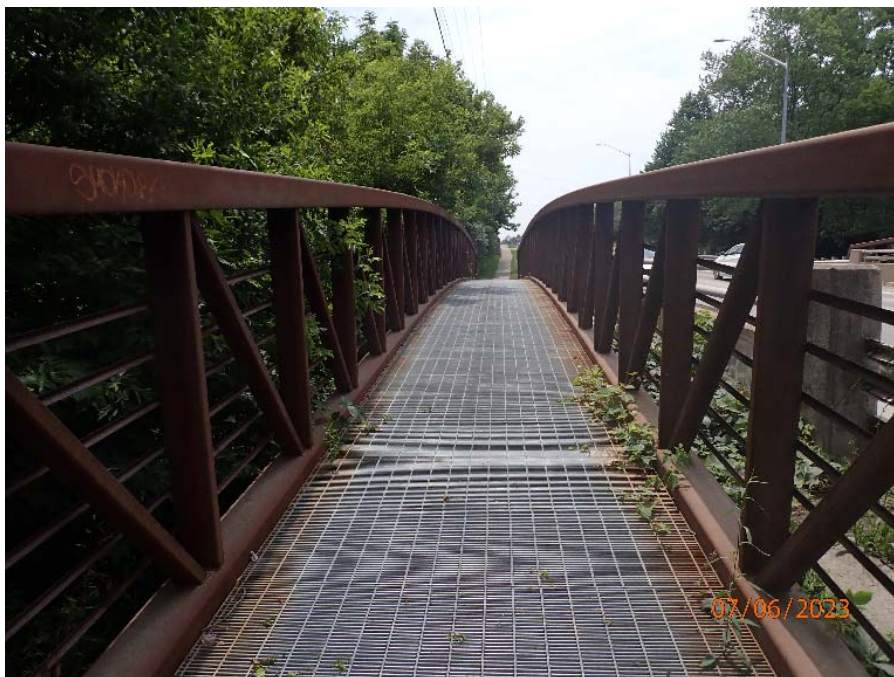
Photograph No. 1: 0683: Walkway over the structure looking south.

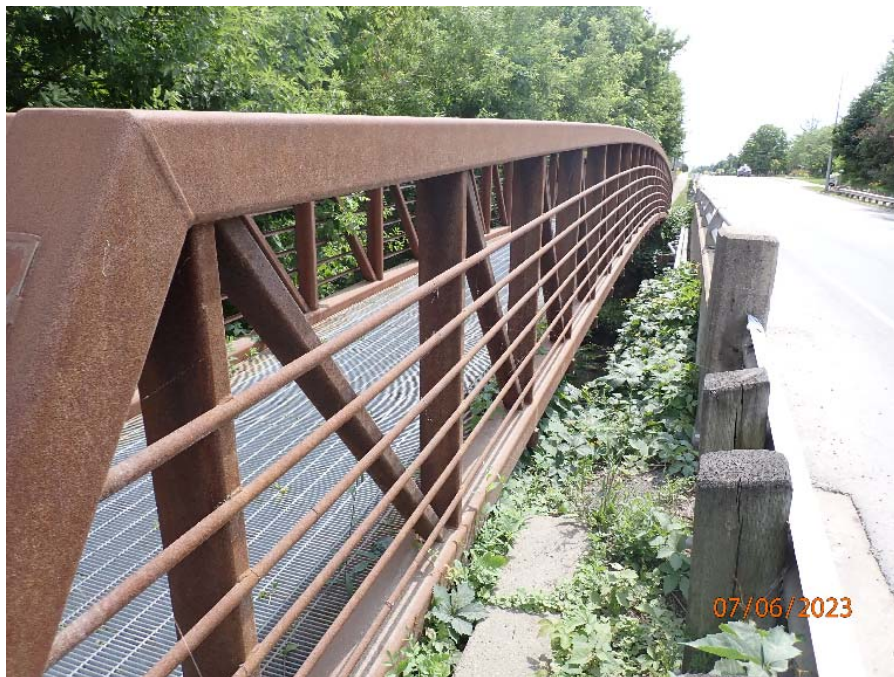
Photograph No. 2: 0811: West elevation.

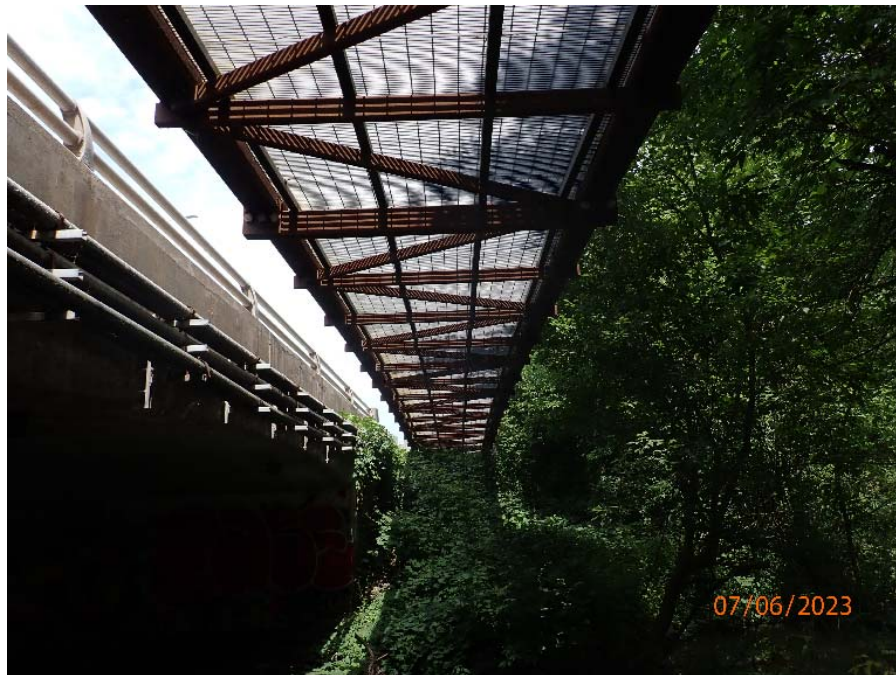
Photograph No. 3: 0700: Underside of the structure looking north.

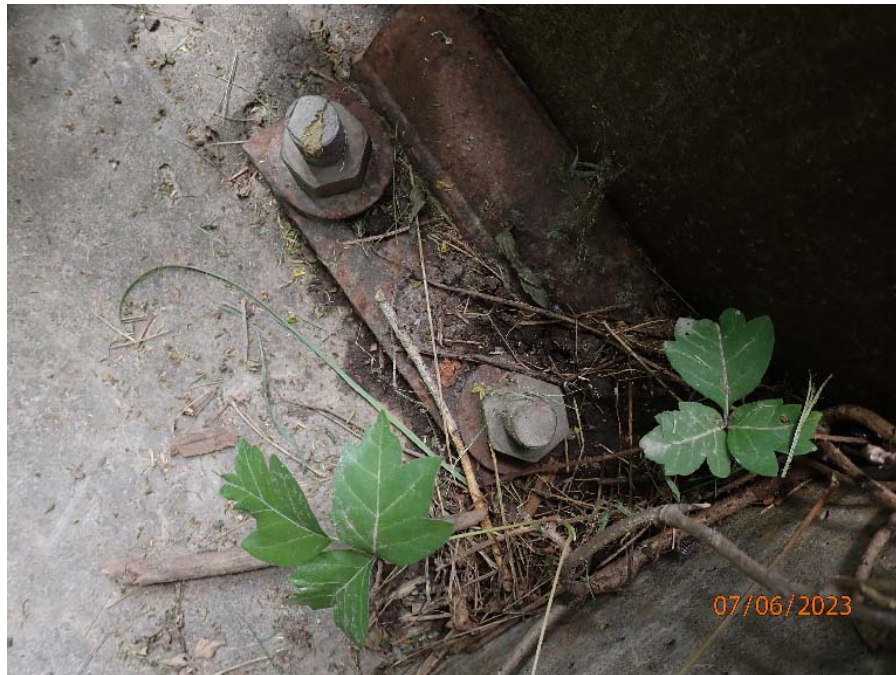
Photograph No. 4: 0742: Northeast bearing.
